**RECALL
BULLETIN:
90521**

**PRODUCT(S)
AFFECTED:**
Jamboree,
Jamboree Sport,
Tioga Ranger,
manufactured
from April 16,
2009 through
May 13, 2009

SUBJECT:
Brake Line
Inspection/
Correction

ISSUE DATE:
July 2009

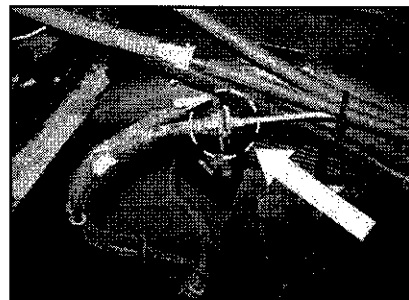
2. Locate the rear connection for the Fleetwood-installed extension brake line by looking under the motor home, slightly forward of the rear axle and near the driver's side rail. See Figures 1 and 2.

Figure 1
Rear brake line extension connection shown from above

- A. If no brake fluid leaks are found at this area, continue to Step 5.
 - B. If the brake line is leaking fluid at the rear connection, use a 1/2" flare nut wrench to hold the brass union stationary, and tighten the flare nut using a 3/8" flare nut wrench until leakage stops. Wipe the connection and verify there are no further leaks; correct if necessary. **Do not over-torque the connection.** Proceed to Step 5 to inspect and if necessary, correct the union connection with the Ford brake line.

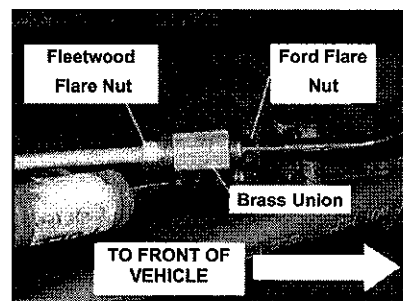
5. Locate the brass union between the Fleetwood-installed brake line extension (silver) and the Ford OEM brake line (black). The union, tucked inside the driver's side frame rail, can be located by following the Fleetwood-installed brake line extension towards the front of the vehicle. See Figure 3.

Figure 3
Forward (union) brake line connection shown

6. Determine the size of the flare nut for the Ford brake line attached at the union connection, using 3/8" and 7/16" wrenches as "go/no go" gauges:
 - If the 3/8" wrench will fit onto the Ford flare nut, the Ford brake line must be replaced. **Replacement of the Ford OEM brake line, if required, must be performed by an authorized Ford repair technician. Contact Fleetwood's Motor Home Dealer Technical Support group for a Prior Authorization Request (PAR) and further instructions.**

- If the 7/16" wrench will fit onto the nut for the Ford brake line, but the 3/8" wrench will not fit, the flare nut size is correct (7/16") and does not require replacement.

- A. If no brake fluid leaks are found at this area, no further action is necessary and this Bulletin is complete.
 - B. If the brake line is leaking fluid at the forward connection, use a 1/2" flare nut wrench to hold the brass union stationary, and tighten the flare nut on the Fleetwood brake line extension using a 3/8" flare nut wrench until leakage stops. Wipe the connection and verify there are no further leaks; correct if necessary. Repeat as necessary for the Ford brake line connection, using a 7/16" flare nut wrench. **Do not over-torque the connections.**
