## Safety Recall

**Subject:** PROPELLER SHAFT BOLT TORQUE

**Bulletin #:** R0036

**Affected Models:** Certain 2009 and 2010 NV8J (338) Hino Conventional Trucks

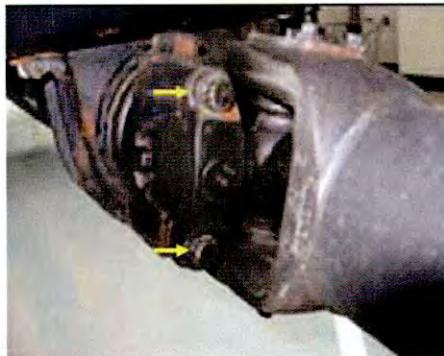
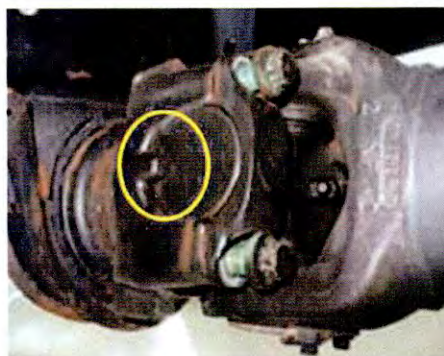
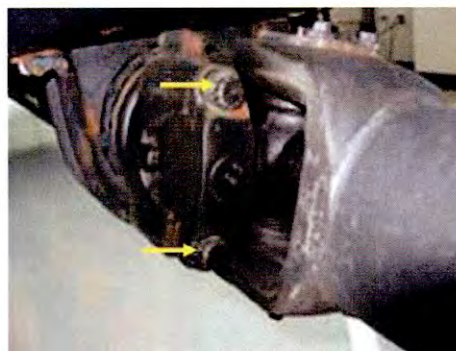
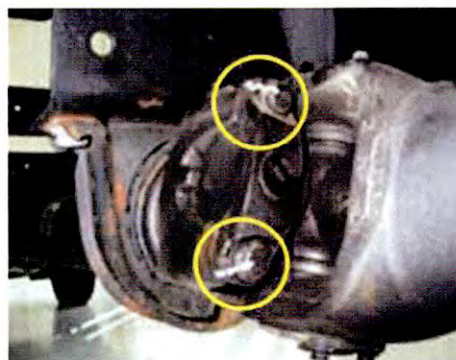
5. Remove two strap bolts and strap from one side of the u-joint.

6. Install, **hand tight**, a new strap and two new bolts.

7. Torque both bolts to 125 ft. lbs. (169 Nm.)

8. Apply paint to each bolt after performing torque procedure.

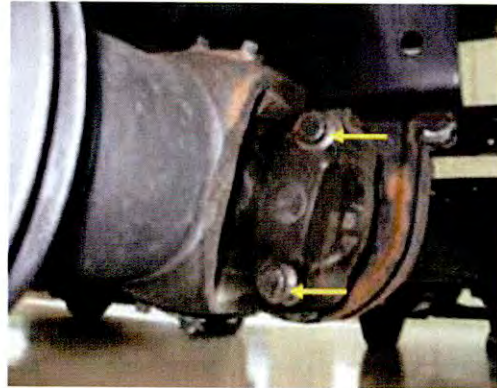
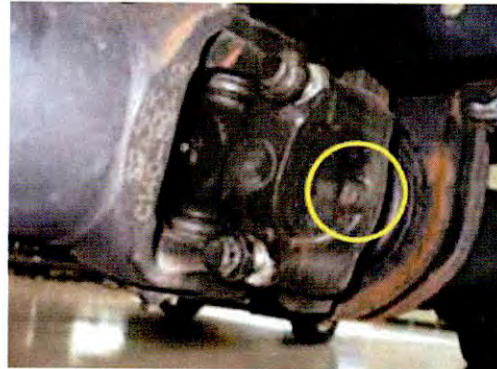
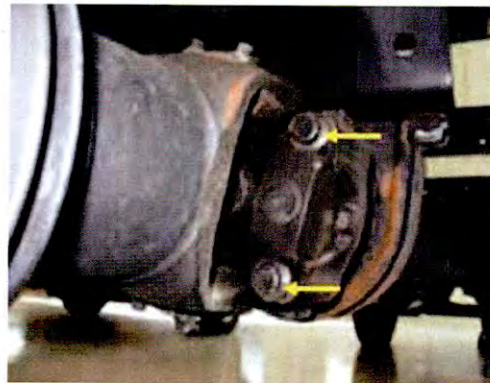
**9.** Remove two strap bolts and u-joint strap from the other side of the u-joint.

**10.** Install, hand tight, one new strap and two new bolts.

**11.** Torque both strap bolts to 125 ft. lbs. (169 Nm.)

**12.** Apply paint to each bolt after performing torque procedure.

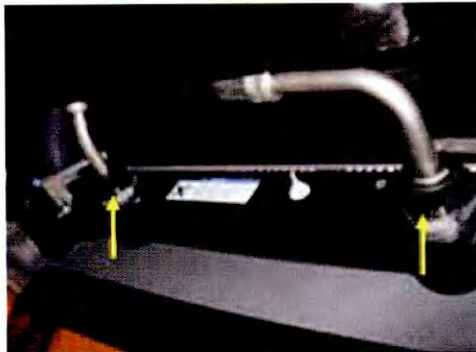
6. Remove both transmission cooler line covers on the radiator by cutting the clamp bands and removing the rubber dust covers.

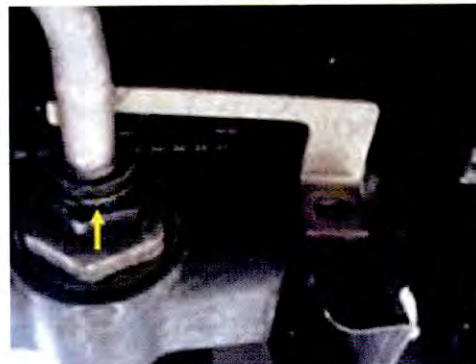
8. Place a drain pan under the lines and remove the retainers. Discard the retainers. Remove the lines from the radiator.

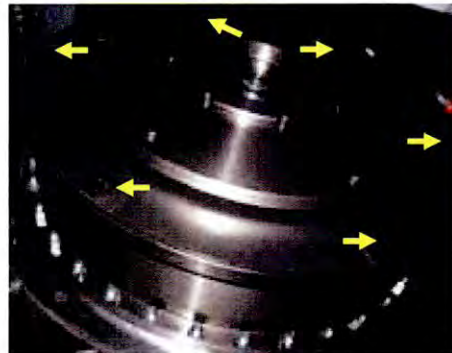
19. Remove and replace, **one at a time**, the six spacer coupling bolts.

Torque the new bolts to 50 lb ft (68 Nm).

If all bolts are removed at once the spacer coupling could fall off.

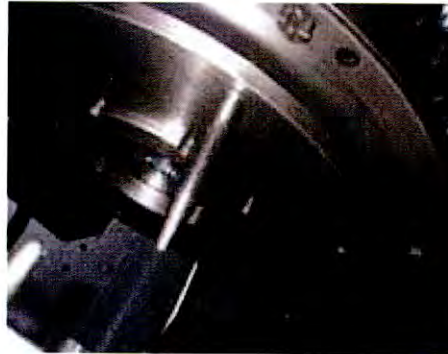
**20.** Install the spacer coupling guide (SST 09657-1370) into the spacer coupling and rotate the torque converter so that the guide faces down.

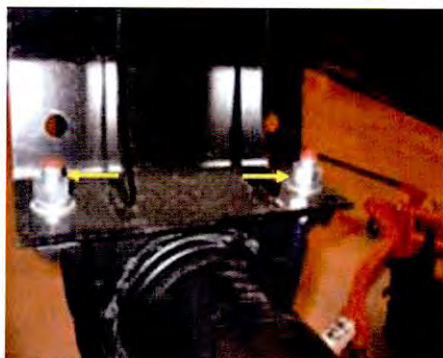
**27.** Reinstall the #1 carrier bearing using the previously removed nuts and bolts.

Torque the bolts to 105 lb ft (142 Nm).

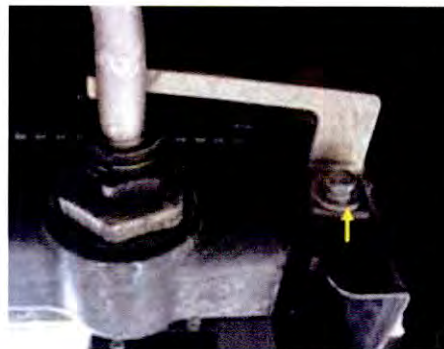
**30.** Reinstall the retaining bolt for each cooler line.

Torque the retaining bolts to 16 lb ft (22 Nm).

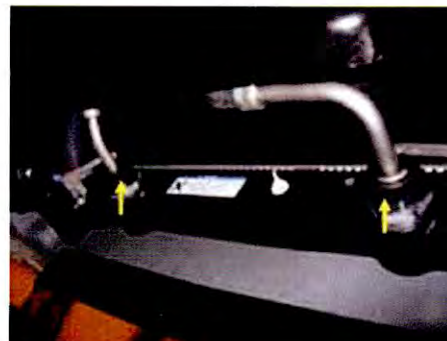
**31.** Replace the transmission cooler line covers and secure with new clamp bands.

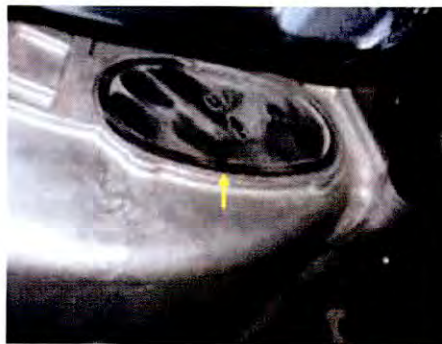
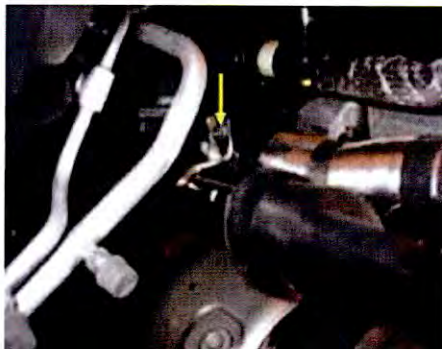
**32.** Remove the spacer coupling guide from the spacer coupling through the flywheel inspection cover. Reinstall, *hand tight*, one coupling bolt and manually rotate the engine to reinstall all six bolts through the inspection cover.

Torque all six flywheel coupling bolts to 55 lb ft (75 Nm).

**33.** Reinstall the flywheel housing inspection cover.

**34.** Reinstall the dipstick mount and bolt to the bracket.

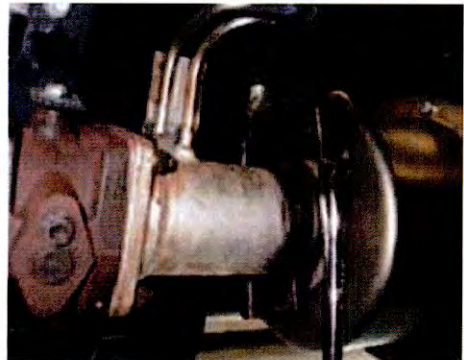
6. Remove the upper bolt, nut, and both clamps.

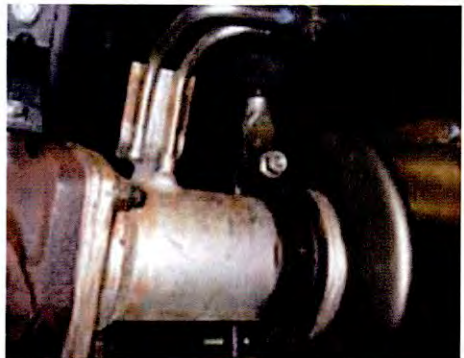
7. Install, *hand tight*, the new upper bolt, new nut, and new clamps.

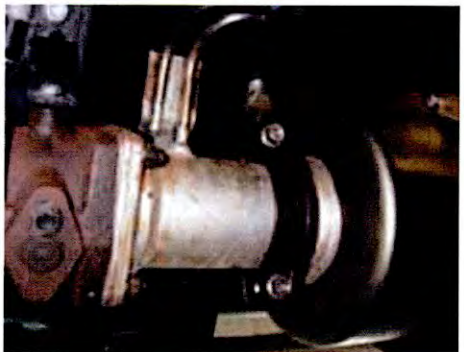
8. Install, *hand tight*, the lower bolt and lower nut.

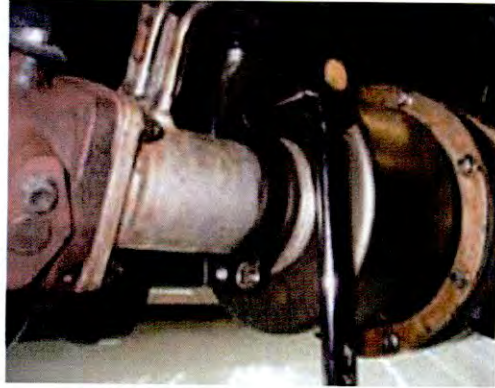
9. Torque the upper bolt to 38 ft. lbs. (51 Nm)

The top bolt must be torqued before the lower bolt is torqued.

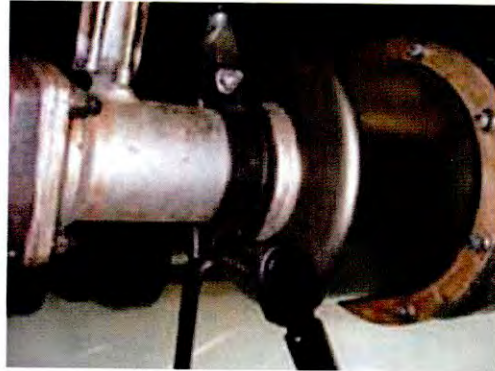
10. Torque the lower bolt to 22 ft. lbs. (30 Nm)

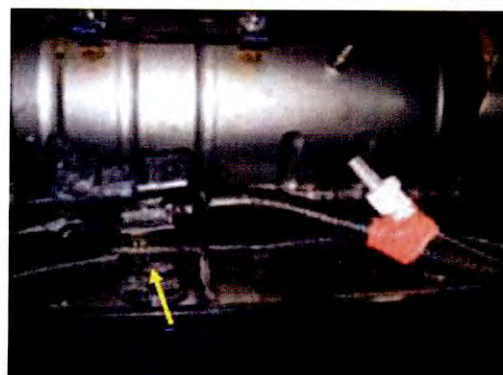
12. Release the wiring harness connector retainer from the bracket and remove the bracket.

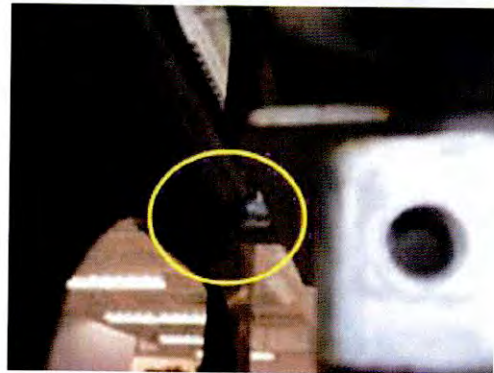
18. Install, *hand tight*, the vertical stack with three new clamps with one of the supplied nuts.

Ensure the locating tabs on the clamps align with the holes in the vertical stack bracket.

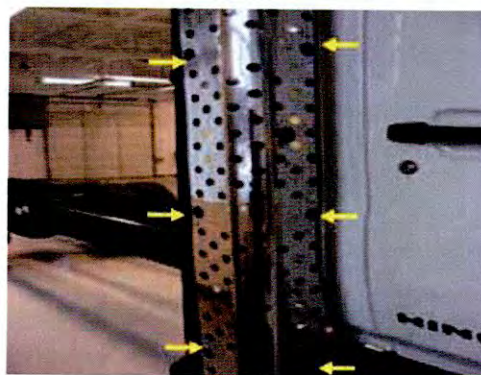
- 22.** Reinstall the heat shield and the six bolts.

Torque the heat shield bolts to 16 ft. lbs. (22 Nm)
