Safety Defect and Noncompliance Report Guide for Vehicles  
**PART 573 Defect and Noncompliance Responsibility and Reports**<sup>1</sup>

On November 22, 2010, Van Hool N.V. decided that a defect which relates to motor vehicle safety exists in the motor vehicles listed below, and is furnishing notification to the National Highway Traffic Safety Administration in accordance with 49 CFR Part 573 Defect and Noncompliance Responsibility and Reports.

**Exhibit 2 : photographs of the rear view mirror remote control switches**

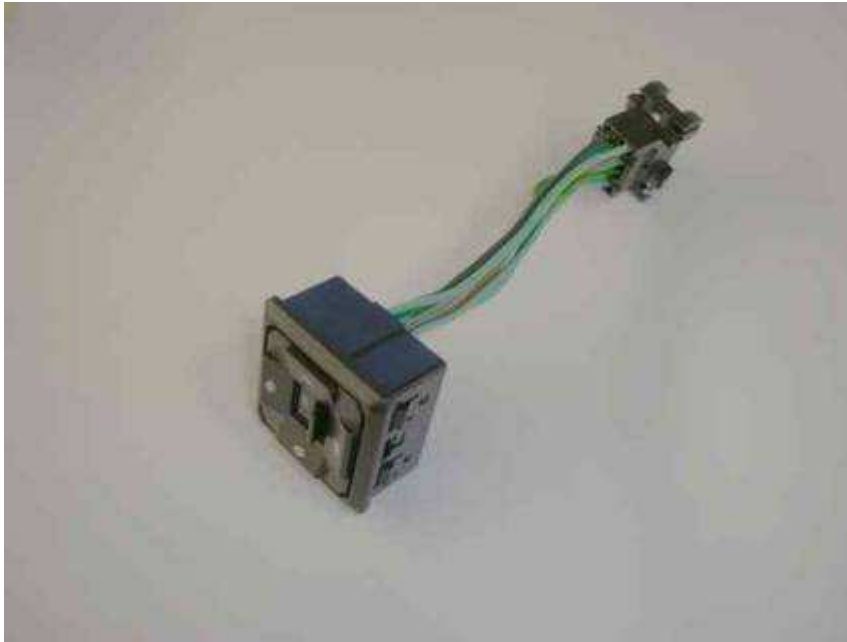
**1. Hadley 509VH (10983192)**

The switch itself can be identified by observing the top of the switch. If it is flat in design with only a small flat paddle to change from the RH to LH mirror control functions, and also has four directional arrows, it is the subject of this recall. If it is a "joystick" design that

The rear view mirror switch Hadley 509 may overheat, causing the plastic housing to melt.

The cause is probably an internal short in the rear view mirror switch, but this should be confirmed by the supplier.

If the Hadley 509VH or 509VH1F switch has not already been replaced, then a permanent fix would be to replace this switch with the Hadley X516-VHASY switch that the supplier determines would address any issue.

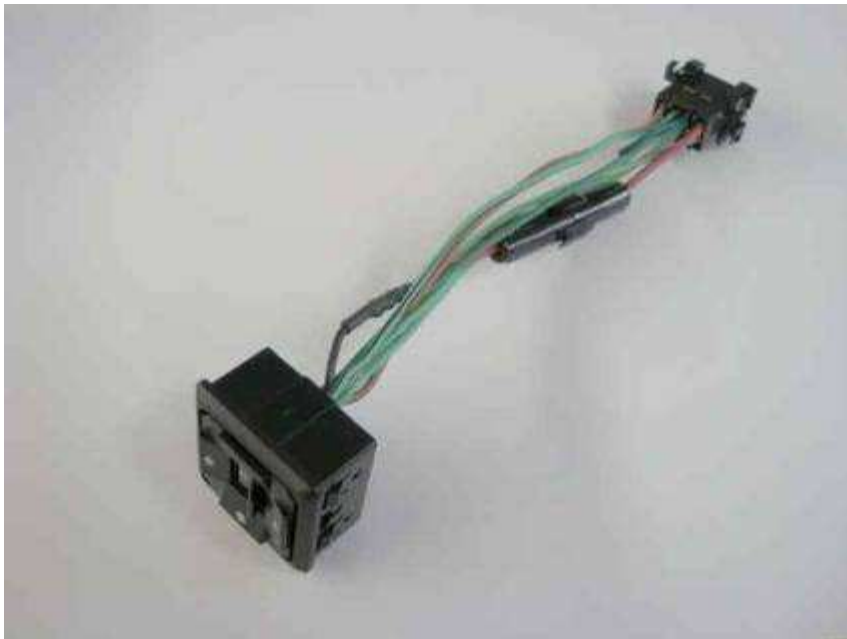
**2. Hadley 509VH1F (11181194)**

- 6) September 12, 2010: the supplier reported the decision to organise a field campaign for all passenger buses to replace the 509VH and 509VH1F switches by the X516-VHASY switch, because the same failure mode happened with the 509VH1F switch as with the original 509VH switch.

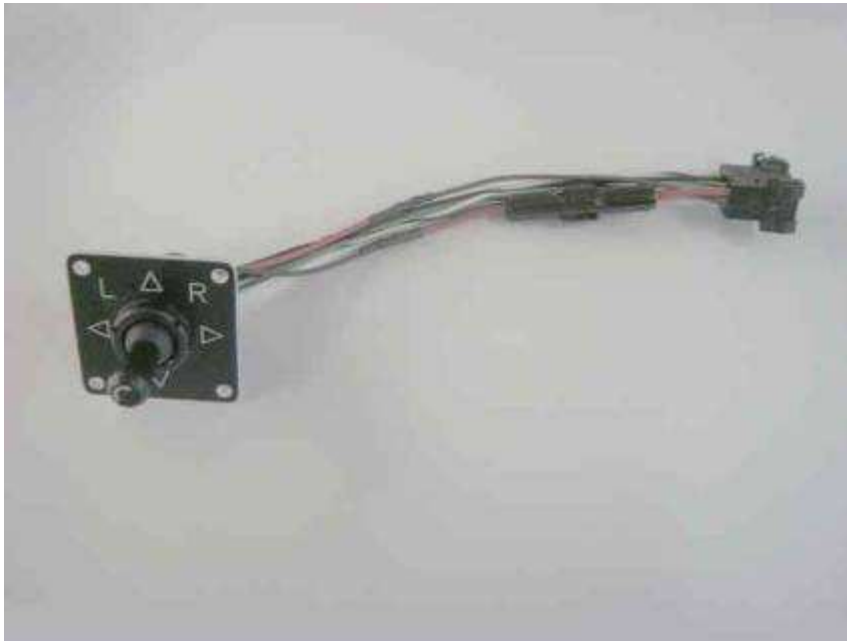
**3. Hadley X516VH-1F (11192087)**

rotates to change the RH to LH mirror functions, it is not subject to this recall; the reference of the latter mirror switch is Hadley X516VH-1F (11192087) or X516-VHASY (11239068).

The switch Hadley X516-VHASY for remedy is of a “joystick” design that is clearly distinguishable from the flat design with small flat paddle of the 509VH and 509VH1F switch subject to the recall.

From December 15, 2009 onwards the rear view mirror switch Hadley X516VH-1F is installed in transit buses, that is identical to the recall remedy.
