10V-603
(19 pages)

Notification to NHTSA in accordance with 49 CFR Part 573

Please find enclosed our 573 Defect and Noncompliance Report for the recall of passenger buses of make Van Hool with a rear view mirror remote control switch of make Hadley.

Safety Defect and Noncompliance Report Guide for Vehicles
PART 573 Defect and Noncompliance Responsibility and Reports¹

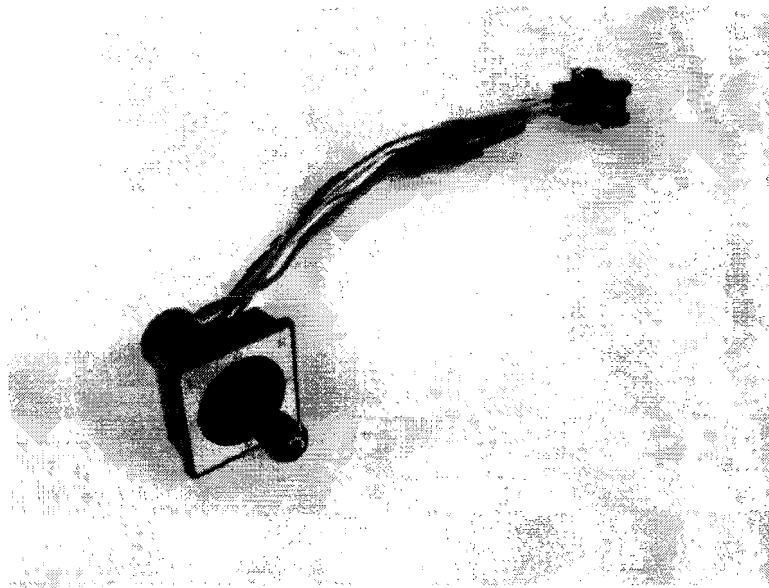
4. Hadley X516-VHASY (11239068)

rotates to change the RH to LH mirror functions, it is not subject to this recall; the reference of the latter mirror switch is Hadley X516VH-1F (11192087) or X516-VHASY (11239068).

The switch Hadley X516-VHAS Y for remedy is of a "joystick" design that is clearly distinguishable from the flat design with small flat paddle of the 509VH and 509VH1F switch subject to the recall.

If the Hadley 509VH or 509VH1F switch has not already been replaced, then a permanent fix would be to replace this switch with the Hadley X516-VHAS Y switch that the supplier determines would address any issue.
