TOYOTA

Subject: Safety Recall – 90L Phase 3
Certain 2005 – 2010 Model Year Avalon Vehicles
Potential Floor Mat Interference with Accelerator Pedal (February, 2010)

Toyota is now launching Phase 3 of Safety Recall 90L on certain 2005 - 2010 Avalon vehicles for potential floor mat interference with the accelerator pedal. All Avalon vehicles are equipped with a CTS pedal. The same templates and gauges provided to dealers for the Camry (Phase 2) will be utilized.

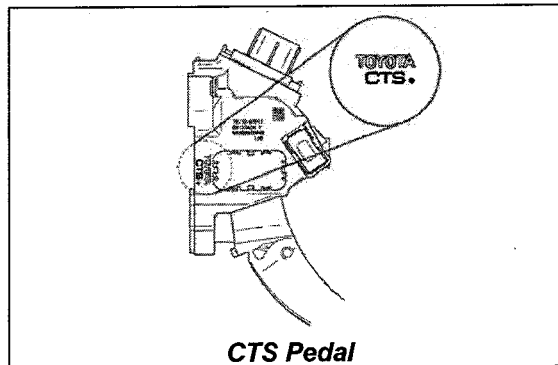
- The name of the pedal manufacturer is embossed (CTS) on the upper sensor housing on the brake pedal side.
- This condition is separate from the Defect Information Report (DIR) filed on 1/21/2010 in reference to the possibility that certain CTS accelerator pedal mechanisms may, in rare instances, mechanically stick in a partially depressed position or return slowly to the idle position.
