# Safety Recall

**Subject: ALLISON 3000 SERIES SPACER COUPLING BOLTS**

**Bulletin #: R0035**

**Affected Models: Certain 2008, 2009, and 2010 NV8J (338) Hino Conventional Trucks with Allison 3000 Series Transmissions**

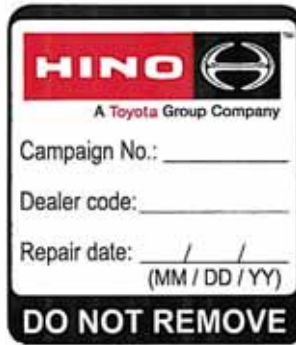
Complete a recall sticker and affix to the left door jam above the V.I.N. decal.

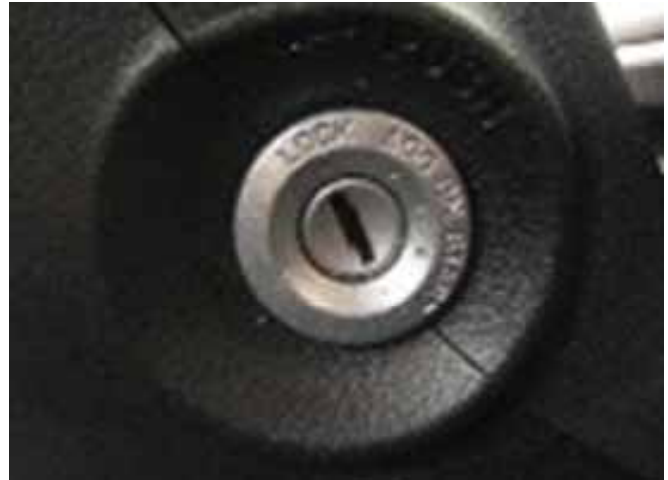
1. Park the vehicle on a level surface.
2. Confirm the engine is stopped, the starter switch is in the off (LOCK) position, and the key is removed.

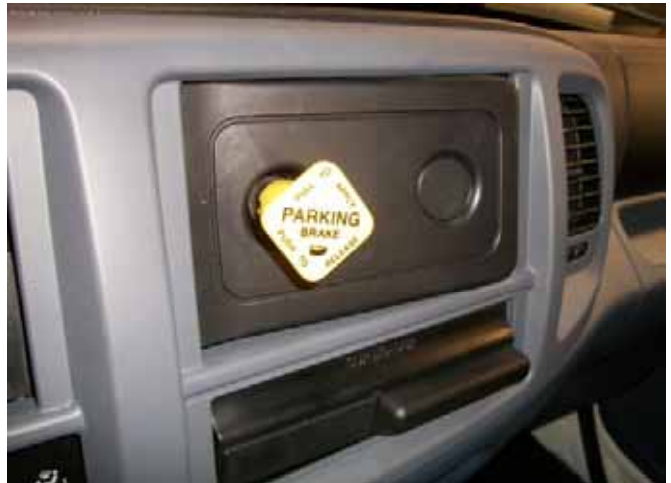
3. Apply the parking brakes.

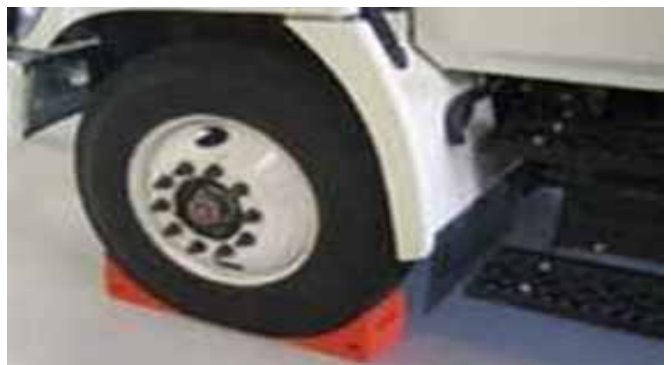
4. Chock all wheels.

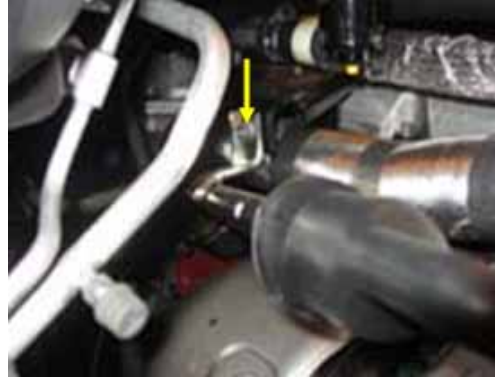
5. Remove the automatic transmission dipstick mounting bracket bolt.

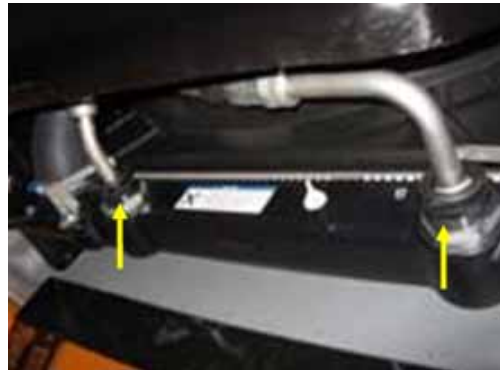
6. Remove both transmission cooler line covers on the radiator by cutting the clamp bands and removing the rubber dust covers.

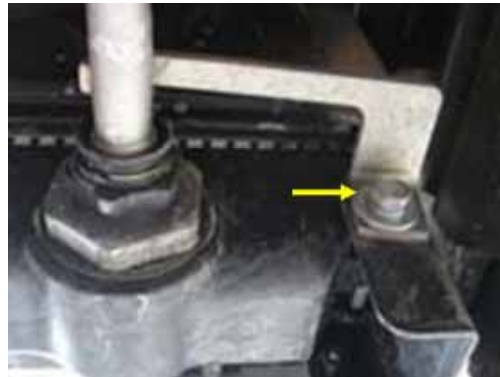
7. Remove the retaining bolts at each cooler line.

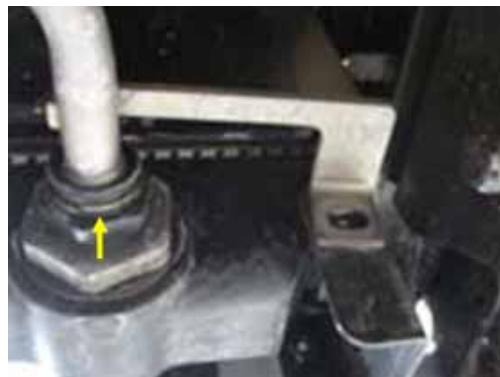
8. Place a drain pan under the lines and remove the retainers. Discard the retainers. Remove the lines from the radiator.

**NOTE:**  
Cap the lines to minimize fluid loss.

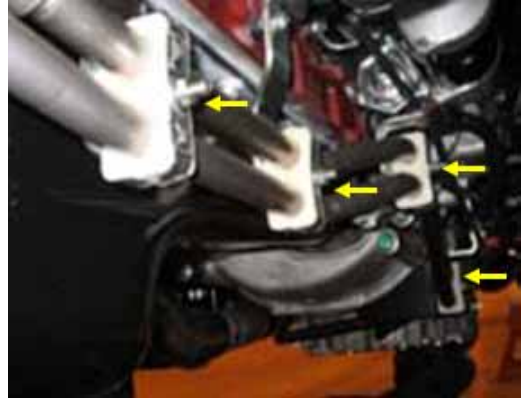
9. Remove the four transmission cooler line clamp nuts and clamps.

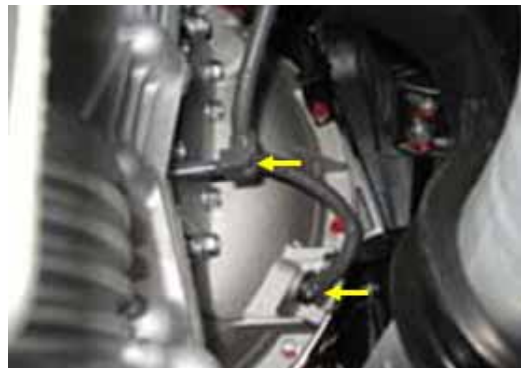
12. Remove the turbine shaft speed sensor harness connector and remove the two harness clips from the brackets.

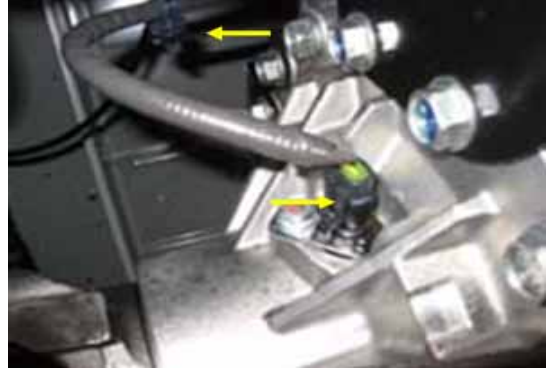
**13.** Remove the speed sensor harness connector and the harness clip from the rear of the transmission.

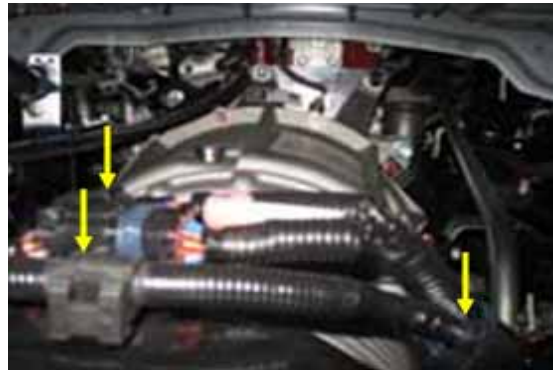
**14.** Remove the feed-through wiring harness connector and hold down nut from the top of the transmission. Remove the wiring harness from the transmission.

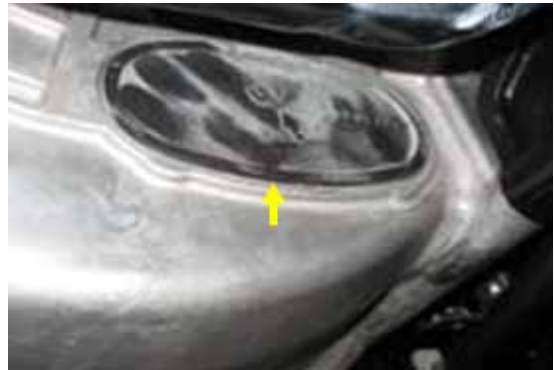
**15.** Remove the inspection cover from the flywheel housing.

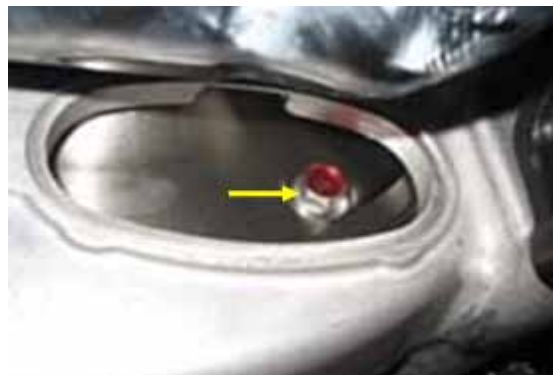
**16.** Remove the six flywheel coupling bolts through the inspection cover.

**NOTE:**  
Turn the flywheel manually to remove each bolt through the inspection hole.

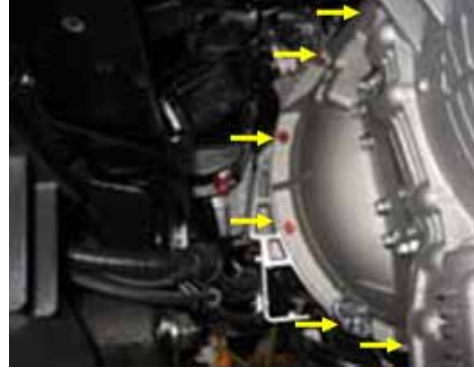
**17.** Position a transmission jack under the transmission and secure the transmission to the jack. Remove the 12 mounting bolts from the torque converter housing.

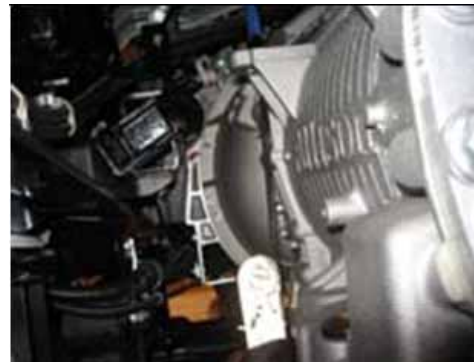
**18.** Ensure that the transmission cooler lines are clear from the brackets and slowly separate the transmission from the flywheel housing. Slide the transmission back far enough to allow access (6 to 8 inches) to the spacer coupling bolts.

Make sure that the transmission is secured to the jack and is balanced correctly to eliminate slippage.

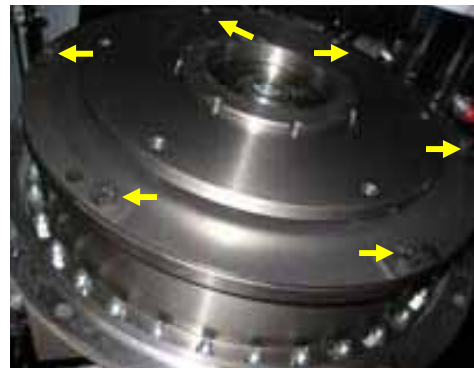
The drive coupling bolts may have not been properly tightened during the manufacturing process. If the bolts were to loosen it could cause a vibration in the driveline. If this vibration were ignored, the drive coupler bolts could shear and the drive coupling between the engine and torque convertor would not transmit power. This ultimately could result in an accident.

**19.** Remove and replace, **one at a time**, the six spacer coupling bolts.

Torque the new bolts to 50 lb ft (68 Nm).

If all bolts are removed at once the spacer coupling could fall off.

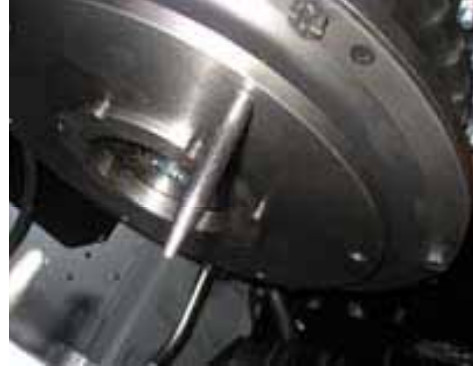
**20.** Install the spacer coupling guide (SST 09657-1370) into the spacer coupling and rotate the torque converter so that the guide faces down.

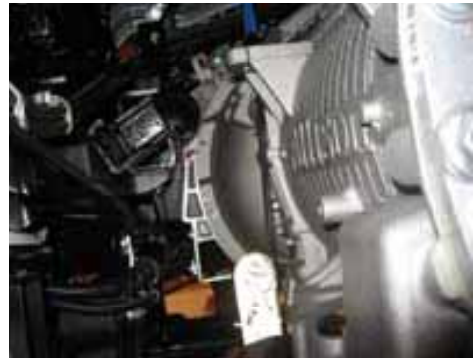
**21.** Slowly align the torque converter housing to the flywheel housing, and ensure that the spacer coupling guide lines up with the flywheel bolt hole seen through the inspection hole.

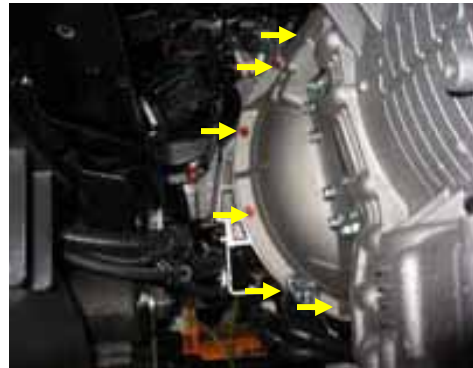
**22.** Reinstall, *hand tight*, the 12 torque converter housing bolts. Once all 12 bolts are installed, torque all 12 bolts to 35 lb ft (47 Nm) and remove the transmission jack.

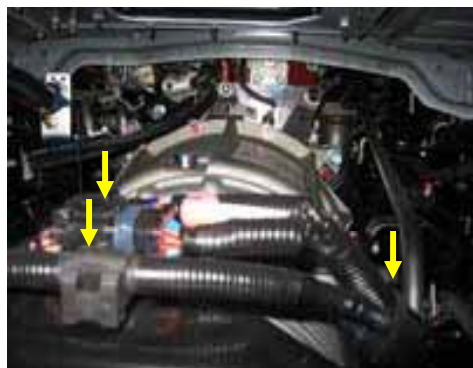
**23.** Reconnect the transmission feed-through wiring harness, harness hold down nut, and wiring harness retainers.

Torque the harness retainer nut to 16 lb ft (22 Nm).

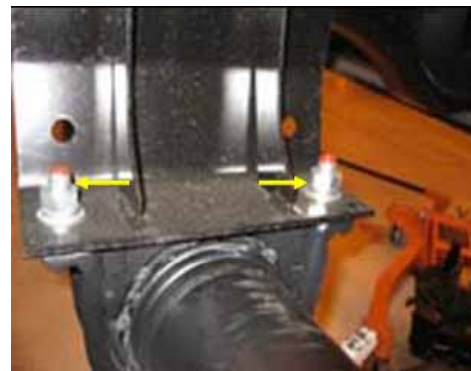
**27.** Reinstall the #1 carrier bearing using the previously removed nuts and bolts.

Torque the bolts to 105 lb ft (142 Nm).

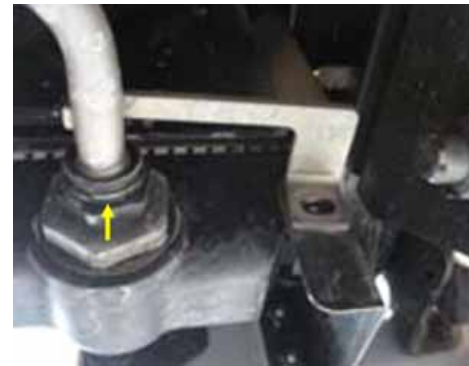
**29.** Reinstall the transmission cooler lines into the radiator. Install new retainers.

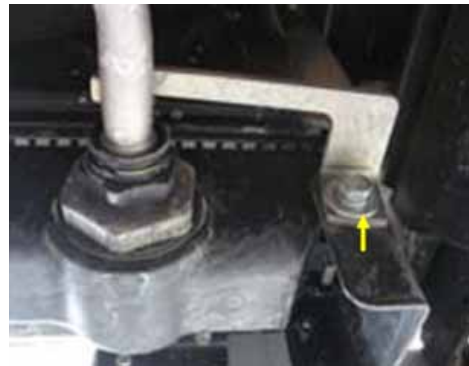
**30.** Reinstall the retaining bolt for each cooler line.

Torque the retaining bolts to 16 lb ft (22 Nm).

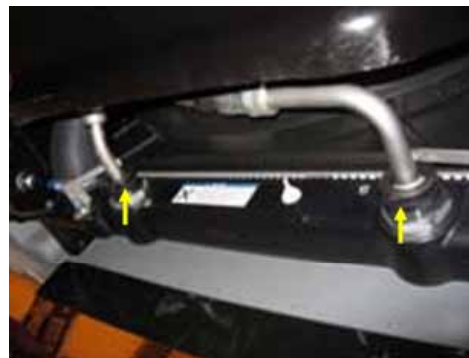
**31.** Replace the transmission cooler line covers and secure with new clamp bands.

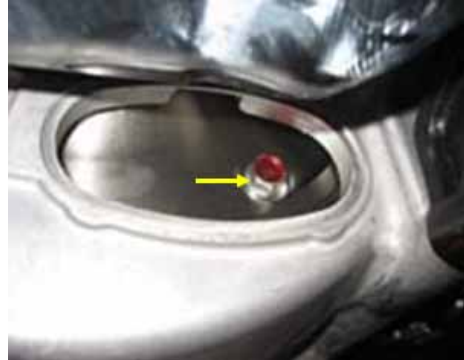
**32.** Remove the spacer coupling guide from the spacer coupling through the flywheel inspection cover. Reinstall, *hand tight*, one coupling bolt and manually rotate the engine to reinstall all six bolts through the inspection cover.

Torque all six flywheel coupling bolts to 55 lb ft (75 Nm).

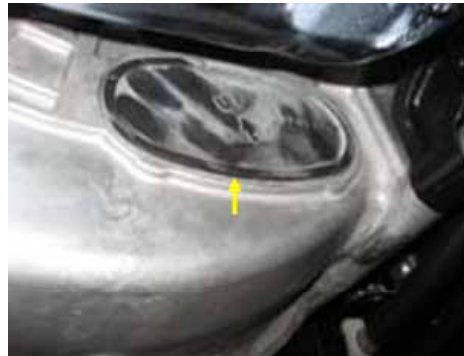
**33.** Reinstall the flywheel housing inspection cover.

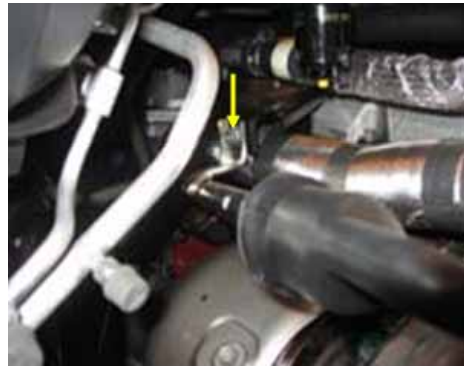
**34.** Reinstall the dipstick mount and bolt to the bracket.

Torque the bolt to 16 lb ft (22 Nm).
