Safety Recall

Subject: NV8J PROPELLER SHAFT BOLT TORQUE

Bulletin #: R0036

Affected Models: Certain 2009 and 2010 NV8J (338) Hino Conventional Trucks

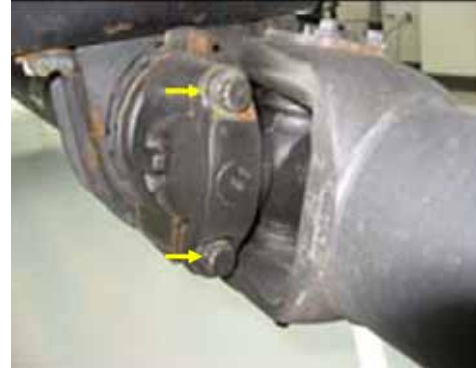
5. Remove two strap bolts and strap from one side of the u-joint.

Discard the strap and bolts.

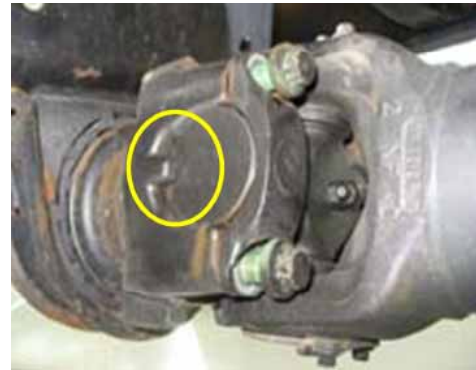
6. Install, **hand tight**, a new strap and two new bolts.

NOTE: Ensure the u-joint cap is properly seated in the saddle.

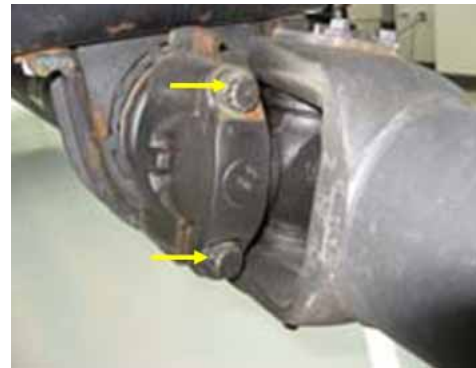
7. Torque both bolts to 125 ft. lbs. (169 Nm.)

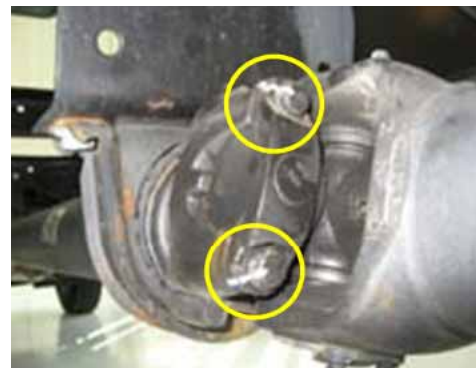
8. Apply paint to each bolt after performing torque procedure.

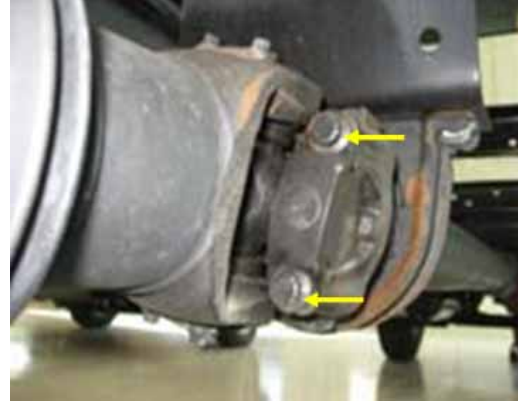
9. Remove two strap bolts and u-joint strap from the other side of the u-joint.

Discard the strap and bolts.

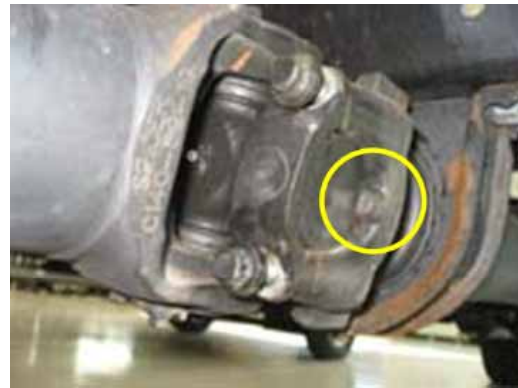
10. Install, hand tight, one new strap and two new bolts.

NOTE: Ensure the u-joint cap is properly seated in the saddle.

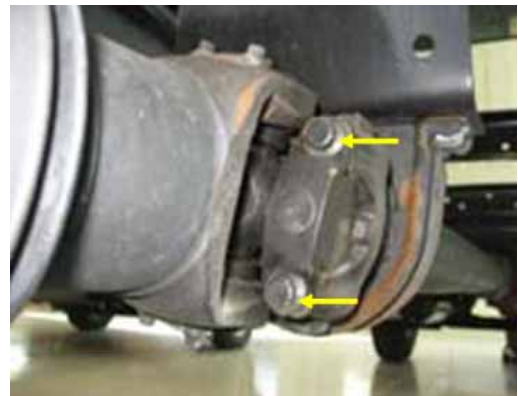
11. Torque both strap bolts to 125 ft. lbs. (169 Nm.)

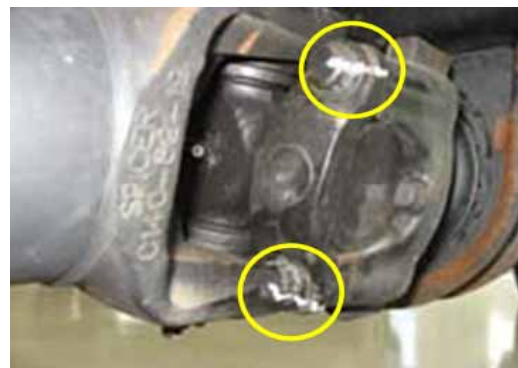
12. Apply paint to each bolt after performing torque procedure.

Repeat the procedure for all remaining u-joint locations on the vehicle.
