Subject: Interim Notice – HDX Heater Actuator

INTERIM NOTICE

Dear Thomas Dealer,
Thomas Built has decided that a defect exists in the Bergstrom defroster units built between 11/15/2007 to 5/15/2009 and installed in HDX school buses built between 11/15/2007 and 6/15/2009.

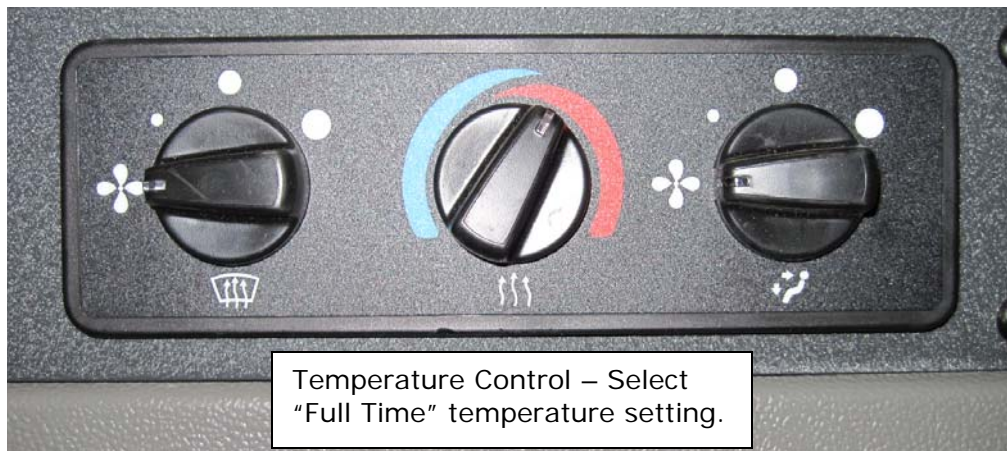
1. Turn the ignition key to the "On" position.
2. Select desired "Full Time" temperature on heater controller. After performing this procedure, the temperature will be fixed at this one setting. If body heat is not required close the heater shutoff valves in the engine compartment.

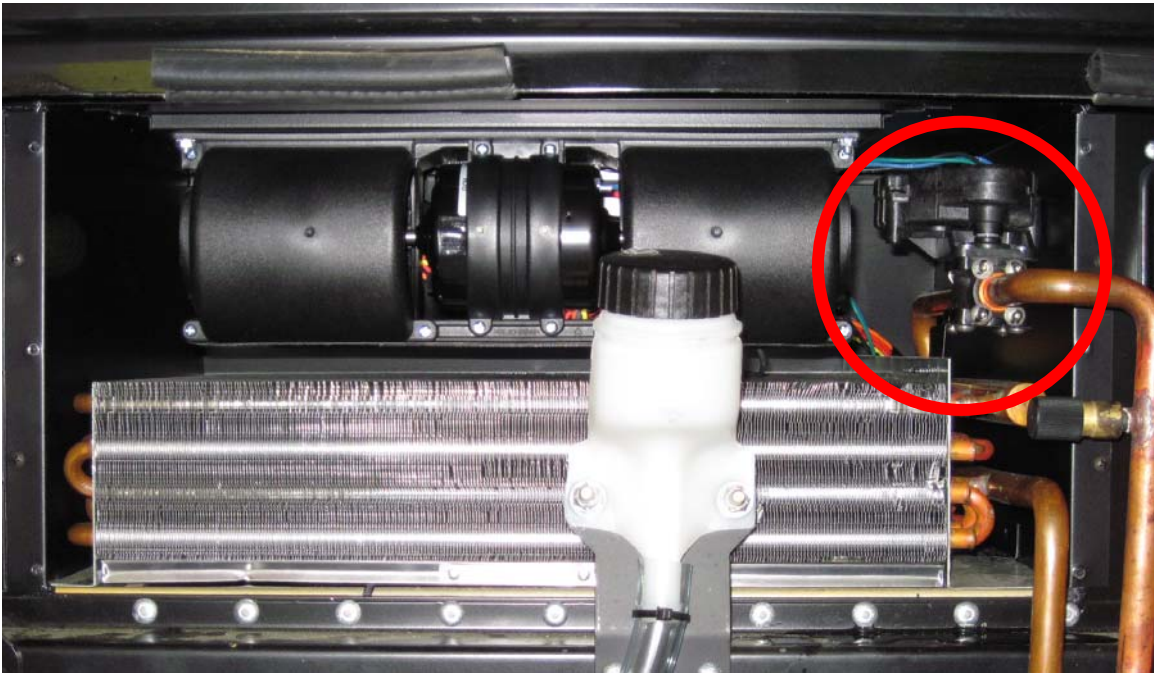
3. Wait 30 seconds after selecting, then turn ignition key "Off".
4. Remove heater access panel and locate the heater temperature actuator.

5. Disconnect the wire harness from the temperature actuator. The connector is behind the actuator body and has a lock button that must be depressed so it can be pushed up. Please be careful with the heater core fins.

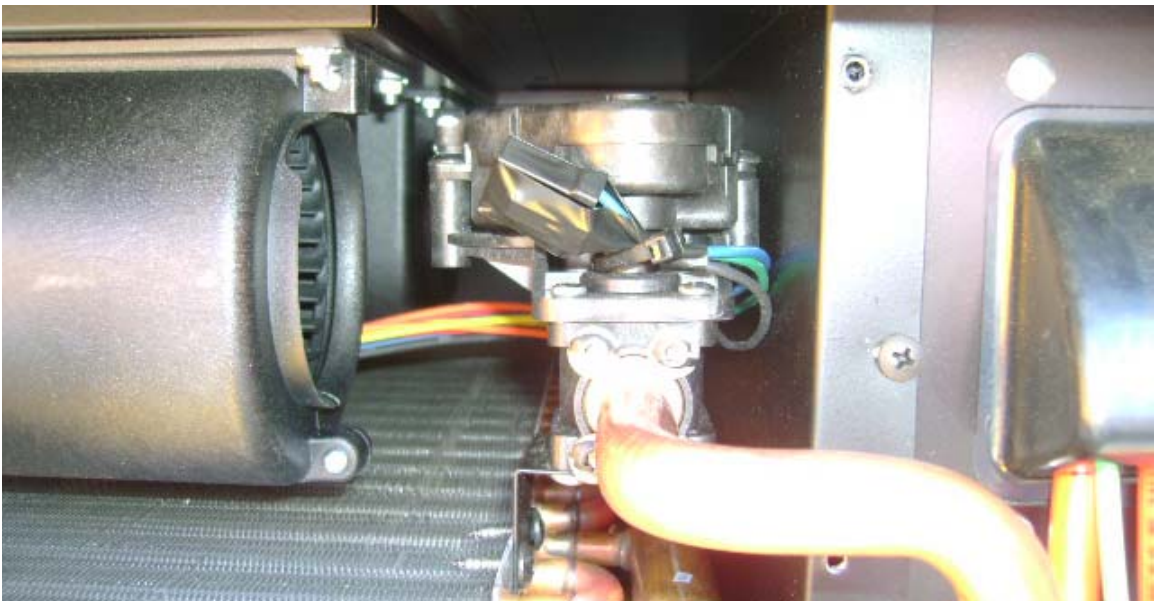
6. Move the loose harness beside heater core, away from fan intakes. Protect the connector with electrical tape as power is still present in the connector housing. If the connector has signs of melting, remove connector and tape off individual wire leads. Secure with a tie strap straddling the plastic portion of the valve body, and ensure that all wires are not disturbed and will not chafe.

The HDX Heater Actuator Interim Notice has been updated. The update includes protecting the connector / terminals with electrical tape and using a tie wrap to secure the loose actuator harness to the actuator.
