## Instructions to Perform Campaign 120 – ADDENDUM Model 32H Dinette Seat Belt Anchorages

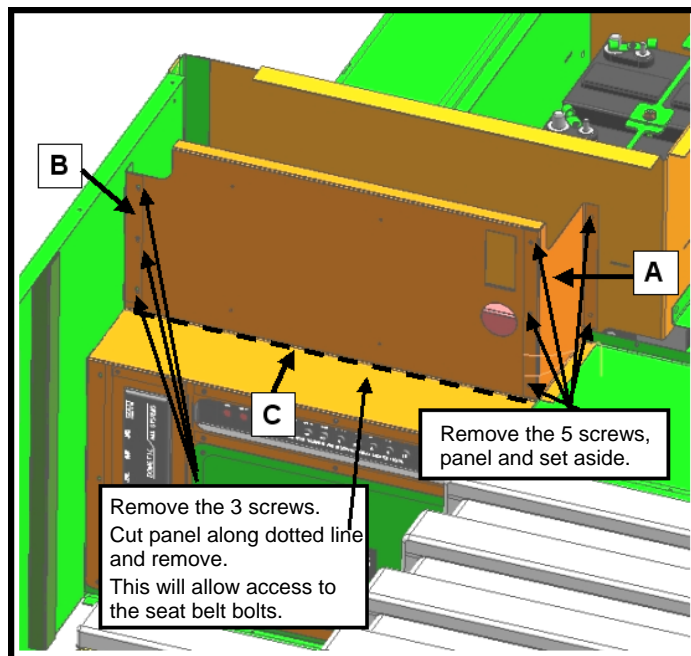
On the following models, the storage compartment is constructed of ribbed, molded plastic, which interferes with panel removal as specified in the original recall instructions starting with step 16.

For the listed models, please follow these steps in addition to the standard recall repair instructions for this campaign. (Other models are not affected by this addendum.) Below is an illustration that identifies this configuration and the method of removing the upper panel.

Using the diagram as reference:

- Remove the end panel, (A) and the fasteners on the inside of the seal plane, (B), this will allow access to the backside of the panel.
- Ensure that the wires, (located on the backside of the panel), are away from the joint you will be cutting.
- Cut the panel at bend (C).

**Note:** Verify that there are no exposed rough or sharp edges at the seam, prior to sealing as called out in the next step.

- Reinstall the panel and end panel.
- Apply a bead of black Urethane sealer, Winnebago Industries part # 072889-01-000 or equivalent, over the seam, (C) which was created between the upper and lower panel.
