Applies To: **See VEHICLES AFFECTED**

November 11, 2010

Safety Recall: Master Cylinder May Be Leaking

(Supersedes 10-069, dated November 6, 2010, to revise the information marked by the black bars)

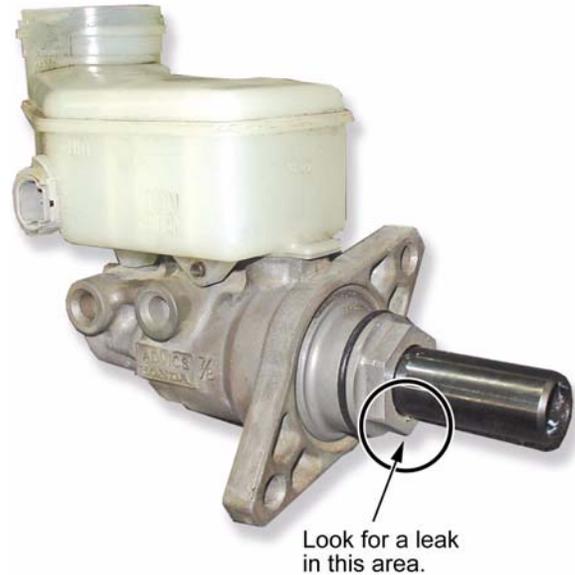
4. Check for brake fluid leaking from the installed end of the master cylinder:

- If there is a leak, go to step 5.
- If there is no leak, go to step 6.

5. Replace the brake booster. Replacement includes checking the adjustment of the brake pedal height and the brake pedal position switch. Torque the brake booster mounting nuts to **13 N·m (9.4 lb-ft)**.

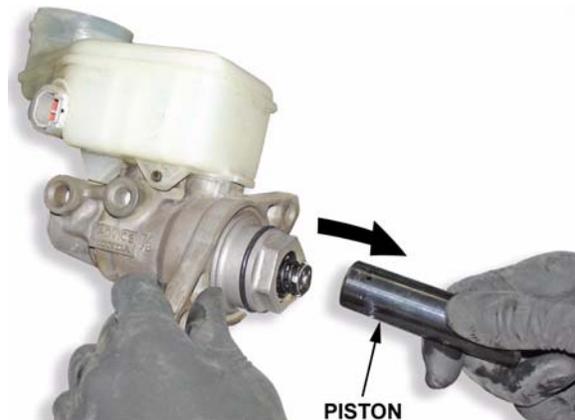
6. Place the master cylinder on clean shop towel on your work bench, then pull out the piston from the end of the master cylinder. A small amount of brake fluid will come out behind the piston; this is normal.

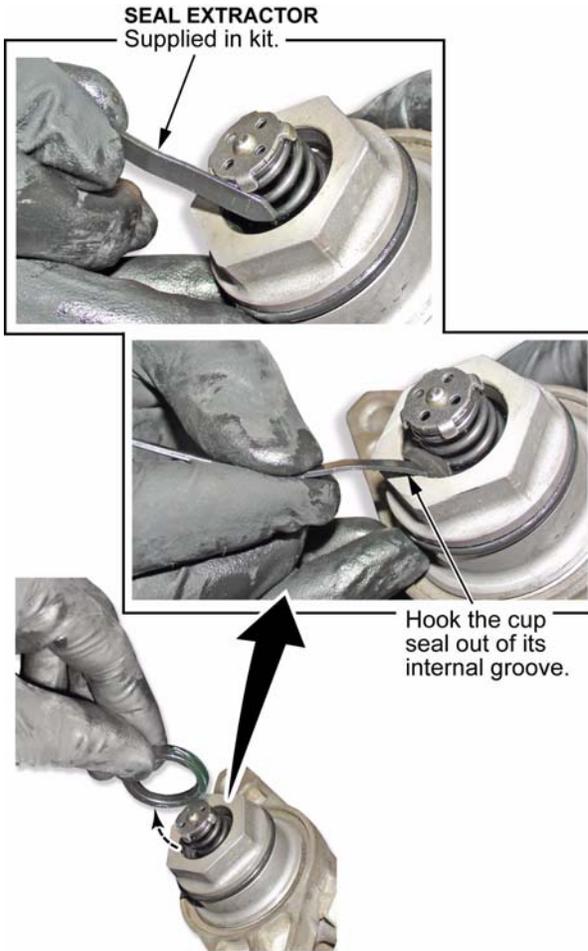
7. Remove the cup seal from the end of the master cylinder using the seal extractor (wire tie) from the kit.

NOTE: To avoid damaging the cup seal retention groove in the master cylinder, do not use a pick seal or any other metal tool to remove the cup seal.

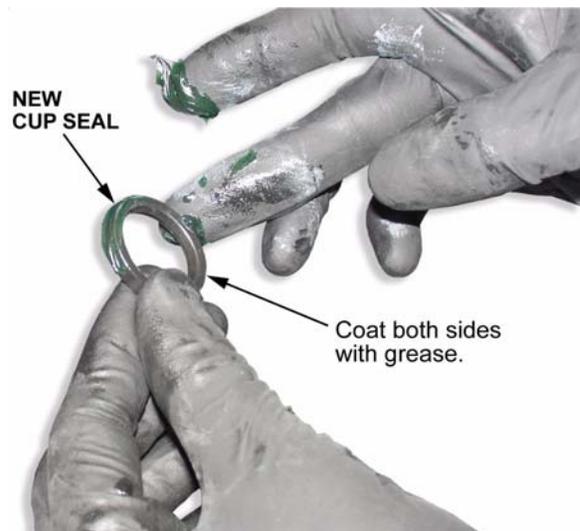
8. Coat the new cup seal with the grease supplied in the kit.

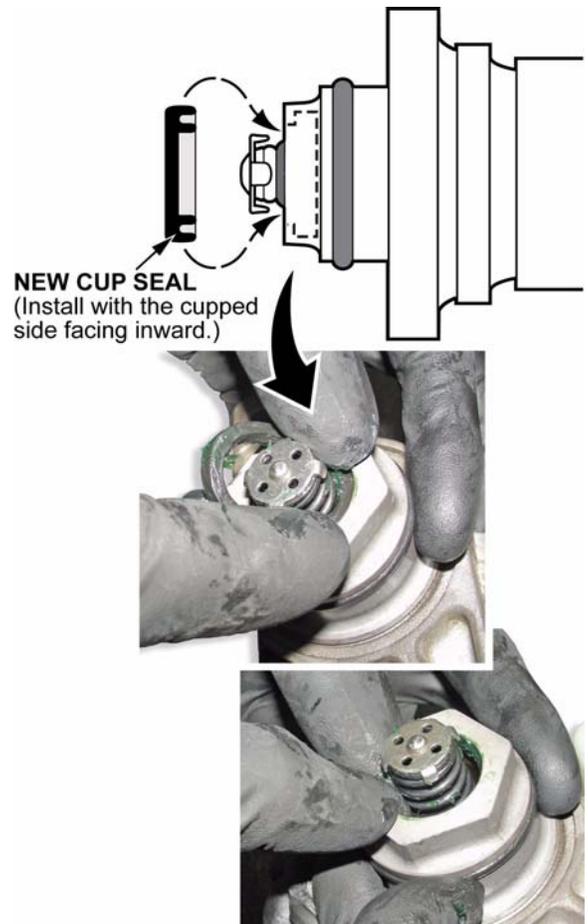
9. Install the new cup seal, by hand, into the seal groove at the end of the master cylinder. Install the seal with its cupped side facing the master cylinder.

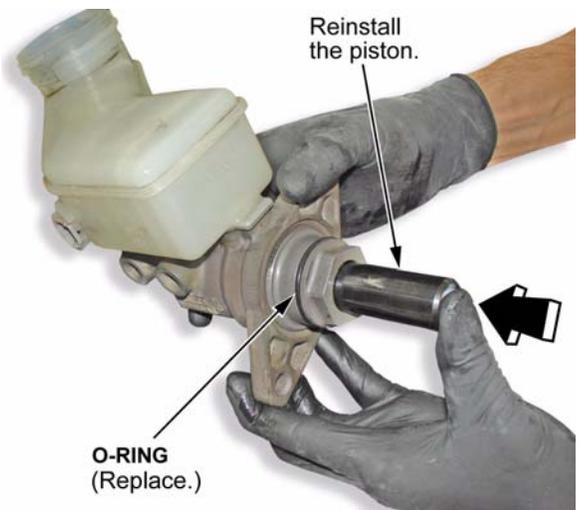
10. Reinstall the piston into the end of the master cylinder.

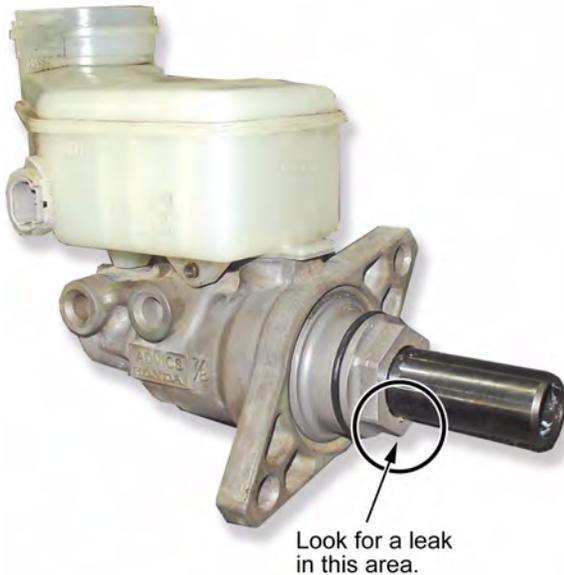
1. Remove the air cleaner and the air duct.
2. Remove the brake fluid from the master cylinder reservoir with a syringe.
3. Remove the master cylinder. Be careful not to bend or damage the brake lines.
4. Check for brake fluid leaking from the installed end of the master cylinder:
 - If there is a leak, go to step 5.
 - If there is no leak, go to step 6.

5. Replace the brake booster. Replacement includes checking the adjustment of the brake pedal height and the brake pedal position switch. Torque the brake booster mounting nuts to **13 N·m (9.4 lb-ft)**.

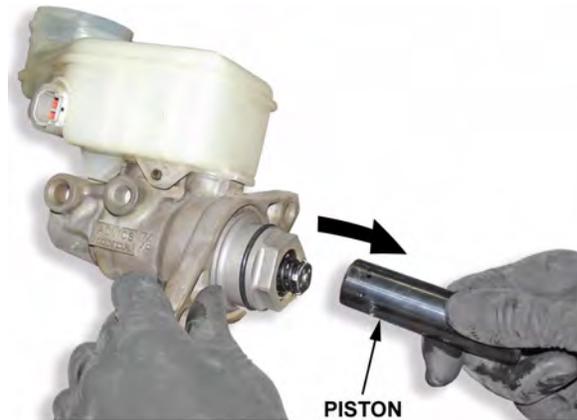
6. Place the master cylinder on clean shop towel on your work bench, then pull out the piston from the end of the master cylinder. A small amount of brake fluid will come out behind the piston; this is normal.

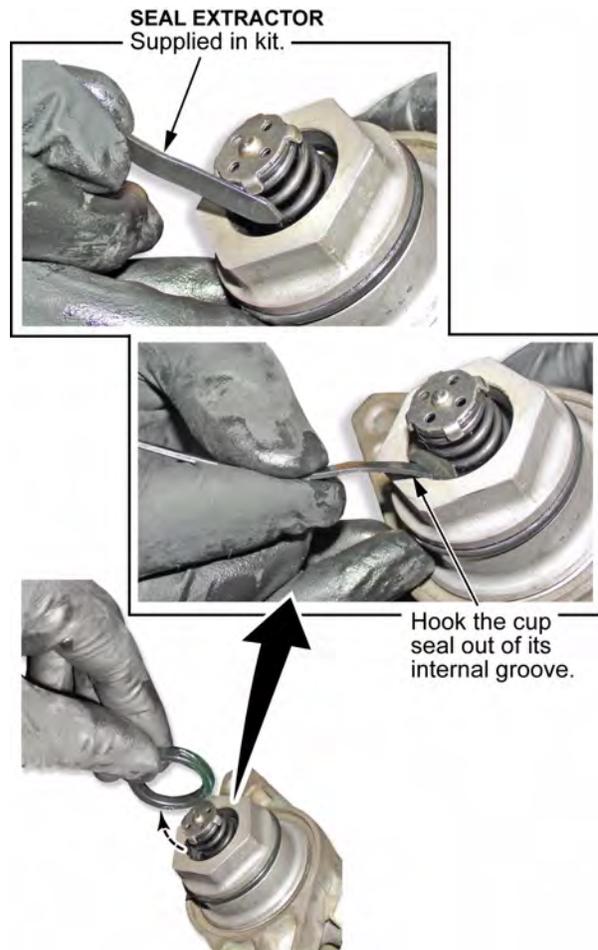
7. Remove the cup seal from the end of the master cylinder using the seal extractor (wire tie) from the kit.

NOTE: To avoid damaging the cup seal retention groove in the master cylinder, do not use a pick seal or any other metal tool to remove the cup seal.

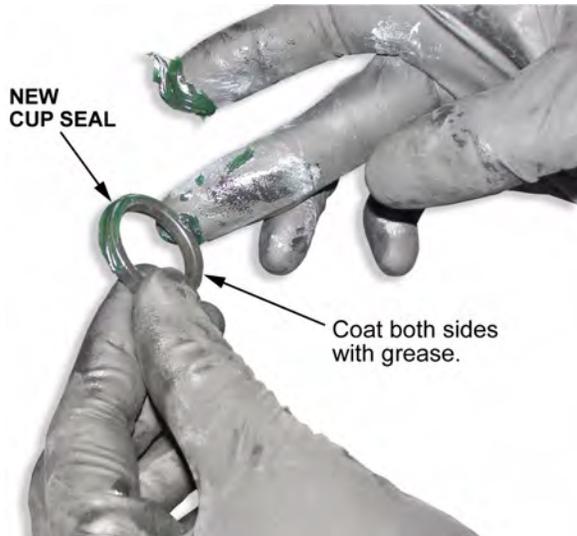
- Coat the new cup seal with the grease supplied in the kit.

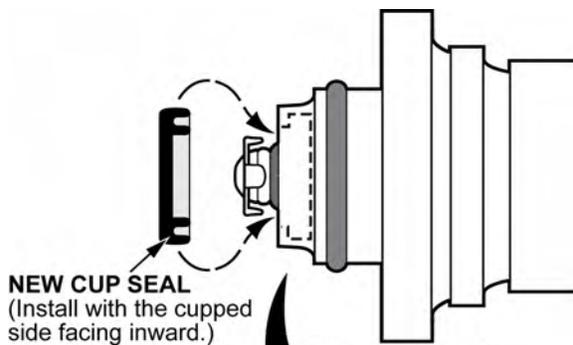
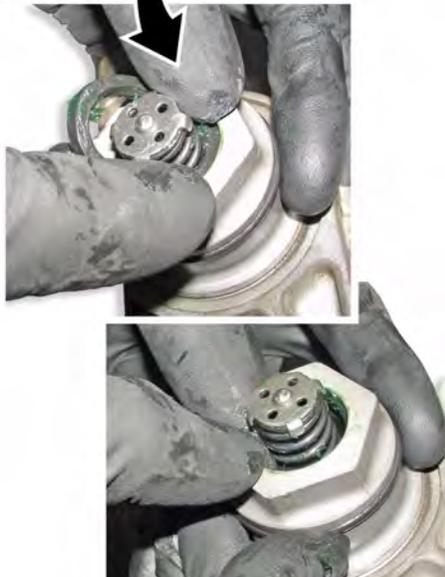
- Install the new cup seal, by hand, into the seal groove at the end of the master cylinder. Install the seal with its cupped side facing the master cylinder.

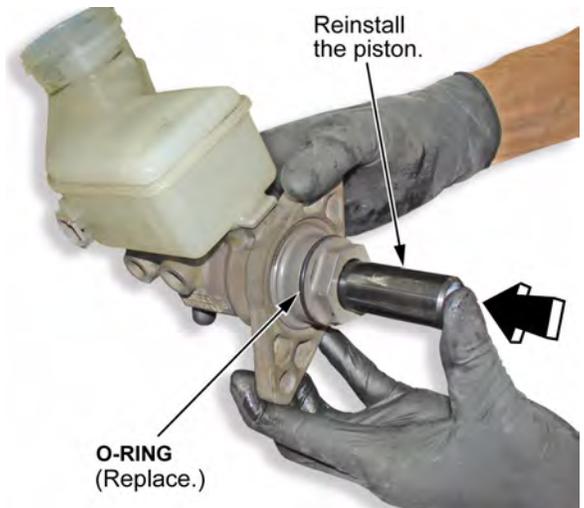
- Reinstall the piston into the end of the master cylinder.

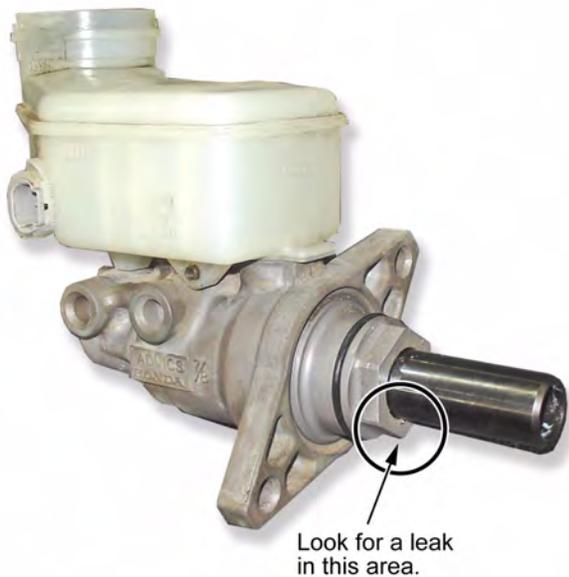
1. Remove the engine covers.
2. Remove the under-hood fuse/relay box, and move it aside.
3. Remove the strut brace.
4. Remove the brake fluid from the master cylinder reservoir with a syringe.
5. Remove the master cylinder. Be careful not to bend or damage the brake lines.
6. Check for brake fluid leaking from the installed end of the master cylinder:
 - If there is a leak, go to step 7.
 - If there is no leak, go to step 8.

7. Replace the brake booster. Replacement includes checking the adjustment of the brake pedal height and the brake pedal position switch. Torque the brake booster mounting nuts to **13 N·m (9.4 lb-ft)**.
NOTE: Be careful not to bend or damage the brake lines.

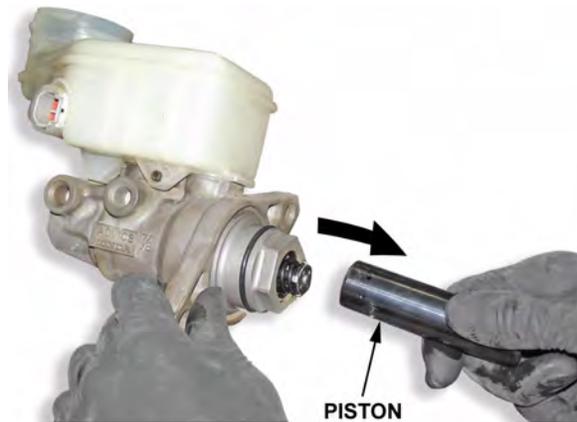
8. Place the master cylinder on clean shop towel on your work bench, then pull out the piston from the end of the master cylinder. A small amount of brake fluid will come out behind the piston; this is normal.

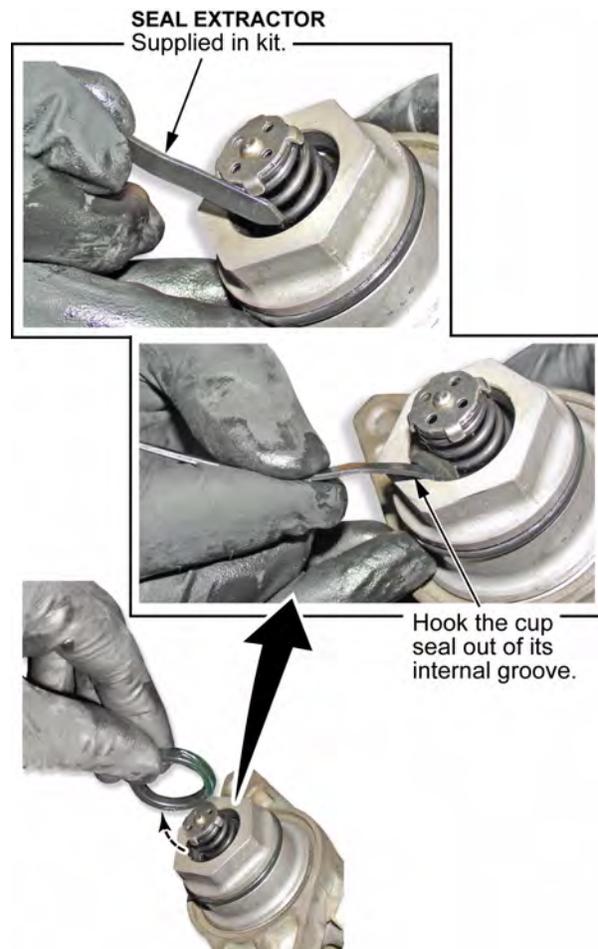
9. Remove the cup seal from the end of the master cylinder using the seal extractor (wire tie).
NOTE: To avoid damaging the cup seal retention groove in the master cylinder, do not use a pick seal or any other metal tool to remove the cup seal.

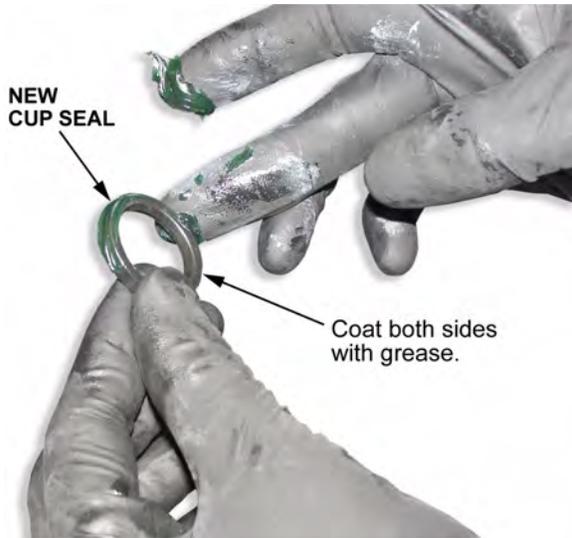
10. Coat the new cup seal with the grease supplied in the kit.

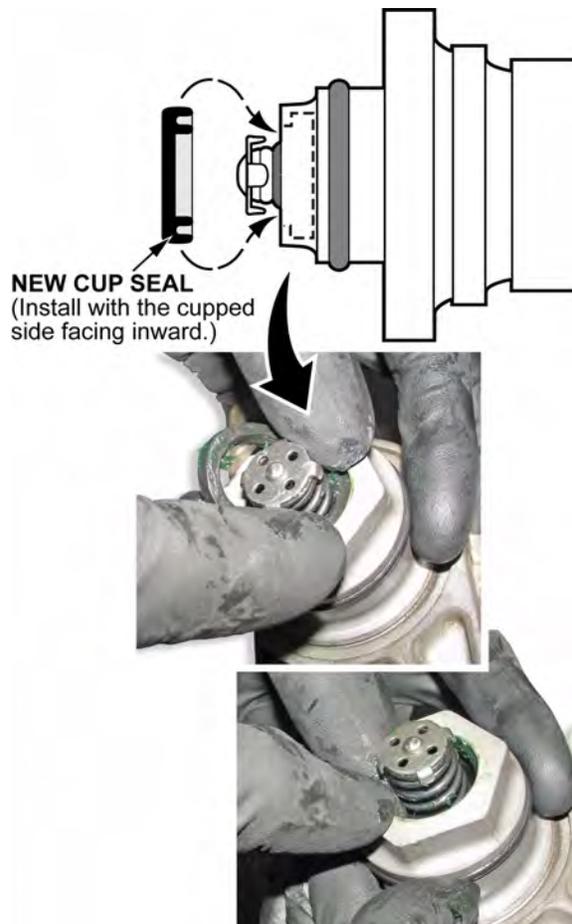
11. Install the new cup seal, by hand, into the seal groove at the end of the master cylinder. Install the seal with its cupped side facing the master cylinder.

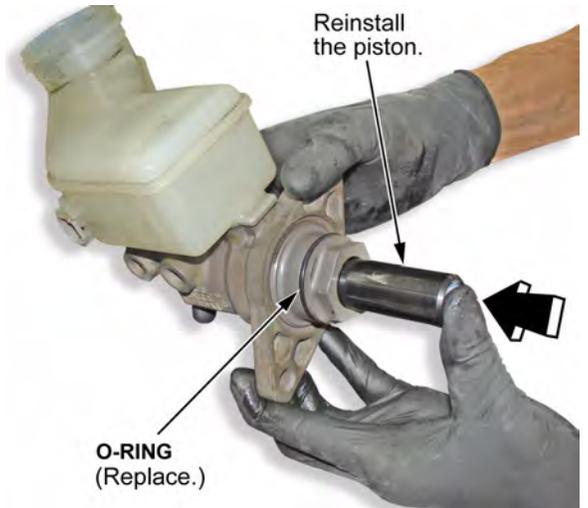
12. Reinstall the piston into the end of the master cylinder.
