SERVICE PROCEDURE

**G-10519
JANUARY 2011**

**SUBJECT: SAFETY RECALL
ENGINE TURBO OIL SUPPLY LINE on certain CE
model school buses built 2/25/10 thru 9/20/10 with
a MaxxForce DT engine**

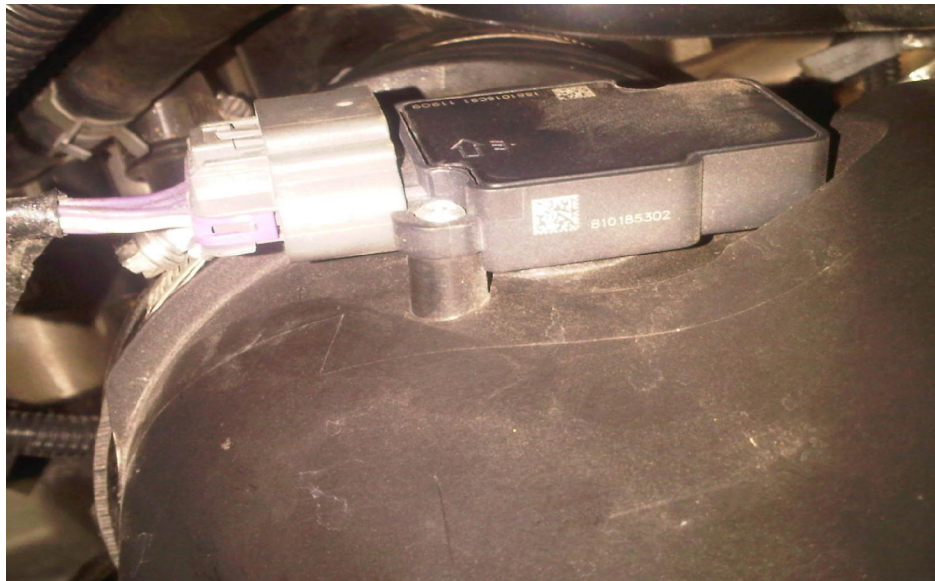
1. Disconnect the MAF sensor connector.

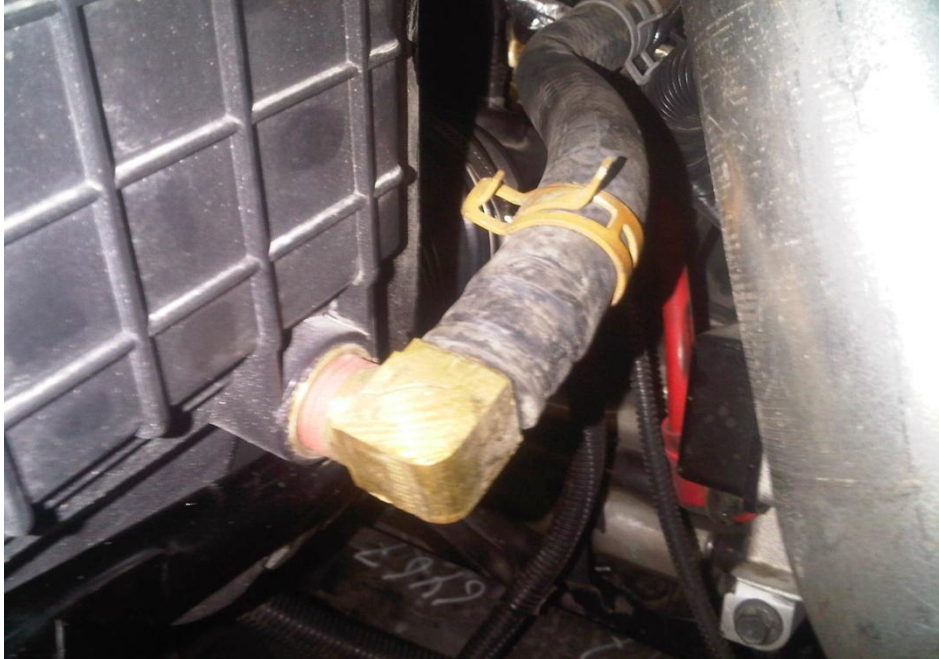
2. Loosen the air box ducting clamps, slide air compressor feed hose clamp to where hose can be removed from 90 degree fitting.

Note: For CE Bus model, removal of the air cleaner is not necessary.

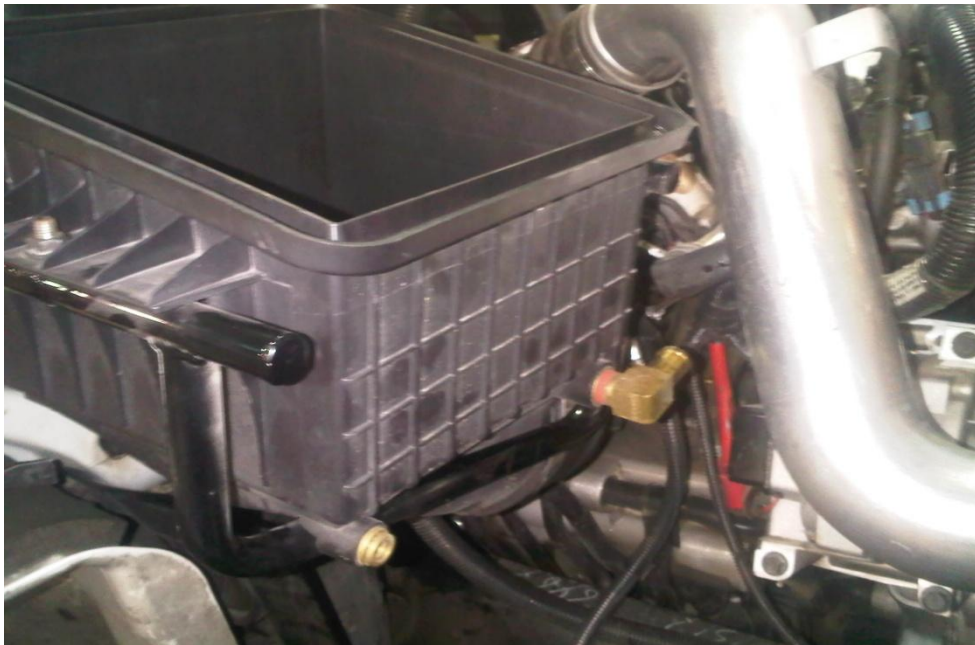
3. Remove retaining nut from air box and remove air box from its frame.

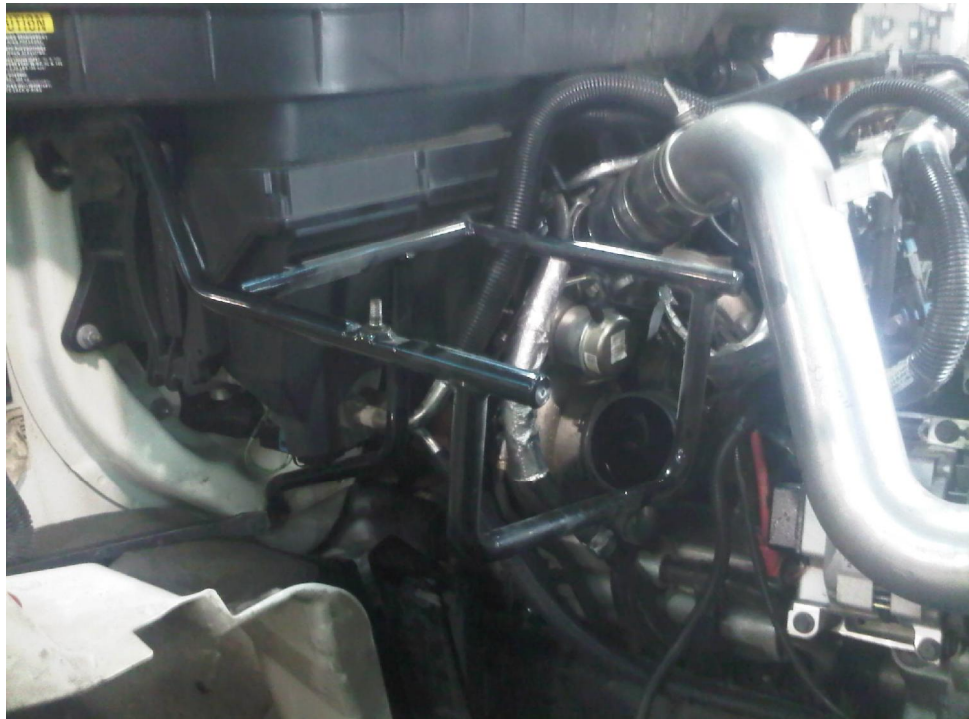
4. Remove the air box mounting frame.

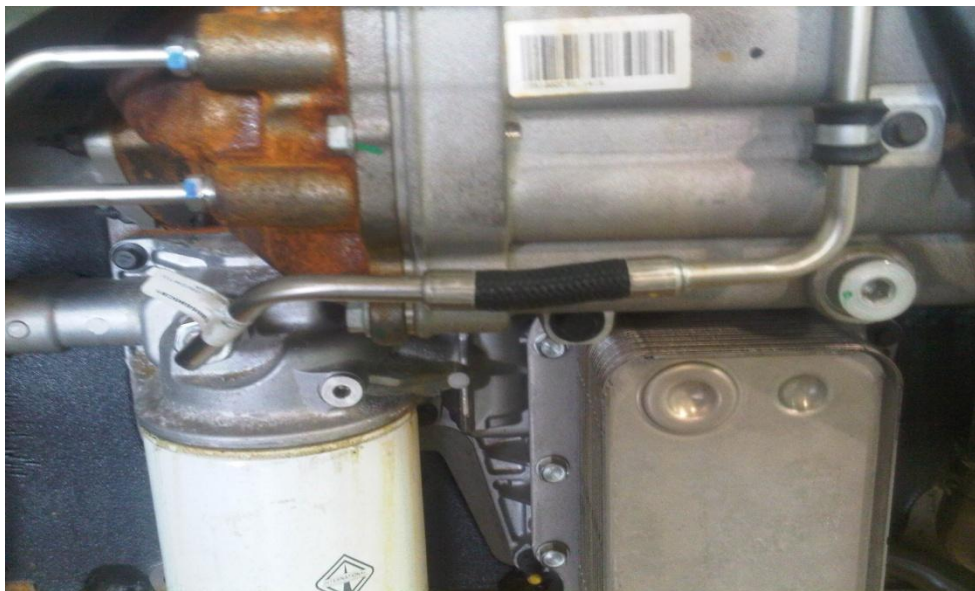
5. Remove the turbo assembly feed line retainers.
6. Remove the oil line clamp located on EGR cooler.
7. Remove the oil supply line from oil filter base.

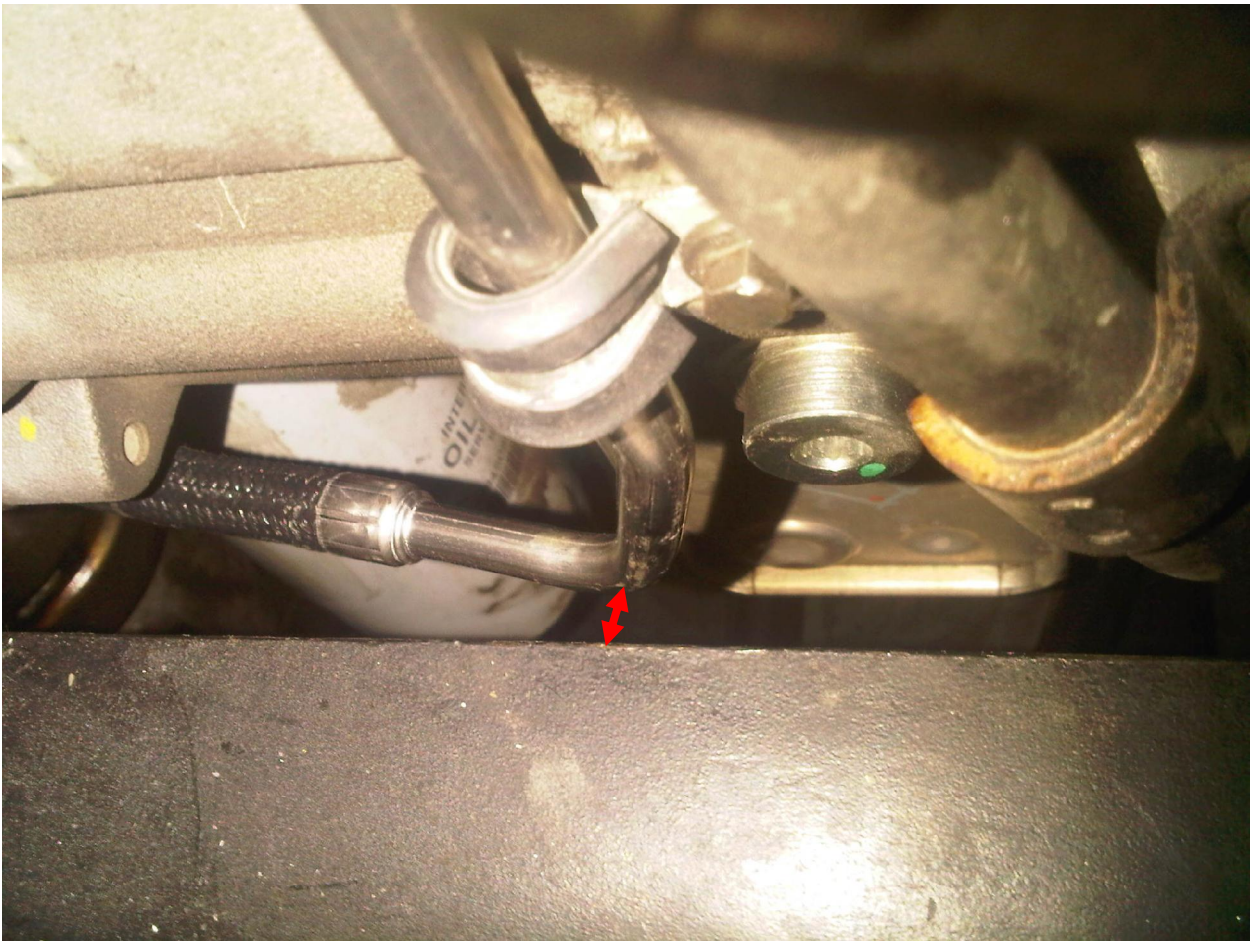
Note: Ensure that the oil supply line is oriented at least 5mm away from frame rail.

8. Apply o-ring lube to the new oil supply hose seals.
9. Install the new oil supply line on the turbocharger assembly.
10. Reinstall the oil supply line retaining hardware and torque to 23 lbs. ft.
11. Secure the oil supply line to oil filter base.
12. Reinstall the oil supply line clamp that secures the oil line at EGR cooler.
