**G-10518
JANUARY 2011**

**SUBJECT: SAFETY RECALL
ENGINE TURBO OIL SUPPLY LINE on certain CE
and HC commercial model buses built 2/25/10 thru
9/20/10 with a MaxxForce DT engine**

**G-10518 R1
JANUARY 2011**

**SUBJECT: SAFETY RECALL
ENGINE TURBO OIL SUPPLY LINE on certain 4300,
4400, CE commercial bus, and HC commercial bus
models built 2/25/10 thru 9/20/10 with a MaxxForce
DT engine**

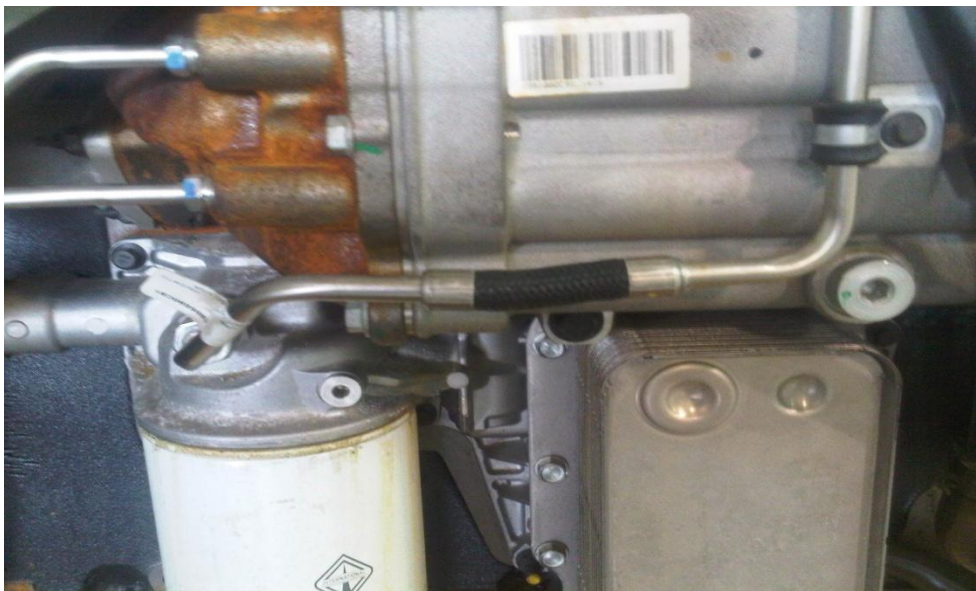
The engine turbo oil supply line may rub on the frame rail possibly causing an oil leak in the engine compartment. An oil leak in the engine compartment may cause a fire possibly resulting in property damage, personal injury, or death.

5. Remove the turbo assembly feed line retainers.
6. Remove the oil line clamp located on EGR cooler.
7. Remove the oil supply line from oil filter base.

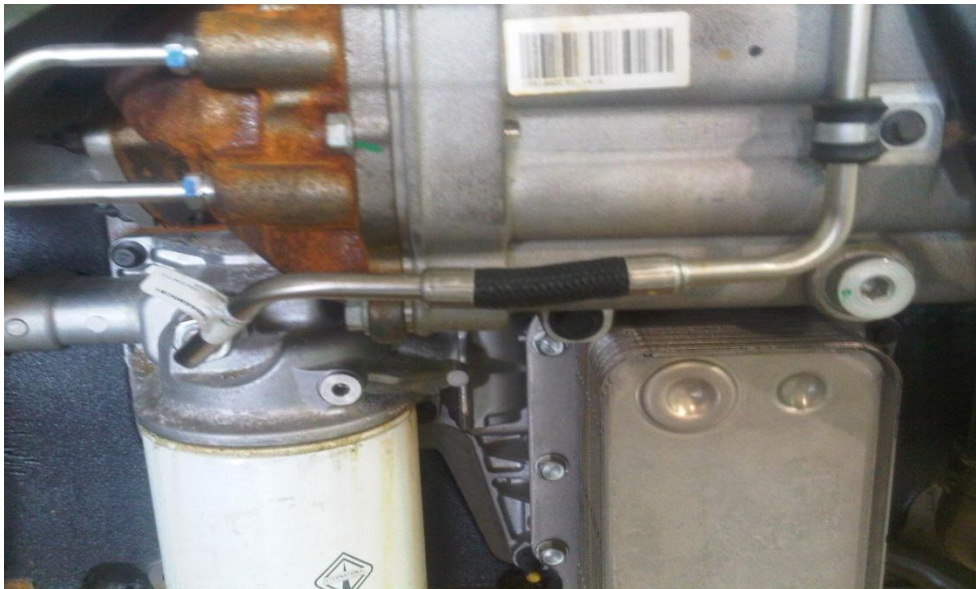
The engine turbo oil supply line may rub on the frame rail possibly causing an oil leak in the engine compartment. An oil leak in the engine compartment may cause a fire possibly resulting in property damage, personal injury, or death.

5. Remove the turbo assembly feed line retainers.
6. Remove the oil line clamp located on EGR cooler.
7. Remove the oil supply line from oil filter base.
