Title Recall 235: Front Power Seat Stop Lugs Inspect / Replace if Necessary

Ref No US24015.1.1 en-GB

Volvo Car Customer Service		
		RTJ Instruction
		RTJ No 24015
		Date December-2010 Issue 01
Title	Recall 235: Front Power Seat Stop Lugs Inspect / Replace if Necessary

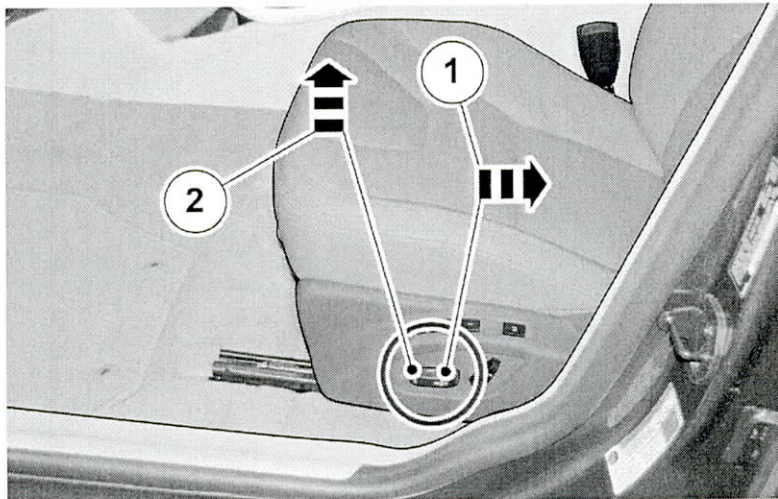
Moving seat for inspection.

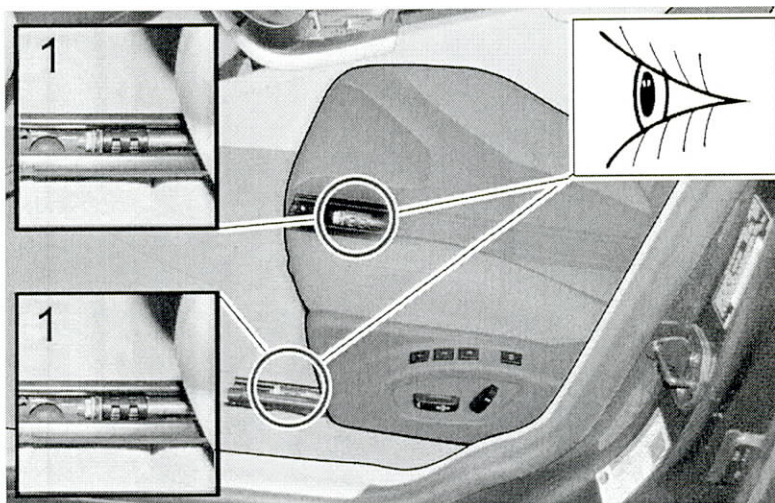
Perform inspection/replacement on the inboard and outboard adjustment rails of both front seats.

Identify which part is installed in seat track. If there is no part or the incorrect part is installed- replace or install the correct part according to instructions below and quick reference chart on page 1 of this document.

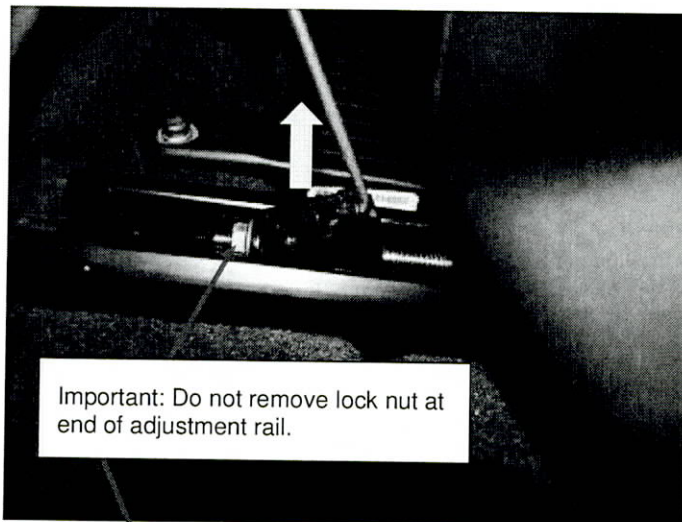
Short and long seat stop removal if necessary.

Use a hook tool, pull straight up.

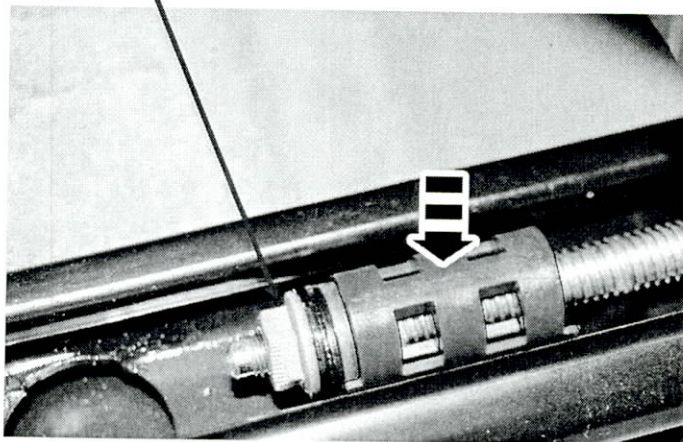
Installing short
(32.3mm) stop.

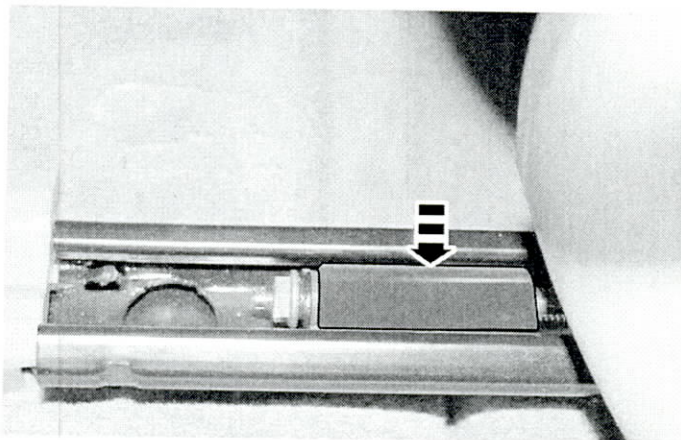
Installing long
(64 mm) stop.
