MODEL: 2009 SUPER SHERPA® (KL250G9F)**TITLE: OIL PASSAGE INSPECTION**

RECALL

On eligible units, a plastic plug improperly used to mask a clutch cover oil passage could cause restriction of oil flow and possible seizure of the camshaft in the cylinder head. This could result in the engine losing power and eventually stopping which could create the risk of a crash while operating the vehicle.

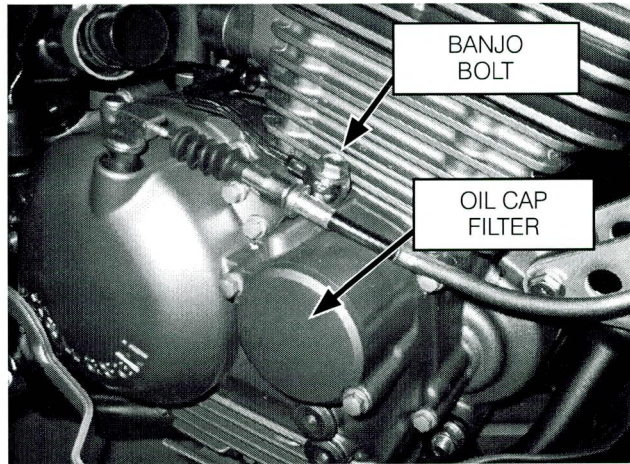
- Remove unit from crate (if applicable).
- Remove exhaust pipe.
- Remove banjo bolt from clutch cover.

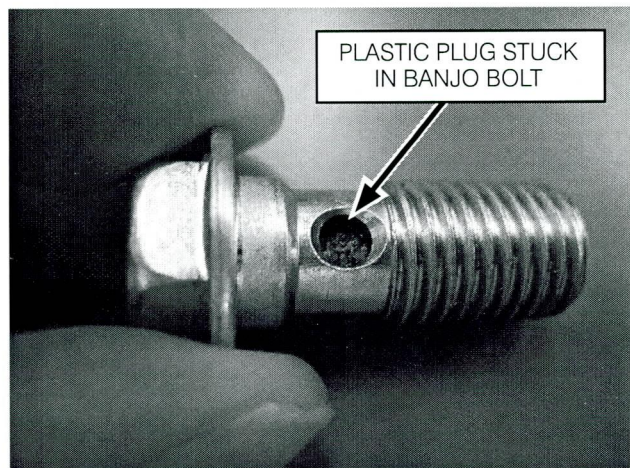
- Inspect banjo bolt for plastic plug.

- ★ If plastic plug is found in the banjo bolt, discard banjo bolt and proceed to "Inspection #3" in this bulletin.
- ★ If no plastic plug is found in the banjo bolt, discard banjo bolt and continue with the next step.
- Inspect oil passage where banjo bolt was removed for plastic plug.

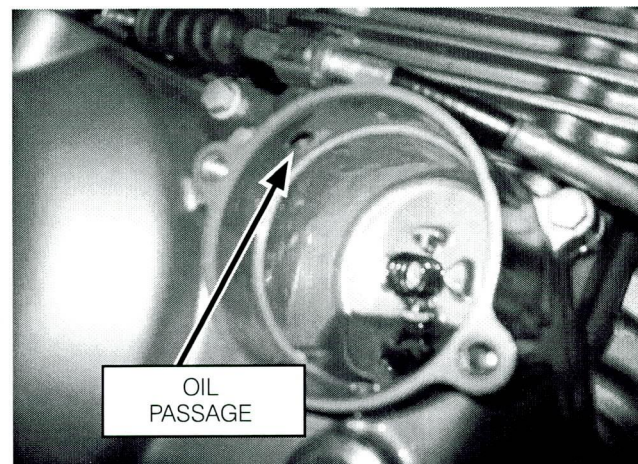
- ★ If plastic plug is found, remove it then proceed to the "Reassemble" section in this bulletin.
- ★ If plastic plug is not found continue with the next step.
- Remove oil filter cap and oil filter.
- Inspect oil passage inside oil filter housing for plastic plug visually and with compressed air.

- ★ If plastic plug is found, remove it then proceed to the "Reassemble" section in this bulletin.
- ★ If plastic plug is not found continue with the next step.

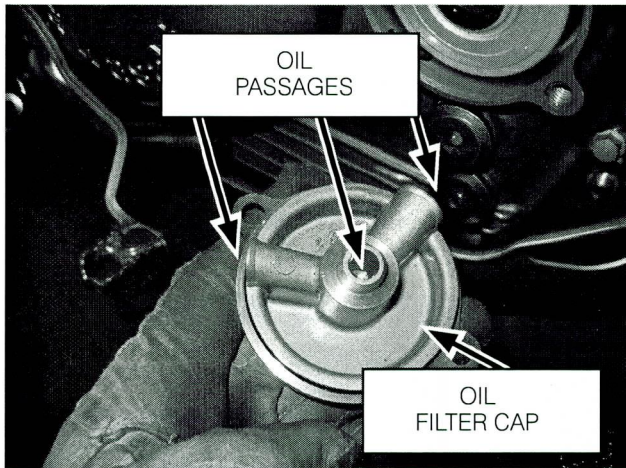
- Inspect oil passages inside oil filter cap.

- ★ If plastic plug is found, remove it then proceed to the "Reassemble" section in this bulletin.
- ★ If plastic plug is not found continue with the next step.
- Inspect the inside of the oil filter for plastic plug.

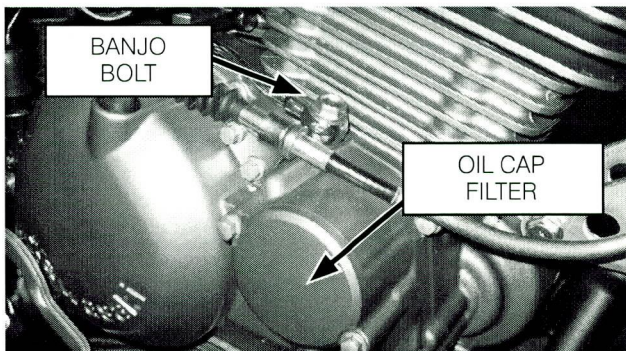
- Remove exhaust pipe.
- Remove banjo bolt from clutch cover.

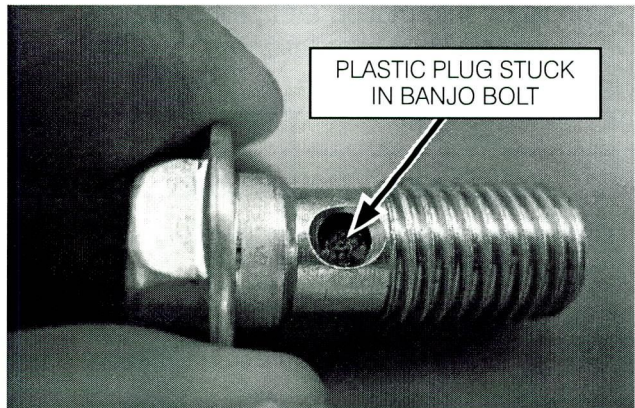
- Inspect banjo bolt for plastic plug.

- ★ If plastic plug is found in the banjo bolt, discard banjo bolt and proceed to "Inspection #3" in this bulletin.
- ★ If no plastic plug is found in the banjo bolt, discard banjo bolt and continue with the next step.
- Inspect oil passage where banjo bolt was removed for plastic plug.

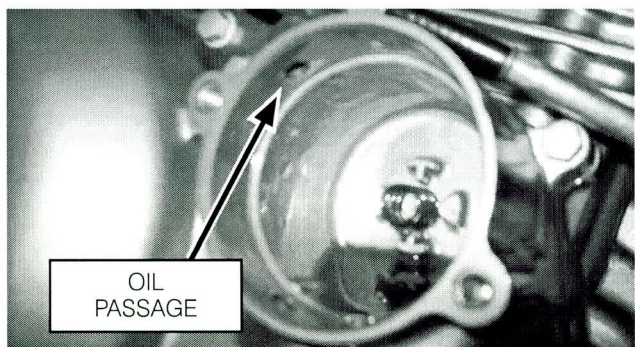
- Remove oil filter cap and oil filter.
- Inspect oil passage inside oil filter housing for plastic plug visually and with compressed air.

- ★ If plastic plug is found, remove it then proceed to the "Inspection #3" section in this bulletin.
- ★ If plastic plug is not found continue with the next step.
- Inspect oil passages inside oil filter cap.

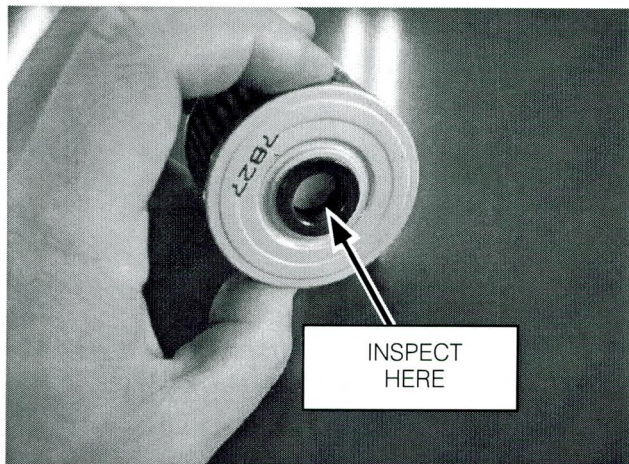
- ★ If plastic plug is found, remove it then proceed to the "Inspection #3" section in this bulletin.
- ★ If plastic plug is not found continue with the next step.
- Inspect the inside of the oil filter for plastic plug.

- ★ If plastic plug is found, remove it then proceed to the "Inspection #3" section in this bulletin.
- ★ If plastic plug is not found continue with the next step.
- Drain the engine oil and remove the clutch cover.

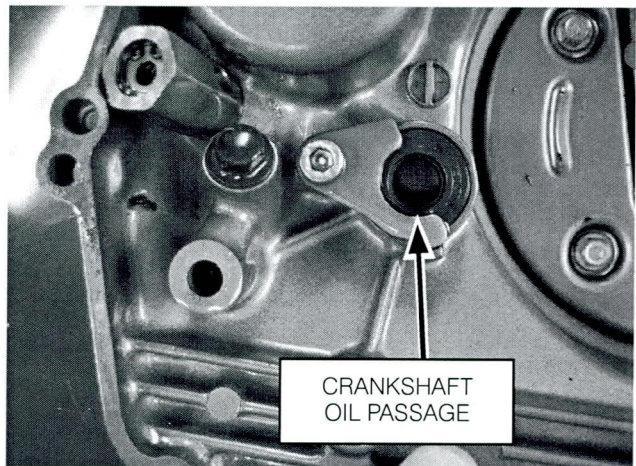
- Inspect the crankshaft oil passage on the inside of the clutch cover for plastic plug.

- ★ If plastic plug is found, remove it then proceed to the "Inspection #3" section in this bulletin.
- ★ If plastic plug is not found continue with the next step.
- Use a flashlight to inspect the crankshaft oil passage for plastic plug.

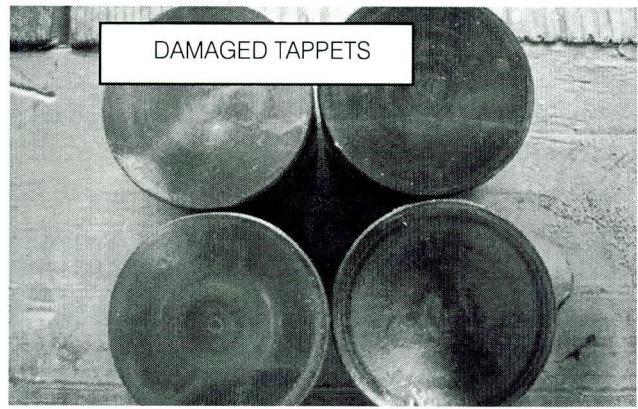
- Remove the cylinder head cover.
- Remove both camshafts.
- Inspect the cylinder head journals, camshaft journals, and tappets for abnormal wear such as galling and/or metal transfer. Some polishing/scuffing is normal.
- Take photos of the cylinder head journals, camshaft journals, and tappets (regardless of condition) and keep them in your dealer records for two years.

★ If no damage is found, proceed to the "Reassemble" section in this bulletin.

★ If damage is found, proceed to the "Replace Cylinder Head" section in this bulletin.

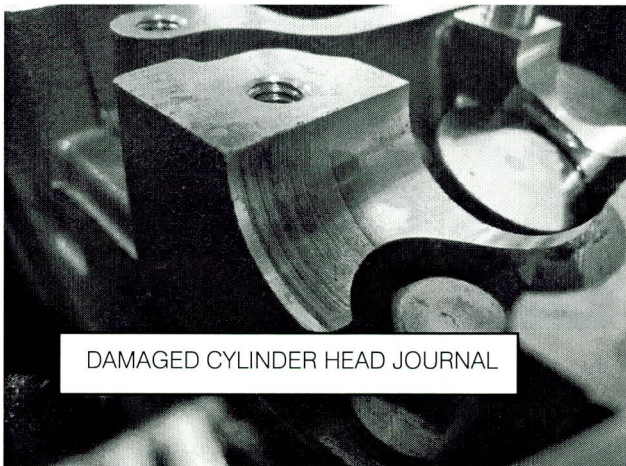
- Replace cylinder head and camshafts as outlined in the service manual using new parts in kits 99999-0278 & 99999-0279.
- Adjust valve clearance.

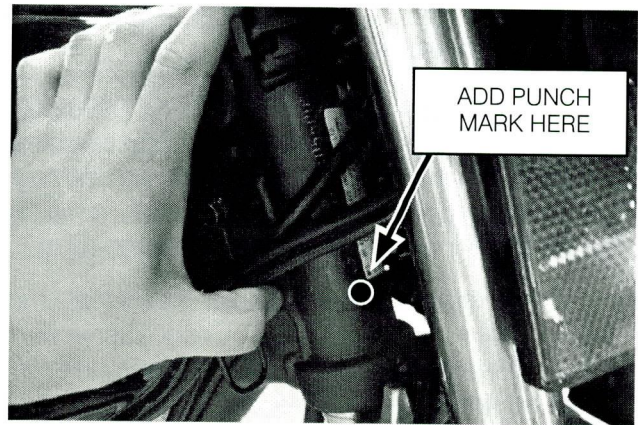
After repair or inspection, make a punch mark in front of the VIN.
