TECHNICAL INSTRUCTIONS
FOR
SAFETY RECALL 90L
ACCELERATOR PEDAL MODIFICATION
2005 – 2010 MODEL YEAR AVALON
REVISED FEBRUARY 23, 2010

In early October, Toyota announced it will initiate a Safety Recall Campaign (Special Service Campaign) for potential floor mat interference with the accelerator pedal. The condition involves the potential for an unsecured or incompatible driver's floor mat to interfere with the accelerator pedal and cause it to get stuck in the wide open position.

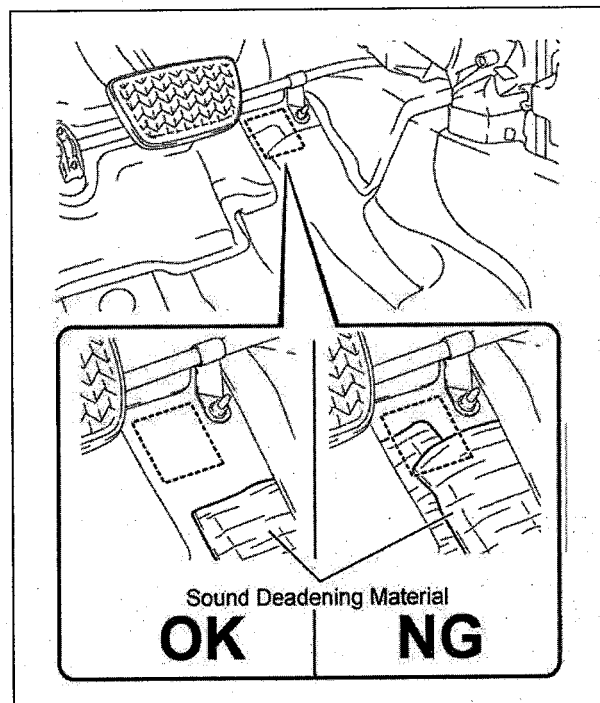
3. INSPECT THE LOWER PORTION OF THE FABRIC FLOOR SILENCING MATERIAL

- a) Inspect the lower portion of the fabric floor silencing material.
 - If OK, proceed to step 4 "RUBBER PAD APPLICATION" below.
 - If NG, please refer to APPENDIX "B" for "CUT THE FLOOR SILENCING MATERIAL"

The fabric floor silencing material is a soft, gray, paper-like material beneath the carpet.
