File In Section: Product Recalls  
Bulletin No.: 10038B  
Date: September 2010

# Recall Bulletin

**SUBJECT:** Potential Floor Mat Interference with the Accelerator Pedal

**MODELS:** 2009-2010 Pontiac Vibe

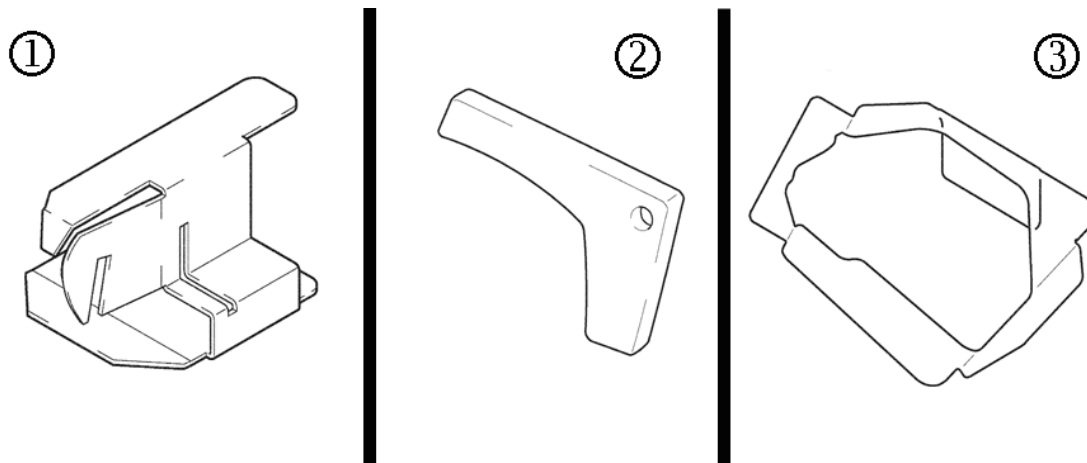
2443928

**(1) Cutting Template (2) Shape Gauge (3) Tibia Marking Gauge****All-Weather Floor Mat Inspection**

Three special tools (cutting template, shape gauge, and tibia marking gauge) are required to complete this recall. Dealers who performed repairs on Pontiac Vibe vehicles under recall 10018 were shipped two sets of these tools from the Warranty Parts Center (WPC) at no charge via UPS Ground Delivery – Attention: Parts Manager, beginning May 25, 2010. If needed, additional special tools sets can be obtained by faxing a request to the WPC at 248-371-0192. Include your physical shipping address and a contact person's name and telephone number on the request. Be sure to ask for Part Number WPC 537.

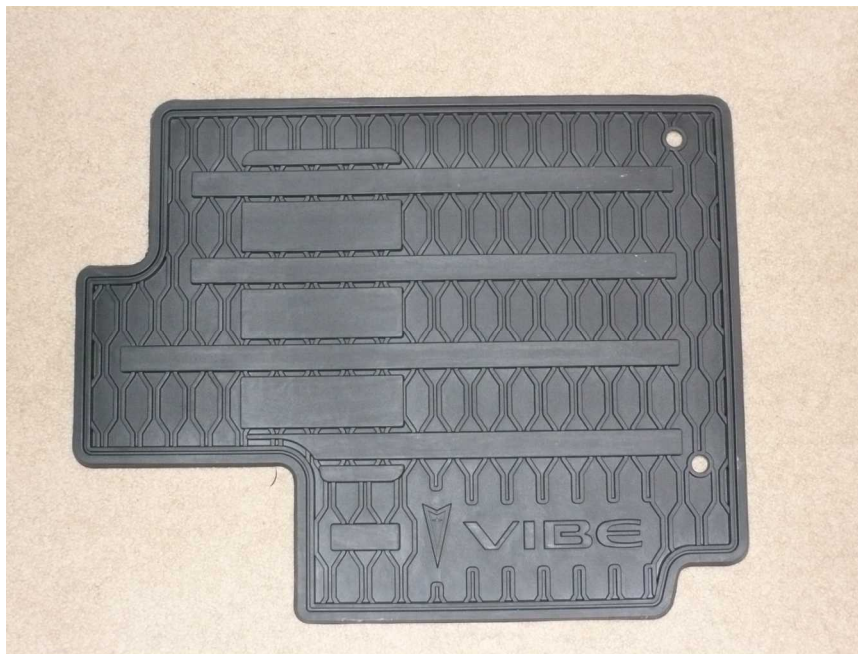
2480311

1. Determine if the vehicle is equipped with GM All-Weather Floor Mats (AWFM).
  - If the vehicle is equipped with Pontiac Vibe AWFM, remove the driver-side floor mat and install the new design driver's floor mat. The new design mat will be available August 16, 2010. If this recall is performed before the new design mat is available, place the driver-side floor mat in the trunk of the vehicle. Inform the customer to leave the floor mat in the trunk of the vehicle and to contact the dealership on or after August 16, 2010, to exchange the old design floor mat for a new design floor mat. Proceed to the *Remove and Cut the Accelerator Pedal* procedure below.
  - If the vehicle is not equipped with Pontiac Vibe AWFM, the mat does not require replacement and can be reinstalled after this recall has been completed. Proceed to the *Remove and Cut the Accelerator Pedal* procedure below. .

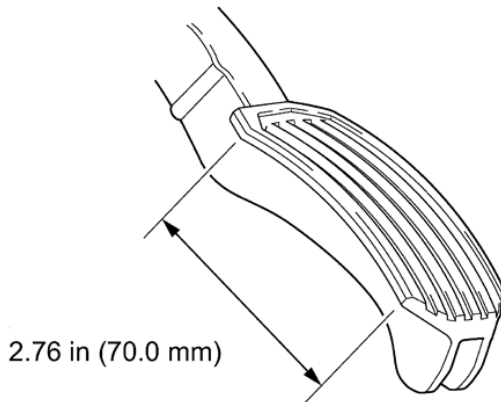
2443069

**Note:** Do NOT modify the second design accelerator pedal, P/N 19205346. Second design pedals do NOT require the pedal modifications provided in safety recall bulletins 10018 and 10038. To determine if the vehicle is equipped with a second design accelerator pedal, measure the length of the accelerator pedal in the area indicated in the arrow span. Refer to the illustration.

- If the length of the accelerator pedal in the arrow span area is 70 mm (2.76 in), the accelerator pedal has been modified or is a second design pedal. Do NOT modify the accelerator pedal. Proceed to the *Floor Carpet Modification* procedure in this bulletin
- If the length of the accelerator pedal in the arrow span area is longer than 70 mm (2.76 in), the accelerator pedal has NOT been modified and is a first design accelerator pedal. Proceed to the next step.

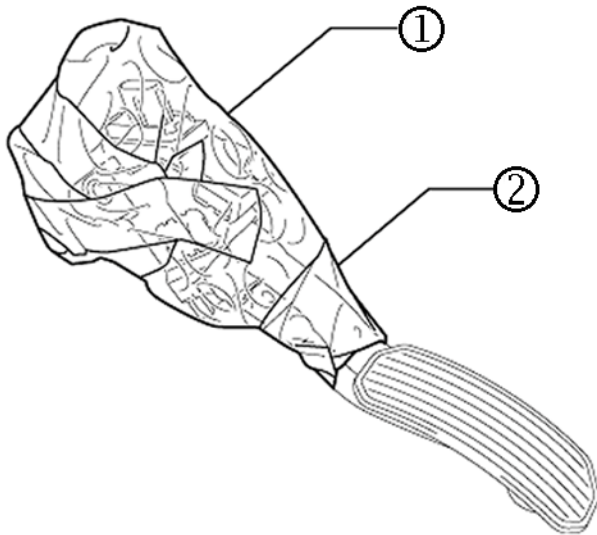
2443074

1. Remove the accelerator pedal assembly.
  - 1.1. Disconnect the accelerator pedal connector.
  - 1.2. Remove the 2 bolts.
  - 1.3. While still inside the vehicle, use bubble wrap (1) and masking tape (2) to cover and protect the sensor.

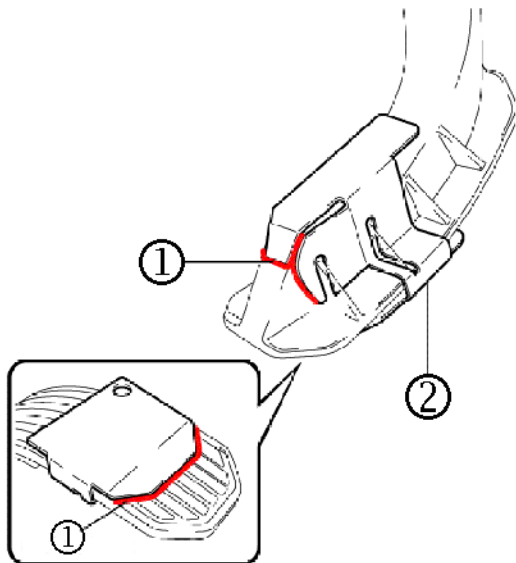
2443076

2. Mark the area to be cut. Firmly set the template (2) to the pedal and scribe guidelines (1) to outline the area to be cut.

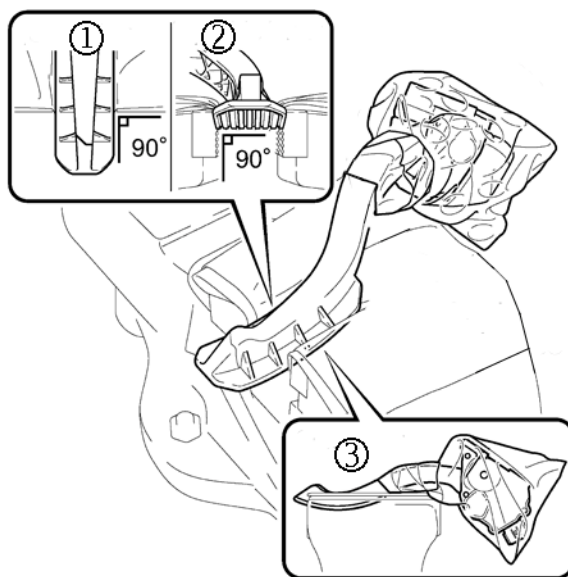
2443078

(1) Upper View (2) Tip Side View (3) Side View

3. Set the pedal in the vise at a right angle using a shop cloth while avoiding the sensor.

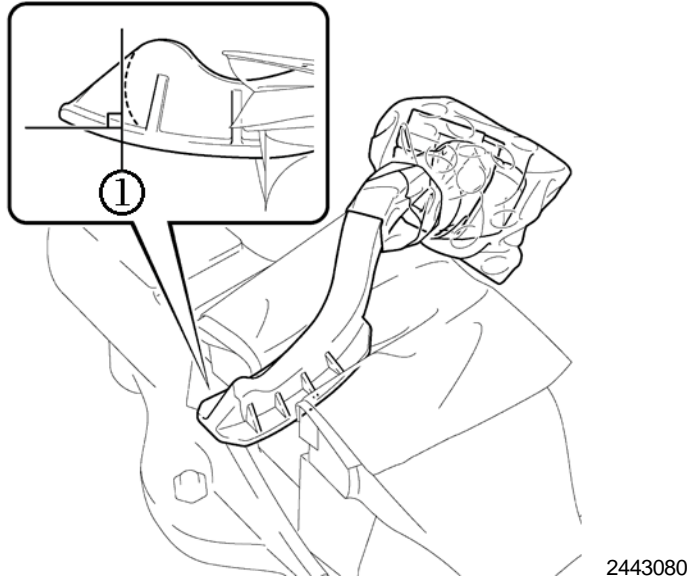
- 4.1. The cut line (1) is slightly outside from the scribed line and it makes 90 degree to the pedal foot pad as shown in the illustration.

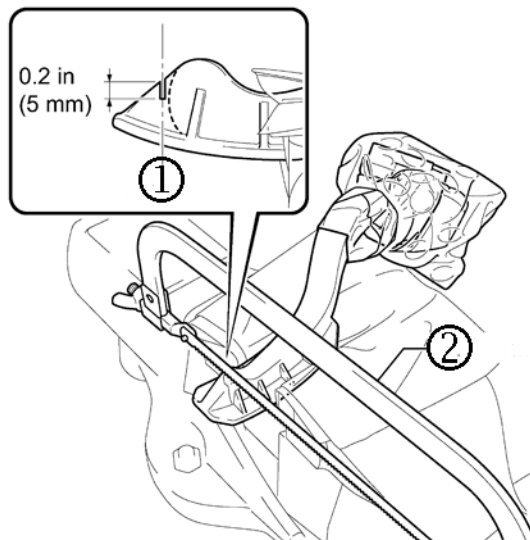
- 4.2. Use a hack-saw (2) and cut the pedal 5 mm (0.2 in) deep (1) as guide groove for reciprocating saw.

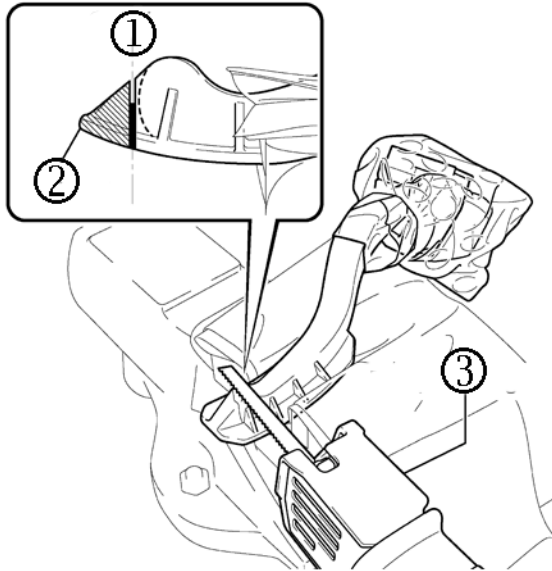
2443082

4.3. Use a reciprocating saw and cut off the lower section of the pedal as shown in the illustration.

(1) Cut Line (2) Cut Area (3) Reciprocating Saw

**Note:** Do not cut at the scribed line. This area will be sanded later.

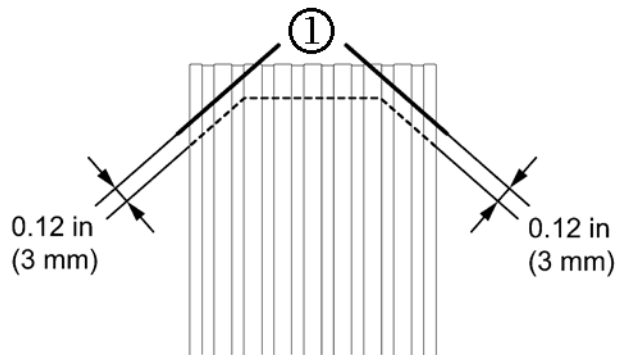
2443083

5. Cut corners of accelerator pedal assembly.

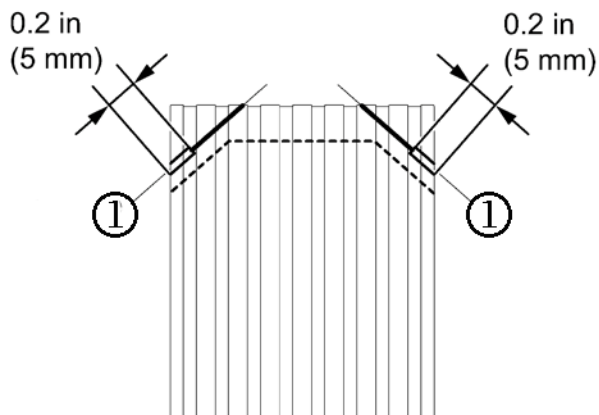
2443085

- 5.1. Turn the pedal over in the vise with the foot pad facing up.
- 5.2. The cut line (1) is 3 mm (0.12 in) outside from the scribed line as shown in the illustration.
- 5.3. Use a hack-saw and cut the pedal 5 mm (0.2 in) deep as a guide groove (1) for the reciprocating saw.

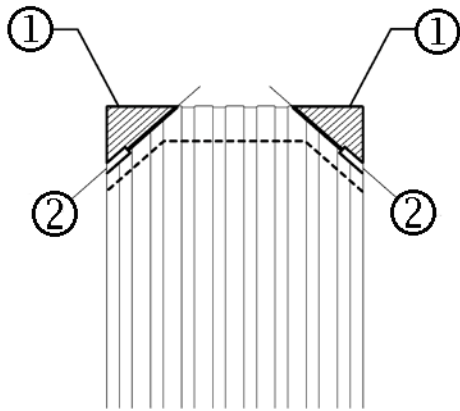
2443086

**(1) Cut Area (2) Cut Line**

5.4. Use a reciprocating saw and cut off the accelerator pedal's corners as shown in the illustration.

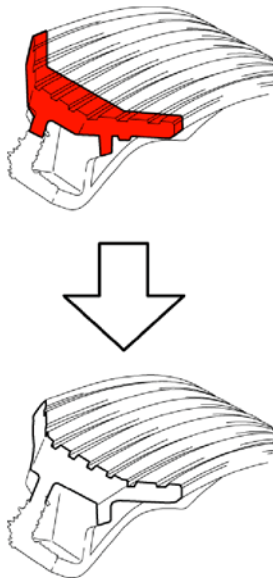
2443087

6. Sand the top surface.

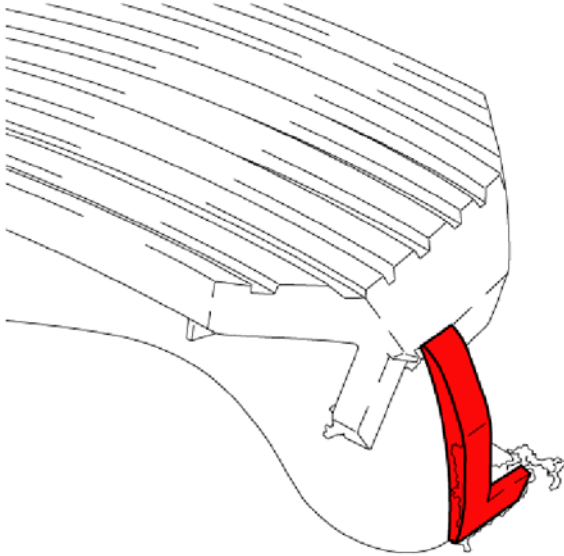
2443089

6.1. Using orbital sander, sand to the scribed line on the top surface and remove any sharp edges and burrs. Be sure to sand the foot pad round and not flat.

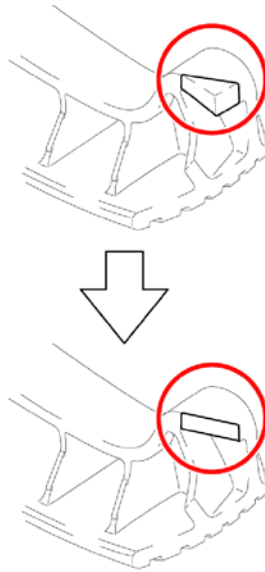
2443090

7.1. Using orbital sander, sand to the scribed radius line and remove any sharp edges and burrs.

**Caution: DO NOT sand pedal stopper area (circled) as shown in illustration.**

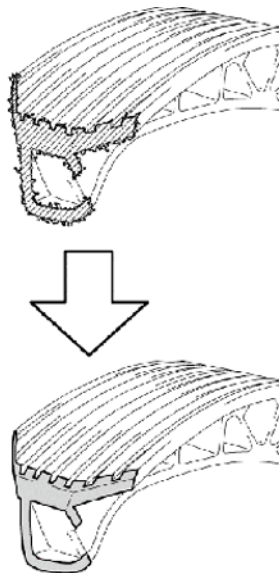
2443091

8.2. Using an orbital sander and hand file, sand the lower corner near pedal stopper.

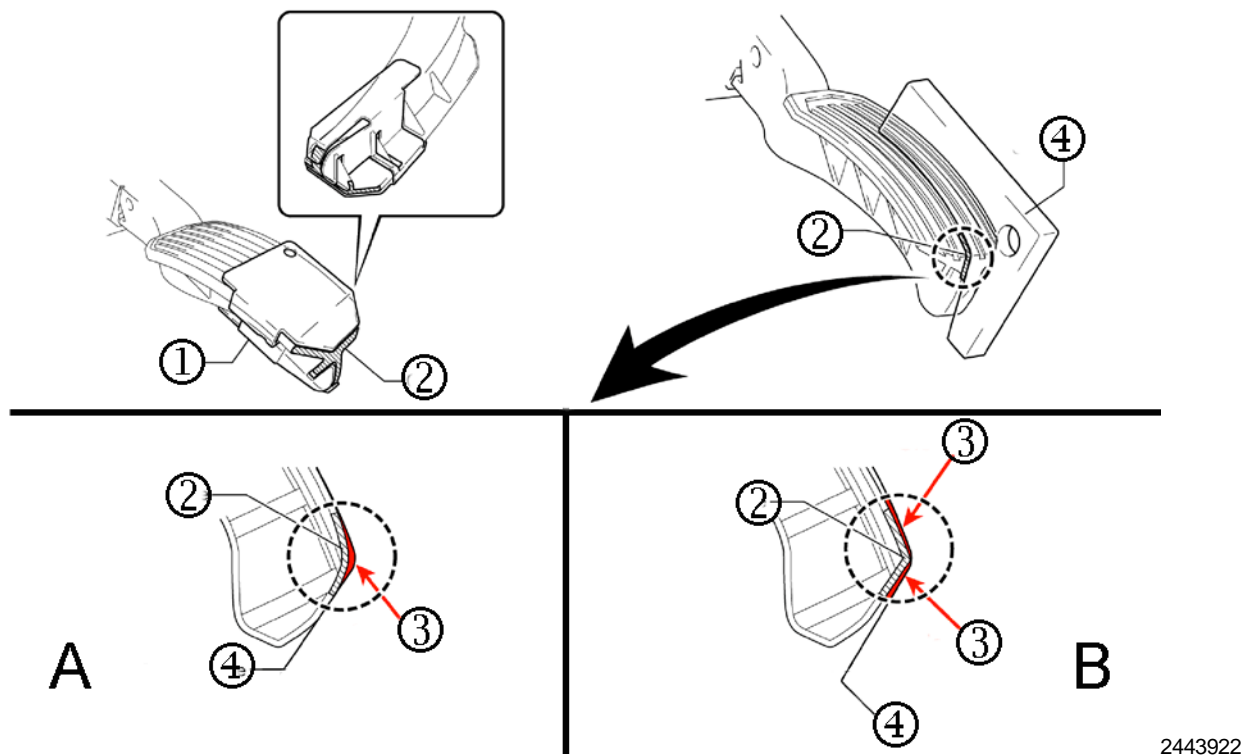
(A) OK (B) No Good (1) Cutting Template (2) Cutting Surface (3) Clearance (4) Shape Gauge

- Always wear protective eyewear and gloves when sanding or filing.
- A tolerance of -1.0 mm is permissible between the final cut surface and the template.
- Regarding the pin hole, the key point of judgment is a "smooth pedal surface".

10.1. Using the correct cutting template and shape gauge, check the shape of the pedal.

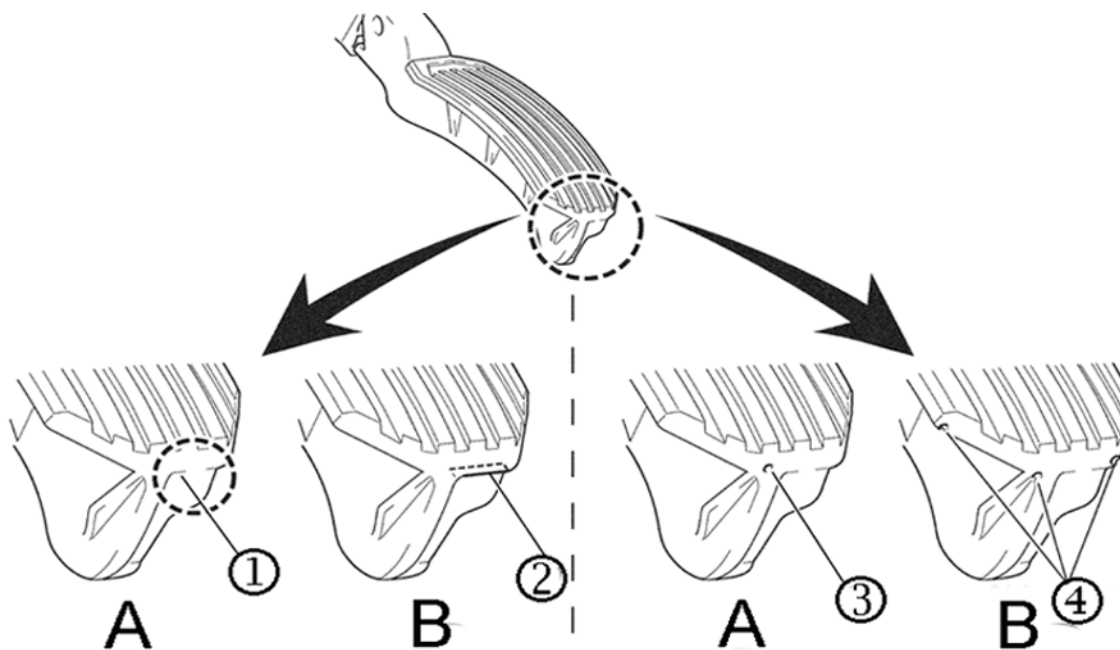
2443918

(A) OK (B) No Good (1) No Rib (2) Rib (3) Pin Hole (4) Chip or Nick

10.4. Check for a rib as shown. If there is a rib, file it until it is gone.

10.5. Check for any chips or nicks on the finished surface edge. If there are any chips or nicks, file the edge to make them smooth.

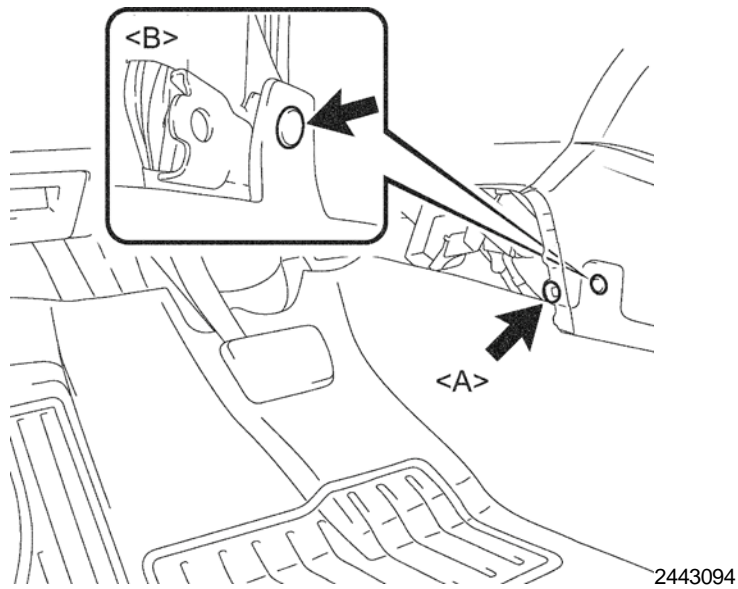
2. Pull back the floor carpet.
  - 2.1. Remove the clip <A>.
  - 2.2. Remove the clip <B>.

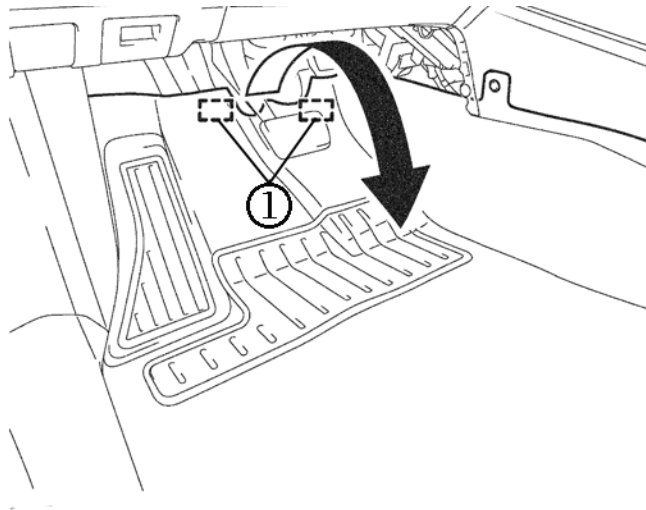
2443095

- 2.3. Disengage the 2 fasteners (1).
  - 2.4. Pull back the floor carpet as shown in the illustration.

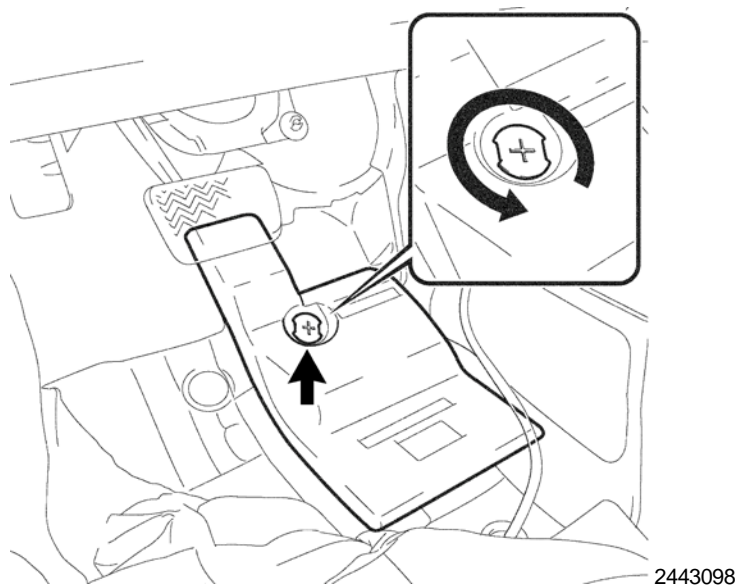
**Note:** It may be difficult to remove the insulator (tibia pad). Pull on the tibia pad while turning the clip.

3. Turn the clip and remove the tibia pad.

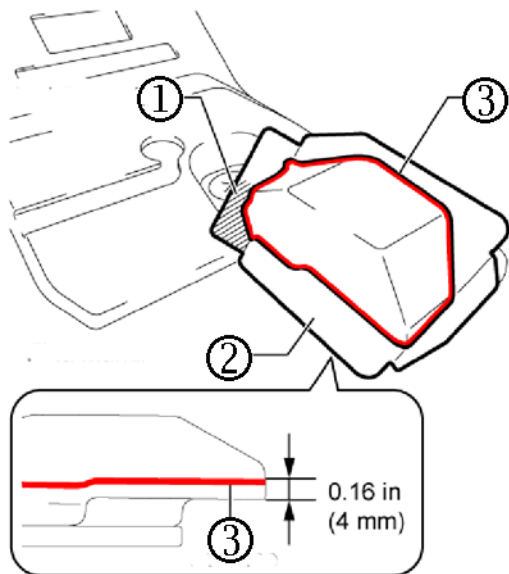
(1) Hold Down Area (2) Tibia Marking Gauge (3) Cut Line

- Hold down the area shown and draw with a colored pen.
- Verify the cut line was drawn 4 mm (.16 in) from the edge as shown.

- 4.1. Place the gauge and draw cut lines onto the tibia pad along the tibia marking gauge.

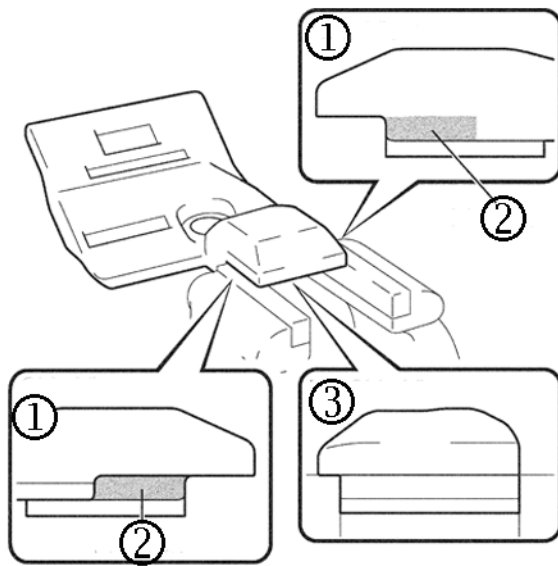
2443101

(1)Side View (2) Fix Area (3)Tip Side View

4.2. Secure the tibia pad in a vise at the contact areas shown.

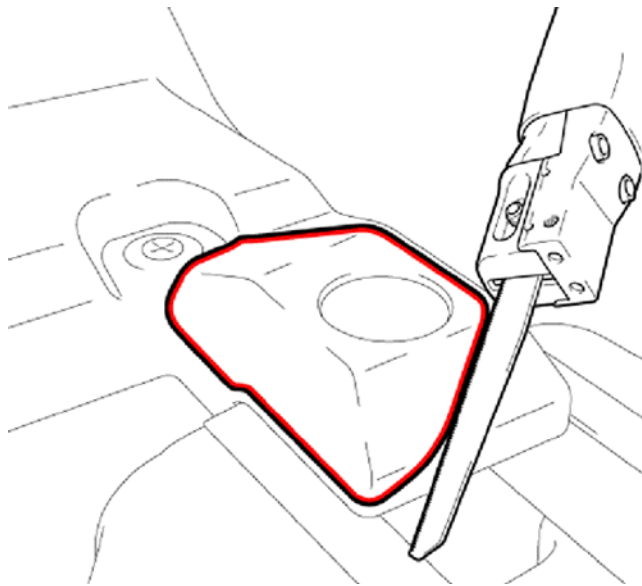
2443102

- Always wear protective gloves and glasses.
- Use blades with full lengths of more than 100 mm (3.94 in).
- Be careful not to contact the blade with the vise.
- Do not stop during the cutting process.

4.3. Cut the tibia pad with an air saw until all of the cut line has been cut away.

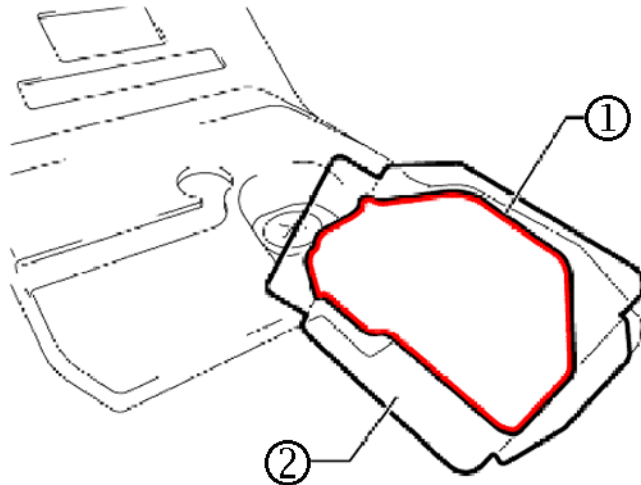
2443106

(1) Cut Line (2) Tibia Marking Gauge

**Note:** Use an orbital sander and file and trim exactly along the cut line.

- 4.5. Place the gauge to the reshaped tibia pad and check if it fits the tibia marking gauge.

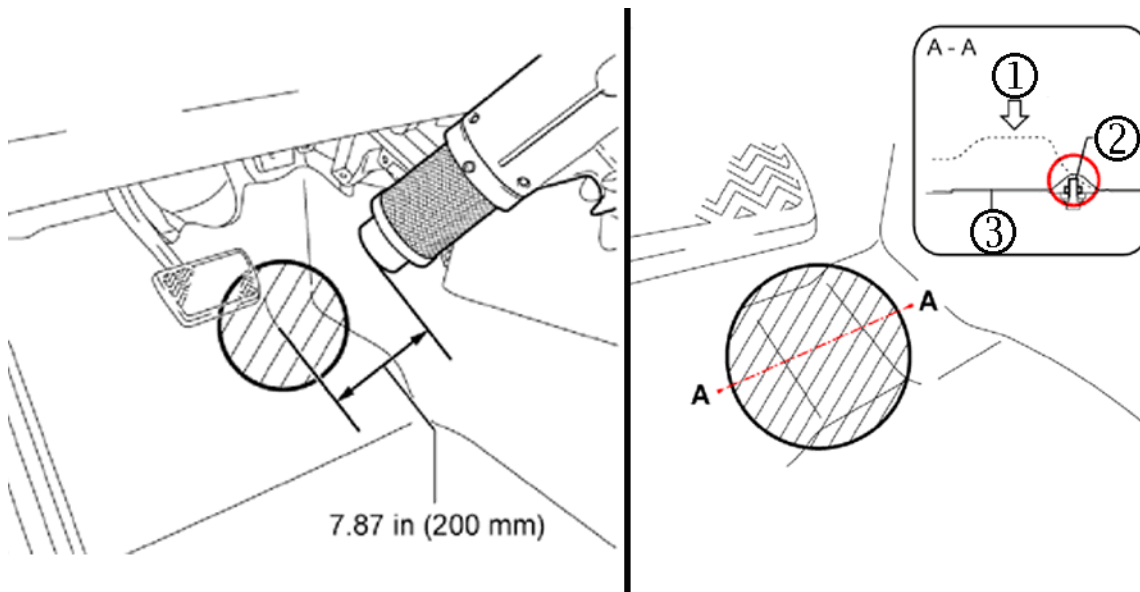
2443905

- A bolt extends from the floor under the floor carpet. Be careful not to bore a hole in the floor carpet when reshaping.
- Keep the hair dryer/heat gun more than 200 mm (7.87 in) away from the floor carpet, and stop after 2 or 3 minute intervals. Continuous heating of the floor carpet may cause damage.
- DO NOT leave hair dryer or heat gun inside of the vehicle when it is hot to prevent unintended heat damage on interior parts.

- 5.1. Heat the floor carpet area as shown in the illustration for 3 minutes with the tibia pad removed and reshape the carpet.

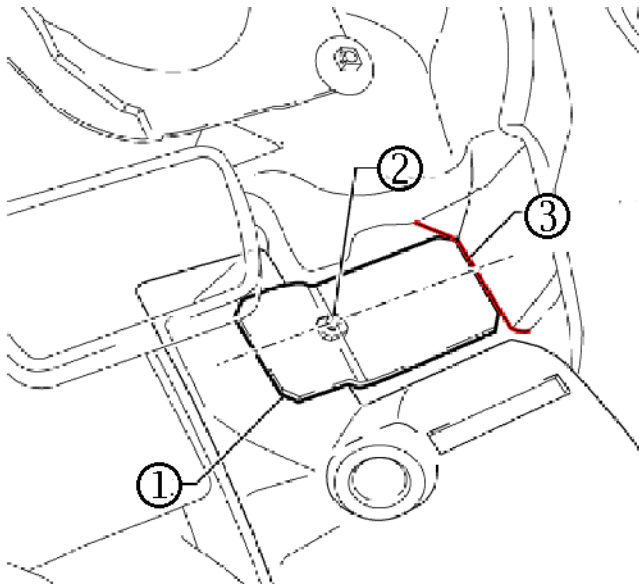
2443113

**Note:** Place the rubber seat (1) so that the bolt (2) aligns with its vertical center.

- 7.1. Clean and degrease the rubber seat application area.
- 7.2. Peel the double sided tape cover off the NEW rubber seat.
- 7.3. Attach the rubber seat (1) along the floor press line (3).

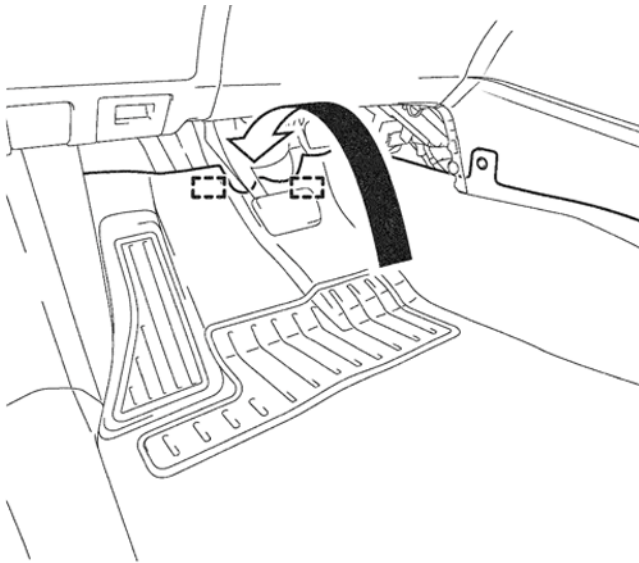
2443114

8. Place back the floor carpet.
  - 8.1. Place the floor carpet back into position as shown in the illustration.
  - 8.2. Engage the 2 fasteners.

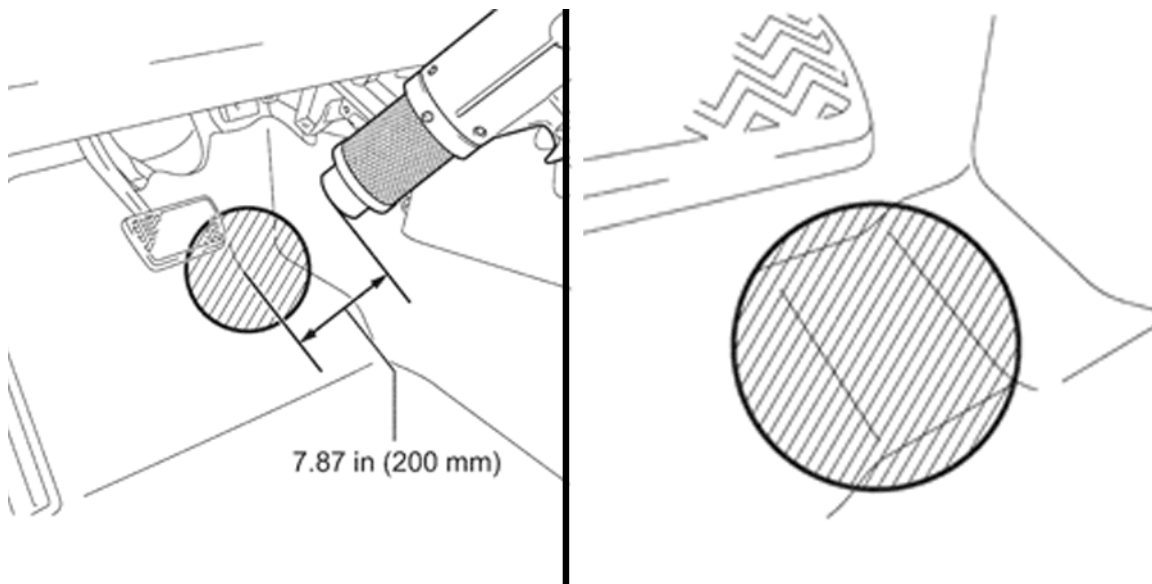
- Always wear protective gloves when heating the floor carpet.
- Keep the hair dryer/heat gun more than 200 mm (7.98 in) away from the floor carpet, and stop after 1-2 minute intervals. Continuous heating of the floor carpet may cause damage.
- DO NOT leave the hair dryer/heat gun inside of the vehicle when it is hot to prevent unintended heat damage on interior parts.

9.1. Heat the floor carpet as shown in the illustration for 2 minutes, and smooth it out by pushing it with your hand. Heat the same area again for 1 minute, and smooth the carpet firmly.

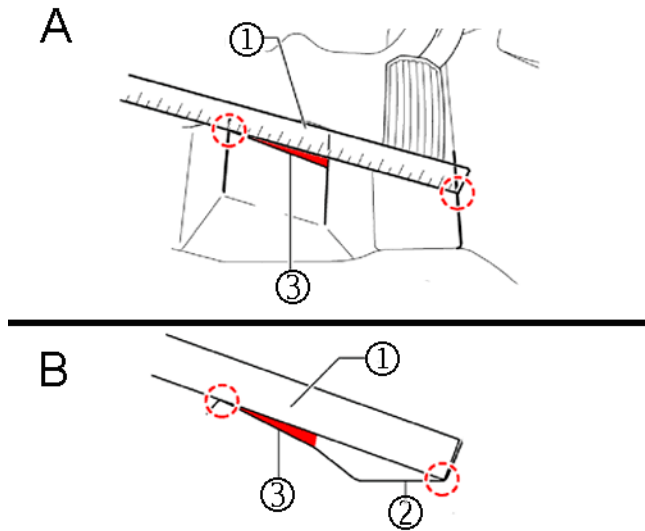
2443121

(A) Make sure there is clearance between the ruler and the floor. (B) Cross Section View (1) Ruler (2) Floor Carpet (3) Clearance Between Ruler and Floor

2. Inspect the floor carpet.
  - 2.1. Depress the accelerator pedal fully and place a ruler at the front tip of the pedal as shown in the illustration, and then make sure that there is a clearance between the ruler and the floor.
  - 2.2. If no clearance exists, reshape the carpet again.
  - 2.3. Confirm a claw and all fasteners are securely fixed with floor carpet.

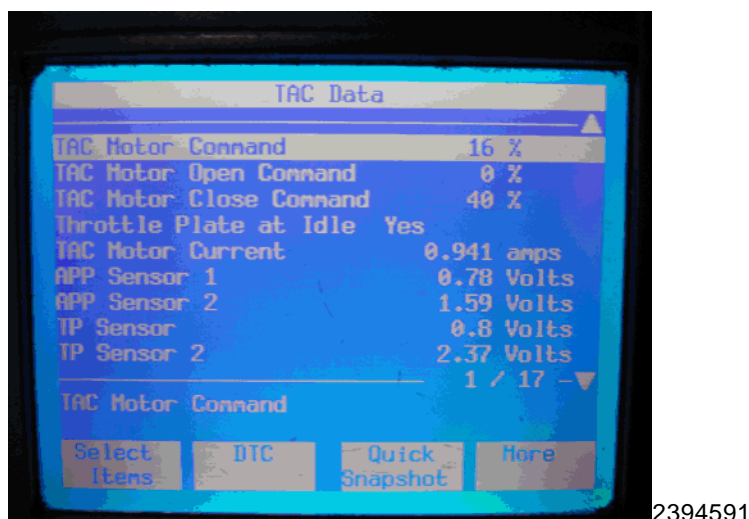
4.2. From the Main Menu of the Tech 2<sup>®</sup>, select Diagnostics>Year>Passenger Car>Division>Model>Powertrain>Transmission Selection>Engine Selection>ECM>Data Display> TAC Data. The TAC Data screen provides voltage information for the Accel Sensor Out No.1 and Accel Sensor Out No.2.

Tester Display	Measurement: Range (Display)	Normal Condition	Diagnostic Note
Accel Sensor Out No. 1	APP Sensor No. 1 Voltage	Accelerator Pedal Released: 0.5 to 1.1 V	Read value with ignition switch to ON (Do not start engine)
		Accelerator Pedal Fully Depressed: 2.6 to 4.5 V	
Accel Sensor Out No. 2	APP Sensor No. 2 Voltage	Accelerator Pedal Released: 1.2 to 2.0 V	Read value with ignition switch to ON (Do not start engine)
		Accelerator Pedal Fully Depressed: 3.4 to 5.0V

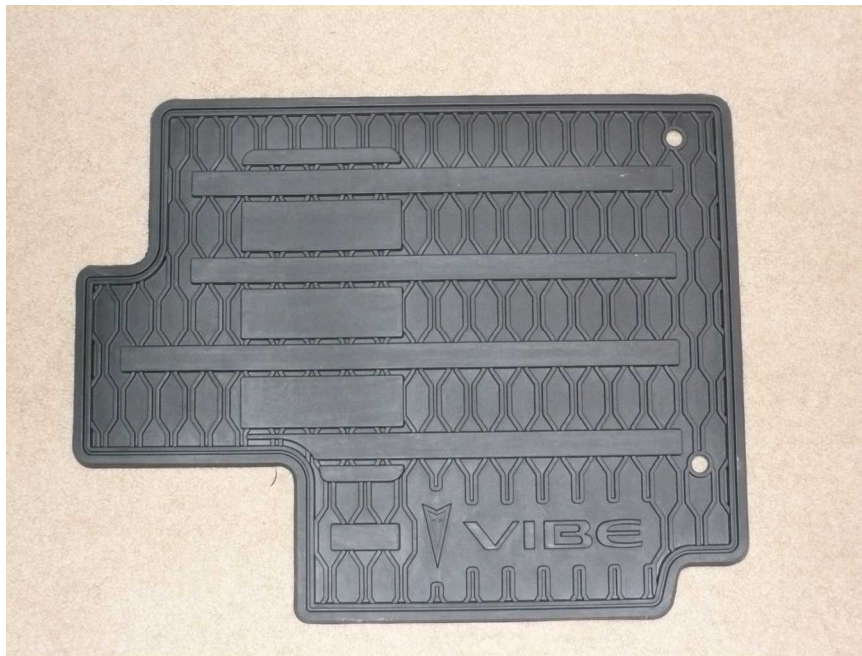
2480311

If your vehicle is equipped with a set of Pontiac Vibe All Weather Floor Mat (AWFM) (see above), the driver's side mat will be replaced. All this will be performed for you at no charge.
