Recall Bulletin

PRODUCT SAFETY RECALL

SUBJECT: Potential Floor Mat Interference with the Accelerator Pedal

MODELS: 2009-2010 Pontiac Vibe

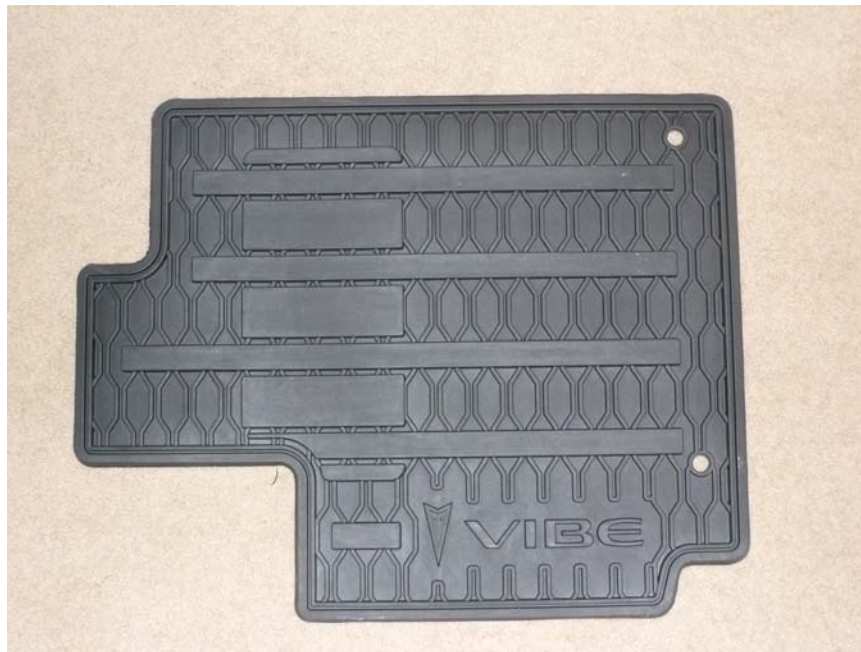
2480311

All-Weather Floor Mat Inspection

1. Determine if the vehicle is equipped with GM All-Weather Floor Mats (AWFM).
 - If the vehicle is equipped with Pontiac Vibe AWFM, remove the driver-side floor mat and install the new design driver's floor mat. The new design mat will be available August 16, 2010. If this recall is performed before the new design mat is available, place the driver-side floor mat in the trunk of the vehicle. Inform the customer to leave the floor mat in the trunk of the vehicle and to contact the dealership on or after August 16, 2010, to exchange the old design floor mat for a new design floor mat. Proceed to the *Remove and Cut the Accelerator Pedal* procedure below.
 - If the vehicle is not equipped with Pontiac Vibe AWFM, proceed to the *Remove and Cut the Accelerator Pedal* procedure below.

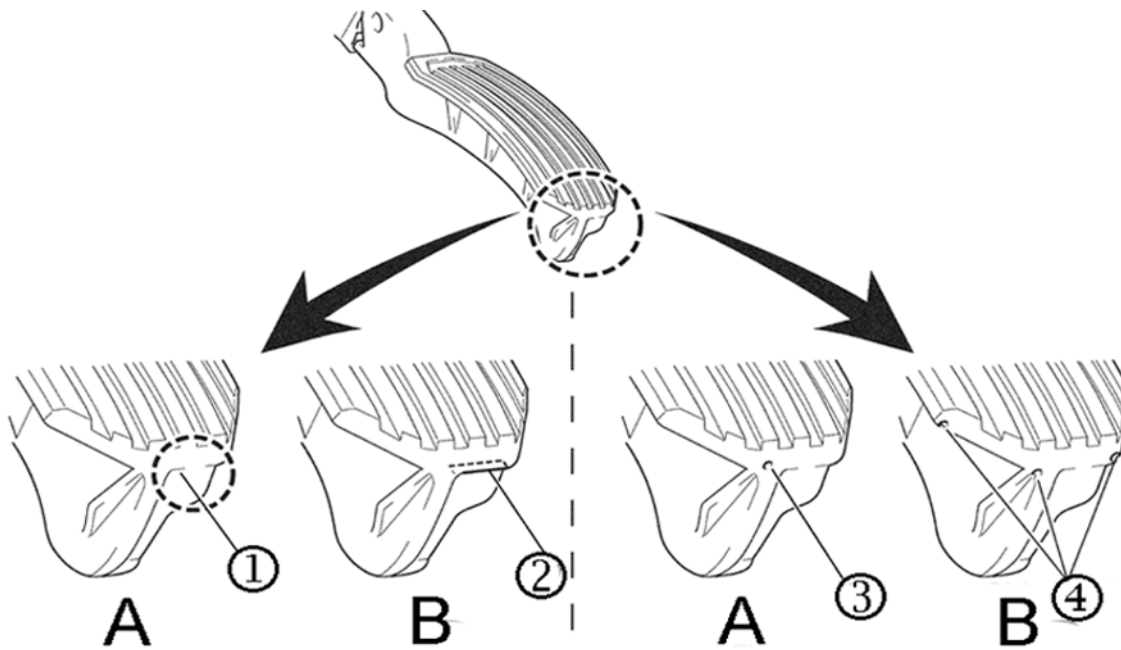
2443918

(A) OK (B) No Good (1) No Rib (2) Rib (3) Pin Hole (4) Chip or Nick

10.4. Check for a rib as shown. If there is a rib, file it until it is gone.

10.5. Check for any chips or nicks on the finished surface edge. If there are any chips or nicks, file the edge to make them smooth.

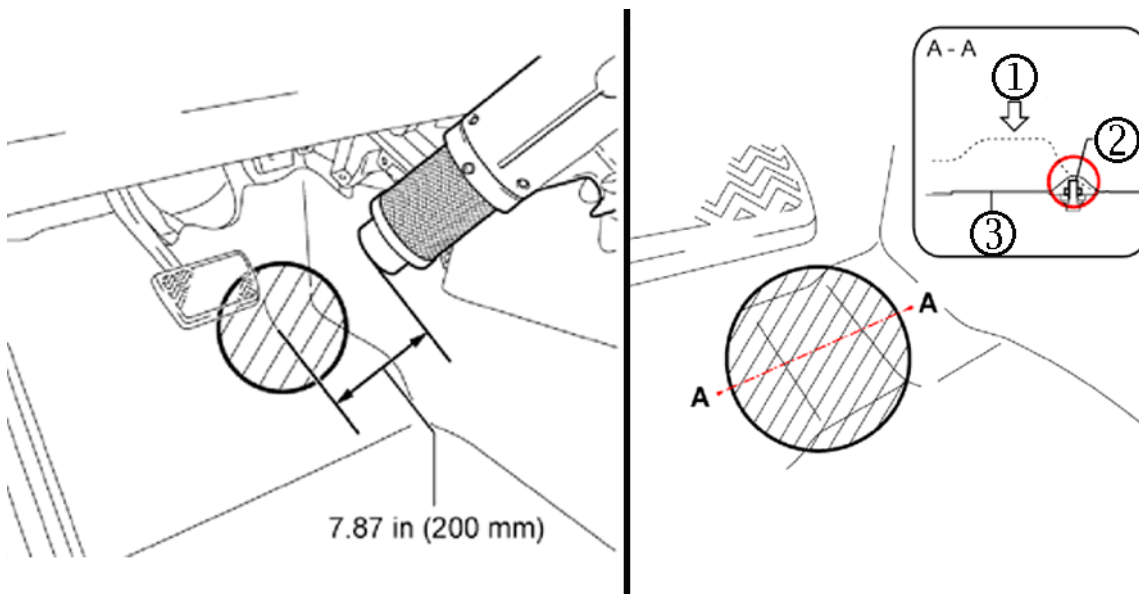
2443905

- **A bolt extends from the floor under the floor carpet. Be careful not to bore a hole in the floor carpet when reshaping.**
- **Keep the hair dryer/heat gun more than 200 mm (7.87 in) away from the floor carpet, and stop after 2 or 3 minute intervals. Continuous heating of the floor carpet may cause damage.**
- **DO NOT leave hair dryer or heat gun inside of the vehicle when it is hot to prevent unintended heat damage on interior parts.**

- 5.1. Heat the floor carpet area as shown in the illustration for 3 minutes with the tibia pad removed and reshape the carpet.
