Applies To: **2007-08 Fit** – ALL

Safety Recall: Power Window Master Switch May Not Work

(Supersedes 10-008, dated March 15, 2010, to revise the information marked by the black bars)

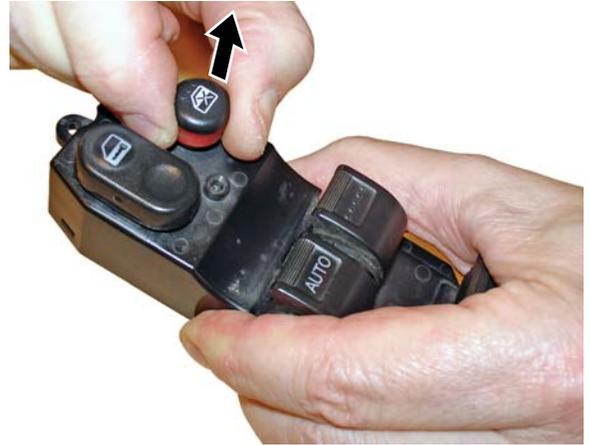
7. Remove the main switch button from the power window master switch body.

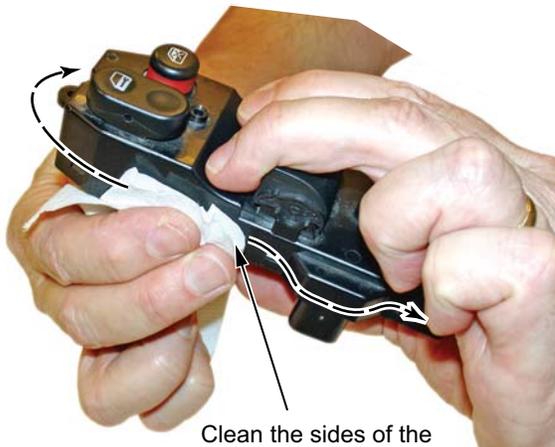
- Insert the PCB into the top half of the switch case, then reassemble the switch case, making sure that all eight clips are secure. Reattach the main switch button.
- Using a dry paper towel, remove any oil or dust from the sides of the switch. Do not use water or solvents.

Clean the sides of the switch all the way around.

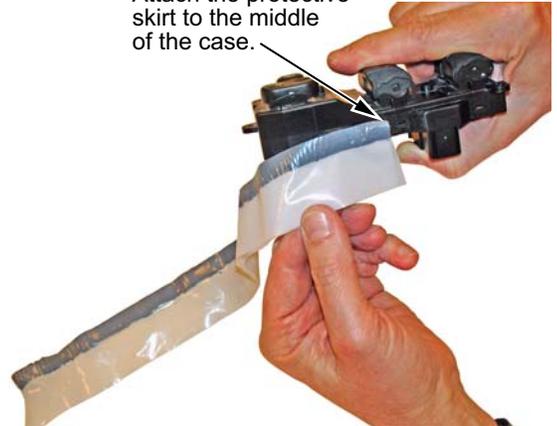
- Apply a protective skirt to the sides of the switch. **NOTE:** The skirt prevents moisture from entering the switch by sealing the tab slots in the sides of the switch case and by surrounding the switch with a moisture barrier.

- Starting in the middle of the switch case, attach the skirt by firmly pressing its sealant onto the case.
- Continue applying the skirt around the entire case. To firmly attach the skirt sealant, press down on the entire length of it with the flat side of a flat-tip screwdriver. Make sure there are no gaps between the sealant and the case, especially in the corner areas.

Attach the protective skirt to the middle of the case.
