# SAFETY RECALL BULLETIN

SUBJECT:			No: <b>SR-10-002REV</b>
<b>2004 ENDEAVOR FUEL FILLER PIPE — SAFETY RECALL CAMPAIGN</b>			DATE: <b>December, 2010</b>
			MODEL: <b>2004 Endeavor</b>
CIRCULATE TO:	<input checked="" type="checkbox"/> GENERAL MANAGER	<input checked="" type="checkbox"/> PARTS MANAGER	<input checked="" type="checkbox"/> TECHNICIAN
<input checked="" type="checkbox"/> SERVICE ADVISOR	<input checked="" type="checkbox"/> SERVICE MANAGER	<input checked="" type="checkbox"/> WARRANTY PROCESSOR	<input checked="" type="checkbox"/> SALES MANAGER

***This bulletin supercedes SR-10-002, issued June, 2010, to delete the fuel filler pipe inspection process. Dealers should replace the fuel filler pipe on ALL affected vehicles. Revised information is italicized and indicated by ◀.***

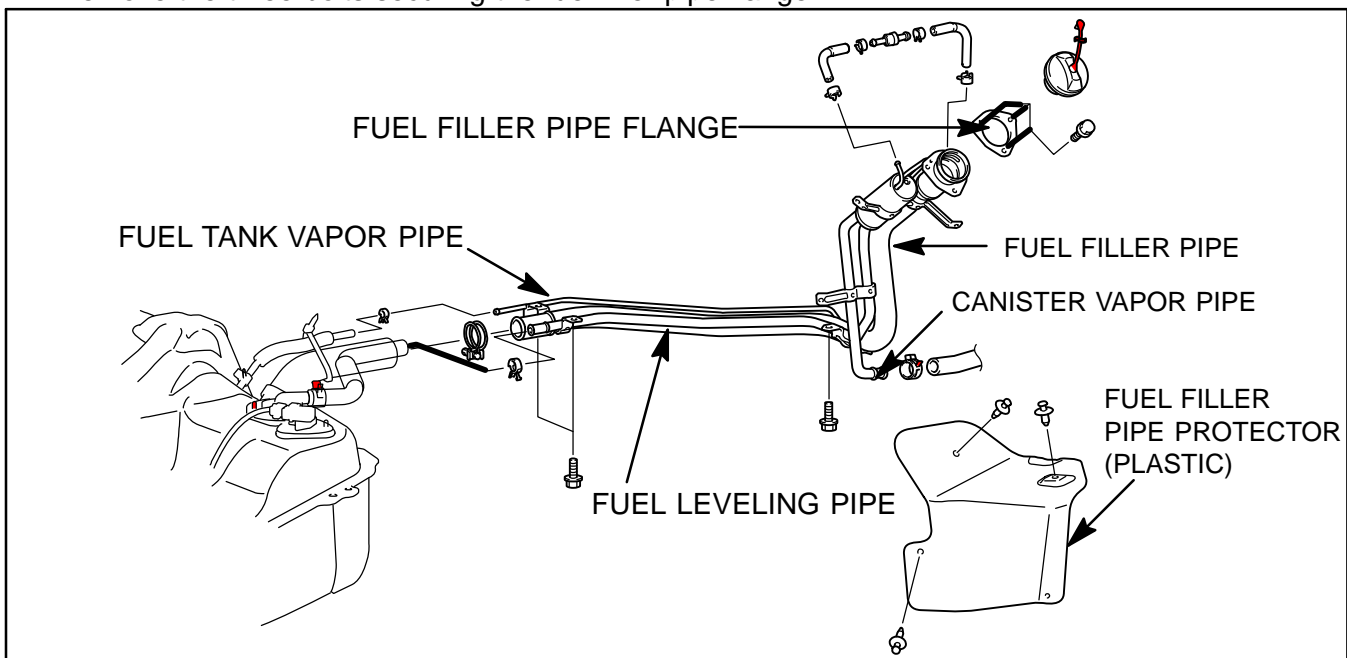
1. Turn the ignition key to the OFF position.
2. Remove the three bolts securing the fuel filler pipe flange.

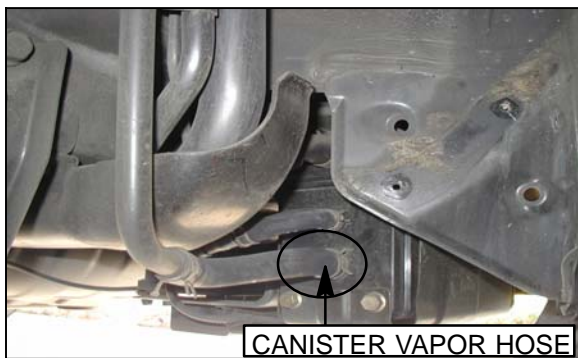
3. Apply masking tape around the fuel filler pipe opening to protect the paint.
4. Raise the vehicle on a lift.
5. Remove the left rear wheel and tire assembly.
6. Remove the plastic fuel filler pipe protector and the wheel splash shield in the left rear wheel well.

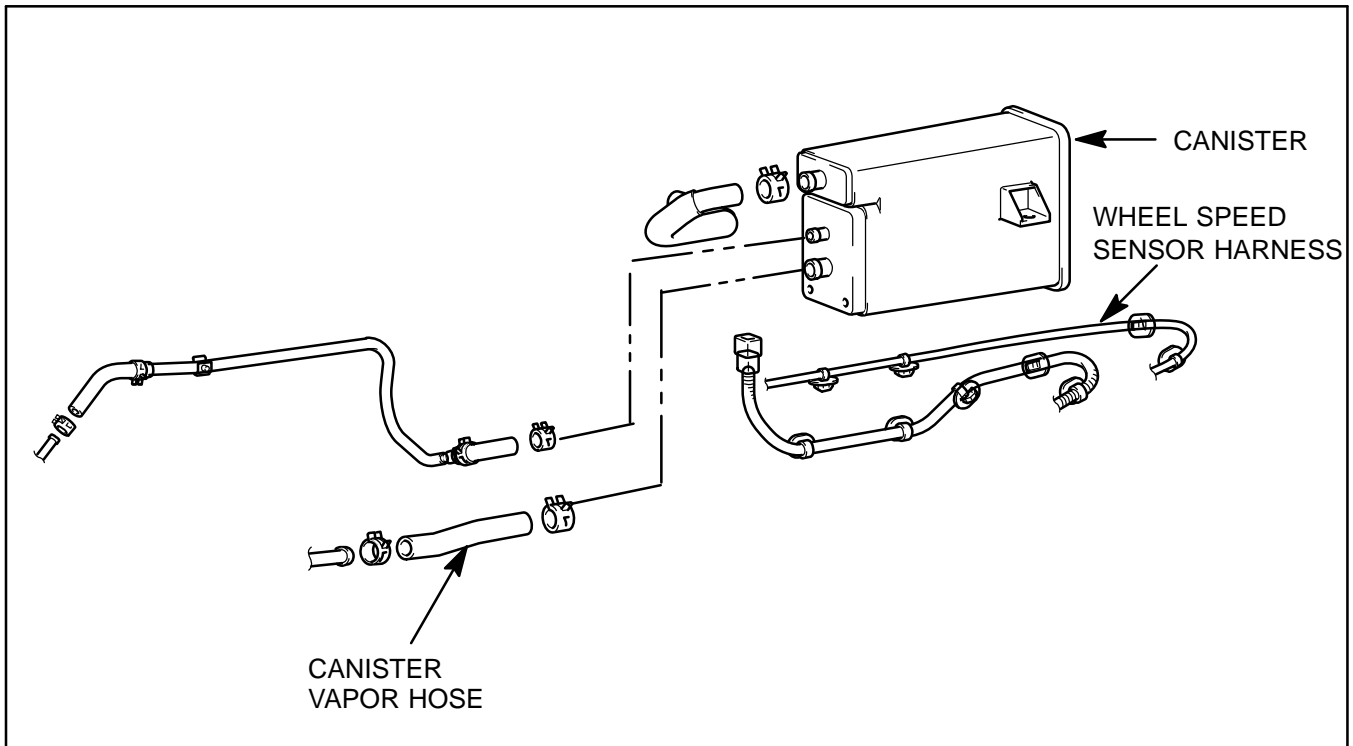
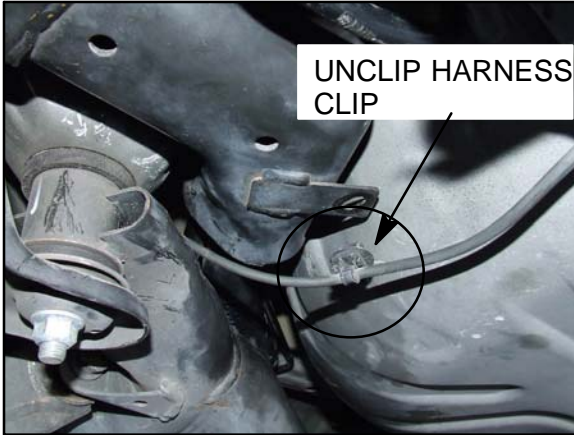
7. Remove the canister vapor hose at the canister.

8. Unclip the wheel speed sensor harness clip at the fuel pipe protector. (The clip will remain on the harness.)

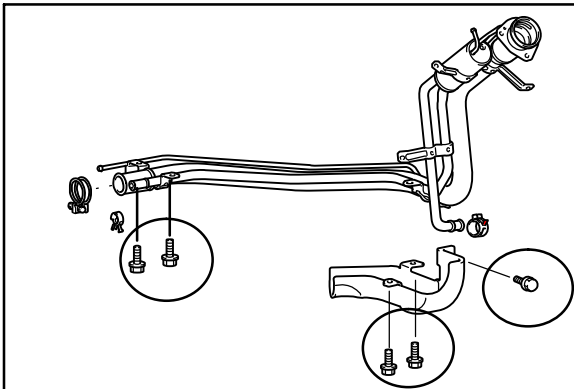
9. At the lower end of the fuel filler pipe, remove the hose clamps from the vapor hose, fuel filler hose, and fuel leveling valve hose. For ease of removal, split the hoses lengthwise, and remove the hoses.  
Discard the plastic hose band securing the vapor hose to the fuel filler hose.

10. Remove the fuel filler pipe assembly as follows:

- a. Remove the 3 bolts securing the metal fuel filler pipe protector.
- b. Remove the 2 bolts securing the lower end of the fuel filler pipe to the vehicle body.

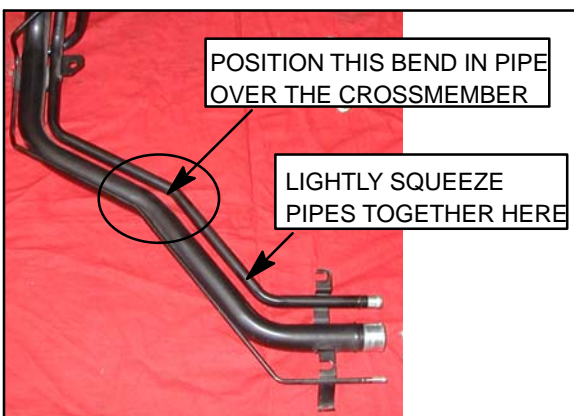
- c. Remove the pipe from the fuel filler opening and lower the pipe down.
- d. Rotate the filler portion of the pipe assembly toward the front of the vehicle, to clear the crossmember.

- e. Be sure the bend in the pipe (the area indicated in the figure at left) is positioned over the crossmember.
- f. On the pipe assembly, lightly squeeze the fuel leveling pipe and main inlet pipe together in the area indicated.
- g. Rotate the pipe assembly downward. Pull the pipe rearward and down from between the crossmember and the body.

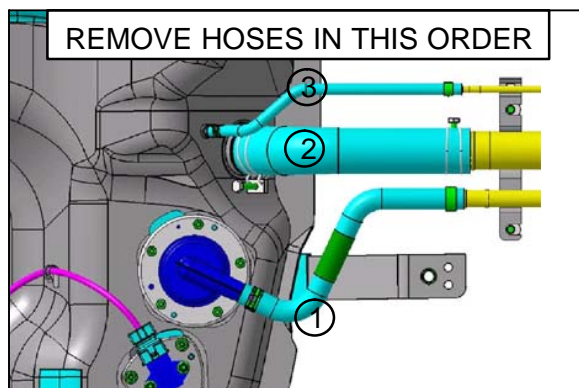
12. Remove the vapor hose, fuel filler hose, and fuel leveling valve hose from the fuel tank. For ease of removal, remove them in the order shown.

Split the hoses lengthwise, then remove them.

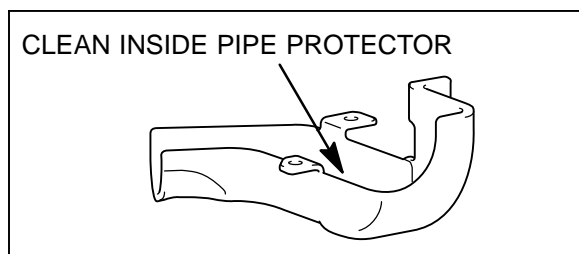
13. Clean any mud and debris from inside the metal fuel filler pipe protector, to clear the drain hole.

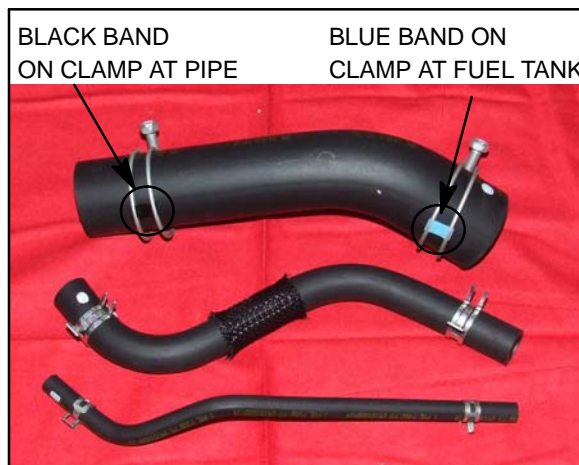
14. Attach the new hose clamps onto both ends of the new vapor hose, fuel filler hose, and fuel leveling valve hose provided in the repair kit.

- a. Install the new fuel filler hose clamp with the **BLACK** band at the **filler pipe**.

Install the new fuel filler hose clamp with the **BLUE** band at the **fuel tank**.

15. Install the three new hoses to the fuel tank in the order shown. Be sure the markings on the new hoses at the fuel tank are facing **UP**. Then reposition the clamps securely.

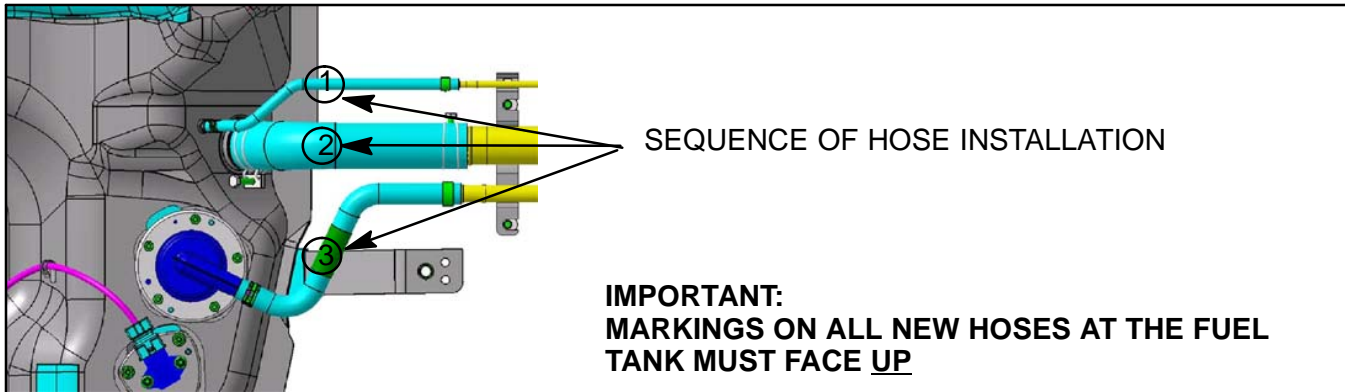
NOTE: The fuel tank vapor hose provided in the repair kit does not have a protective sheath like the original hose and does not need to be secured to the fuel filler hose.

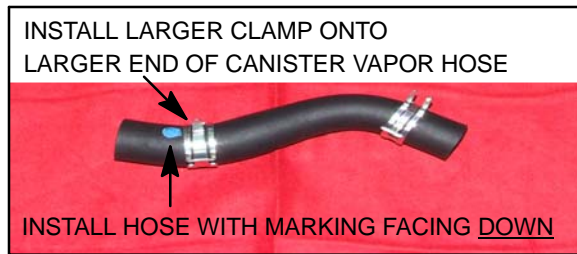
19. Attach the new hose clamps onto the new canister vapor hose, and install the hose.
  - a. Be sure the hose marking is facing **DOWN**.
  - b. The larger end of the canister hose requires the larger clamp as shown. This end is installed at the canister.

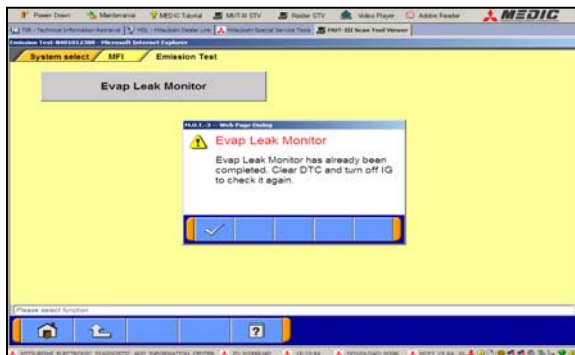
If the Evap Leak Monitor cannot be run because all readiness tests are completed, or a DTC is present, this screen will display. Clear the DTCs in the MFI system, cycle the ignition key to the OFF position, start the engine, and then run the Evap Leak Monitor again.

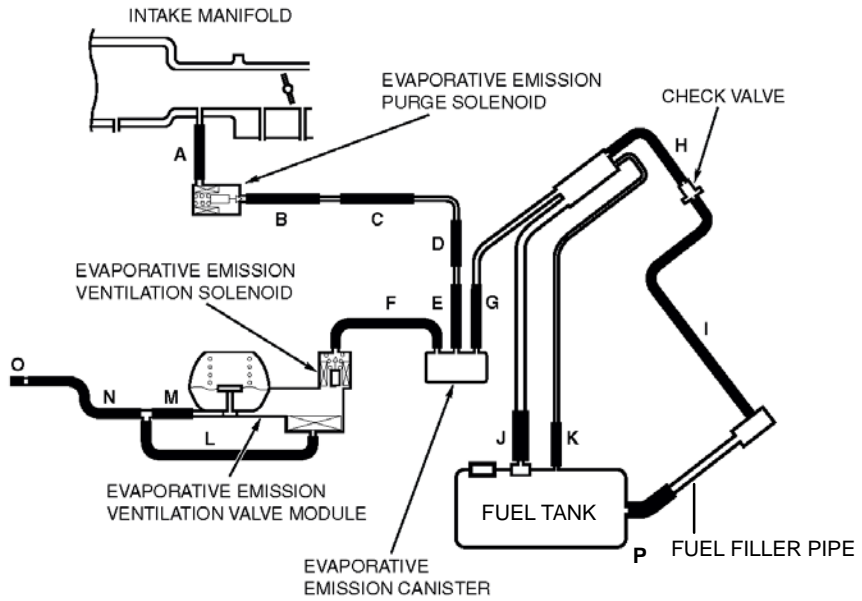
### EVAPORATIVE EMISSIONS SYSTEM DIAGRAM

- G = Canister hose
- J = Fuel Leveling Hose
- K = Fuel Vapor Hose
- P = Fuel Filler Hose
