RECALL CAMPAIGN BULLETIN

NTB10-030

VOLUNTARY RECALL CAMPAIGN 2008 - 2010 ARMADA & TITAN AND 2008 - 2009 QUEST BRAKE PEDAL PIVOT PIN INSPECTION

NHTSA ID # To Be Determined
APPLIED VEHICLES: 2008 - 2010 Armada (TA60)
 2008 - 2010 Titan (A60)
 2008 - 2009 Quest (V42)

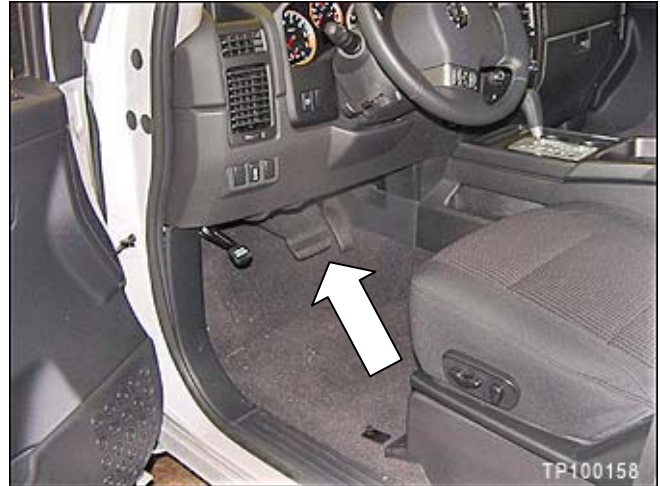
Figure 1

1. Look under the dash to view the brake pedal pivot pin.

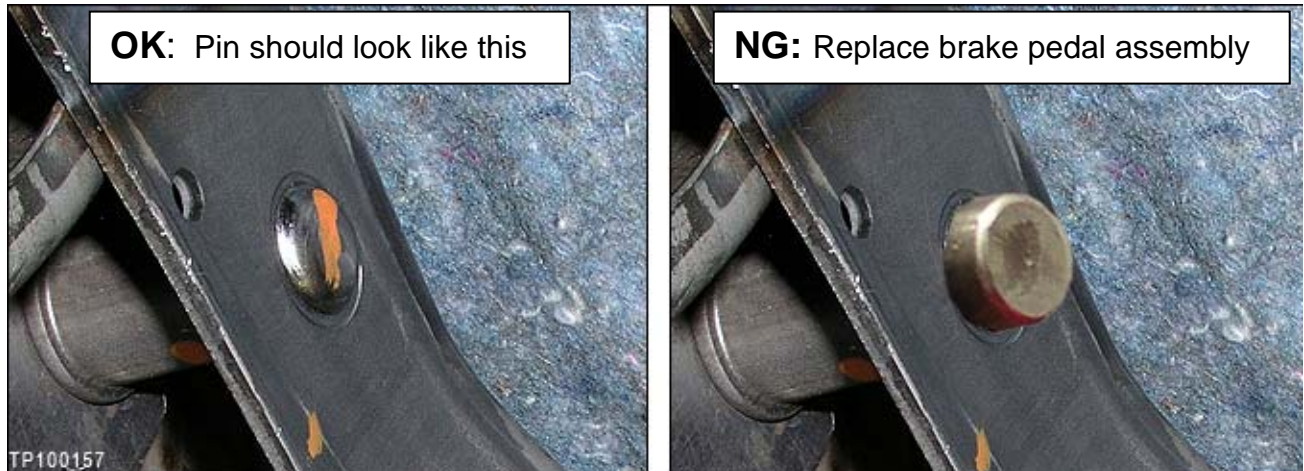
Figure 3

3. Inspection results (see Figure 3):

- OK - No further action required.
- NG – Replace the brake pedal assembly.
