## INSTRUCTIONS TO PERFORM CAMPAIGN 115

- Certain 2010 model year Winnebago Sightseer®/Itasca Sunova® (Model D33C) and Winnebago Vista®/Itasca Sunstar® (Model E30W)

These motor homes were manufactured July 16, 2009 through January 14, 2010.

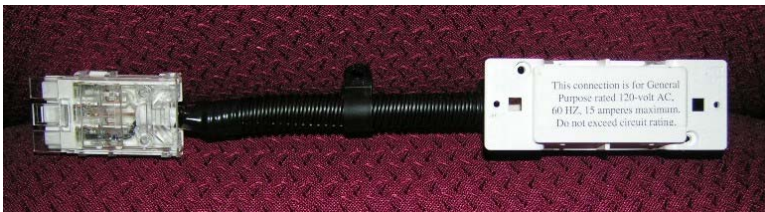
**Wire Assembly A**

**Wire Assembly B**

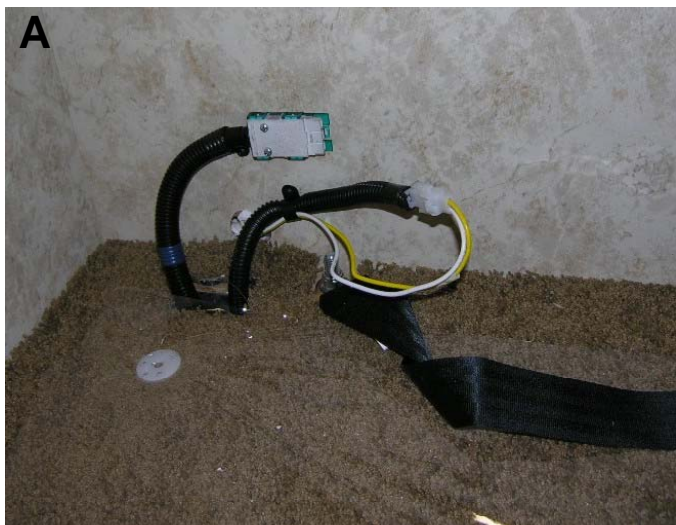
**Open Molex Connector Assembly  
(Go to Step 1-D)**

1-D. Connect Wire Assembly A to current Molex connector assembly located behind the sofa bed. Secure wire assembly connector to wall (using two 1½" screws). See Photos A and B.

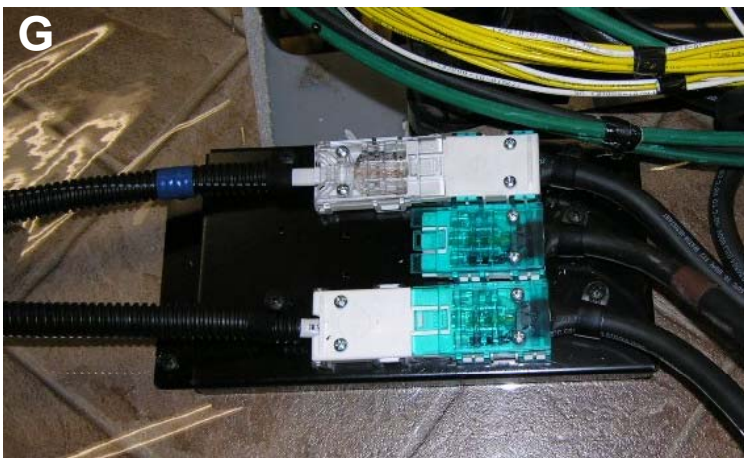
**Open Molex Connector Assembly  
(Go to Step 2-D)**

- 2-C. If Wire Assembly B is already connected to the Molex connector assembly located beneath the refrigerator (as shown in Photo H), proceed to Step 2-G. If Wire Assembly B is not connected, continue with Step 2-D.
- 2-D. Connect Wire Assembly B to current Molex connector assembly located underneath refrigerator. Secure wire assembly connector to the metal plate on floor (using two 1½” screws). See Photos G and H.

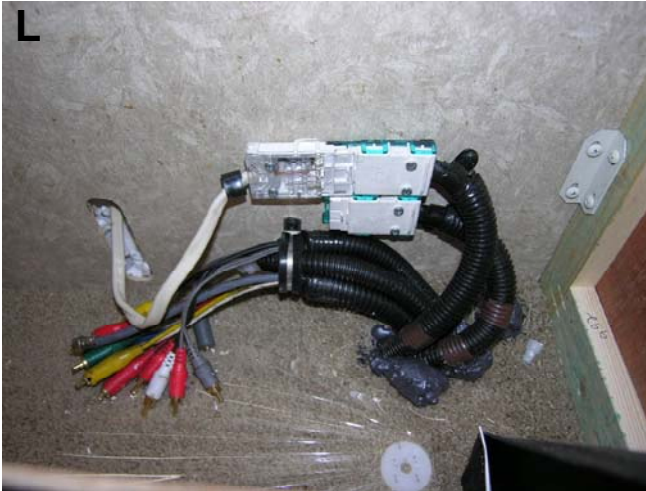
**Open Molex Connector Assembly  
(Go to Step 3-D)**

3-D. Connect Wire Assembly A to current Molex connector assembly located behind the dinette. Secure wire assembly connector to wall (using two 1½” screws). See Photos L and M.

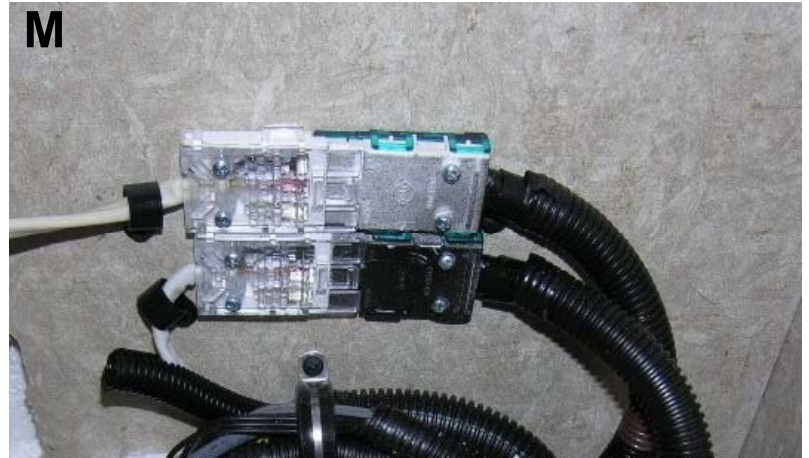
**Installation Complete  
(No Action Needed)**

3-C. If Wire Assembly A is already connected to the Molex connector assembly located behind the dinette (as shown in Photo M), proceed with Step 3-H. If Wire Assembly A is not connected, continue with Step 3-D.

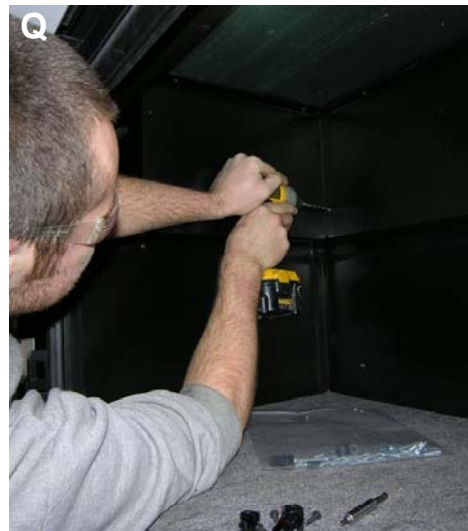
**CAUTION: A holding tank is located directly behind the inner compartment wall. Use extreme caution when drilling the rivets out that you do not puncture the holding tank!**

- 4-A. Eliminate all 120-volt power sources to the coach (ensure shoreline is unplugged, the generator is not operating, and 300-watt inverter power switch is off – if equipped). *If your coach is equipped with a 300-watt inverter, it will be located near the entrance door.*
- 4-B. Drill out the two rivets located on the inner edge of the removable access panel. This panel is located on the inside wall of compartment #3. See Photos P and Q.

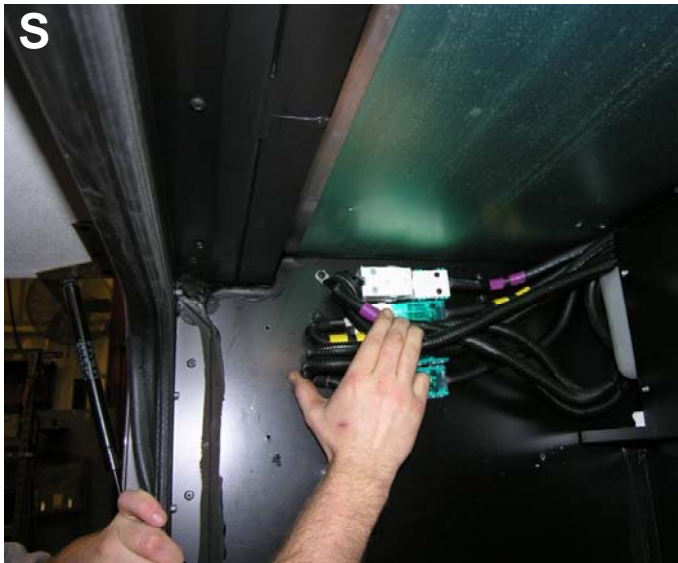
**Open Molex Connector Assembly  
(Go to Step 4-E)**

4-E. Connect Wire Assembly A to current Molex connector assembly located on the compartment wall. See Photos S and T.
