SERVICE REPAIR PROCEDURE

Freedman Seating company 33 ½” Barrier Foam Retro Fit			RECALL # 10V-095
BY: Jose Vazquez	DEPARTMENT: Warranty	DATE: 4/5/2010	REVISION: 1

2007 STHF5, STH5 and Universe US Bus Corporation School Bus

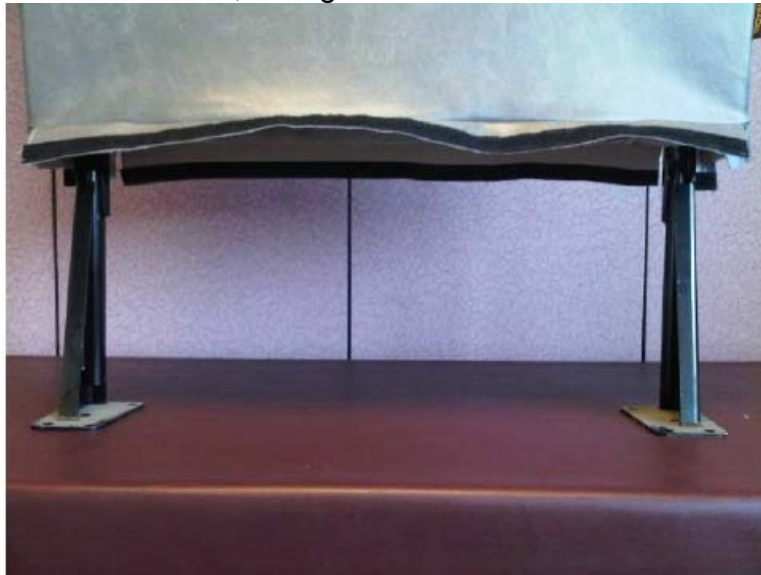
Picture 1 – Barrier with Velcro Removed

- 1) It is recommended that the barrier be exposed to a minimum temperature of 65° F for three (3) hours prior to applying for tape adhesive to be effective.
- 2) Unhook the cover Velcro, taking note of how to re-hook it. **See picture 1 below**

- 3) While holding down the barrier frame, pull up on foam to remove the foam and cover as a whole, taking note of its direction.
- 4) Cut two (2) strips from the 3M VHB 4941 series double sided tape, 15" each.
- 5) Place the tape strips on the barrier plate on the side angled towards the rear seats.

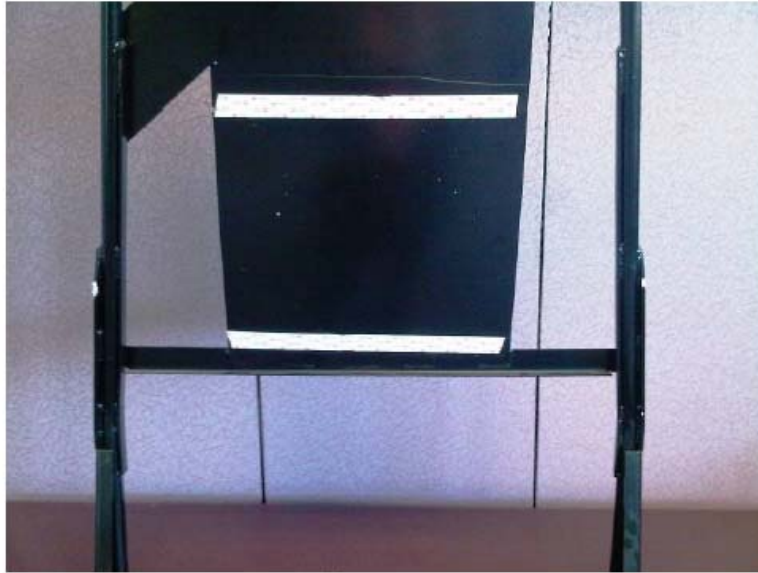
Picture 2 – Adhesive Strip Placement

The first strip 1" and the second strip 15" up from the horizontal barrier bracket, with the adhesive side facing the barrier plate. Firmly press the tape onto the barrier plate. **See Picture 2 below.**

- 6) Remove the non adhesive backing from the double sided tape.
- 7) Line up the square expanded polystyrene piece with the bottom edge resting on the horizontal barrier bracket and center the square with the center of the bracket barrier plate. Marking the center line of the barrier bracket and foam will make this easier. **See *Picture 3 below.***
