INTERIM TECHNICAL INSTRUCTIONS
FOR
SAFETY RECALL A0E
ORIGINALLY SOLD IN OR CURRENTLY REGISTERED IN
CT, DE, IL, IN, KY, MA, MD, ME, MI, MN, NH, NJ, NY, OH, PA,
RI, VA, VT, WI, WV and the District of Columbia
SPARE TIRE CARRIER CABLE INSPECTION
1998 – 2010 SIENNA 2WD

Subject: Safety Recall – A0E
Certain 1998 through 2010 Toyota Sienna 2WD Vehicles Equipped with a Spare Tire
Severe Corrosion of Spare Tire Carrier Cable
Interim Inspection Procedure of Spare Tire Carrier and Temporary Relocation of Spare Tire

Subject: Safety Recall – A9E
Certain 1998 through 2010 Toyota Sienna 2WD Vehicles Equipped with a Spare Tire
Severe Corrosion of Spare Tire Carrier Cable
Remedy Procedure – Phase 1 (1998 – 2006 model year)

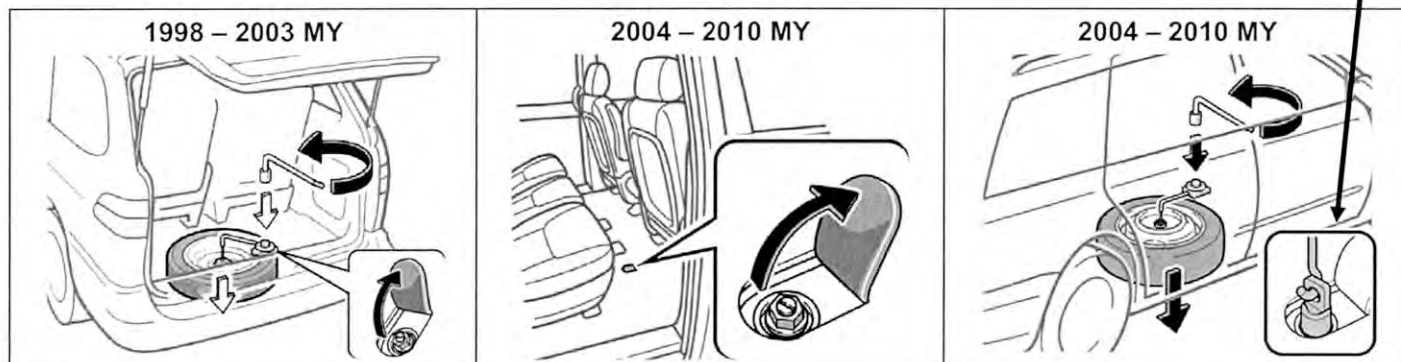
- Do not use an impact wrench/power tool when lowering or raising the spare tire. This action may cause spare tire carrier damage.
- Take care not to damage the interior with the wrench when turning the clamp bolt.
- If the vehicle is equipped with the pentagonal type spare tire clamp bolt, loosen it using the adapter socket from the vehicle's tool kit.

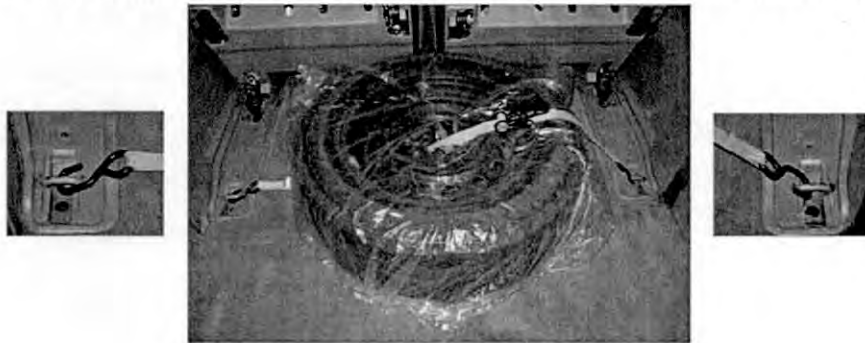
Option 1 - Customer does NOT use the third row: Use the third row seat anchor and tie straps to secure the tire.

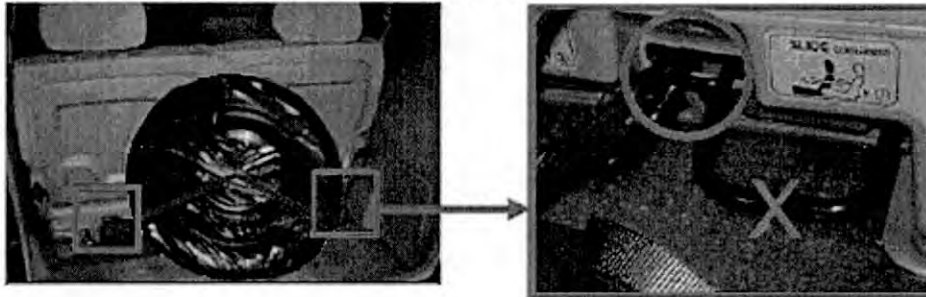
Option 2 - Customer uses the third row: Use the child seat anchors and tie straps to secure the tire.

NOTE: Only use this option if the customer does not use child seats in the third row.
Keep the tire upright against the third row seat.

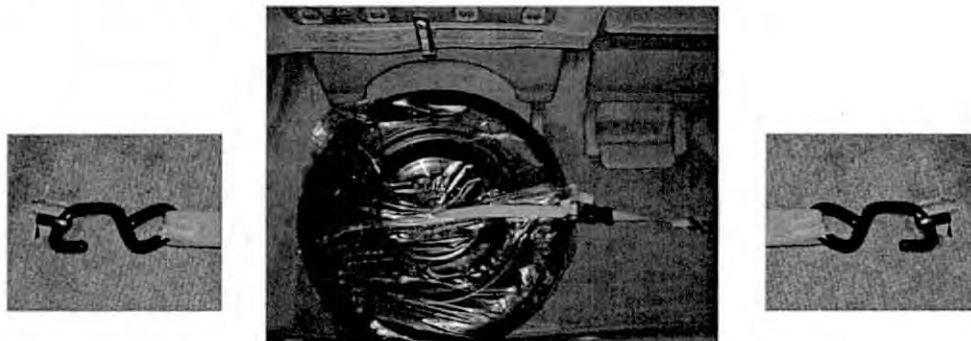
Use the hold down hooks and tie straps to secure the tire.

Note: the customer cannot stow the rear seats, but they can still fold the third row seatbacks flat.

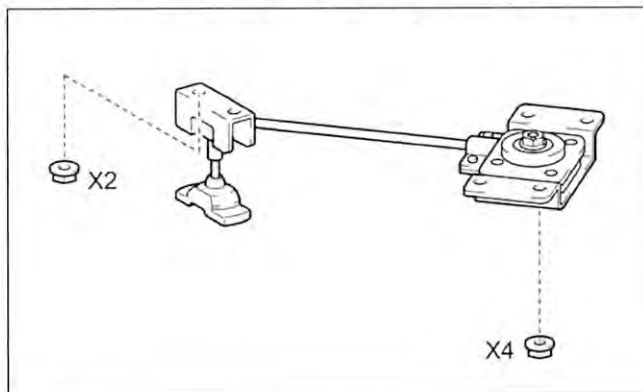
REPLACEMENT OF THE SPARE TIRE CARRIER ASSEMBLY 1998 – 2003 MY

1. REMOVE THE SPARE TIRE CARRIER

- a) Remove the 6 nuts and spare tire carrier.

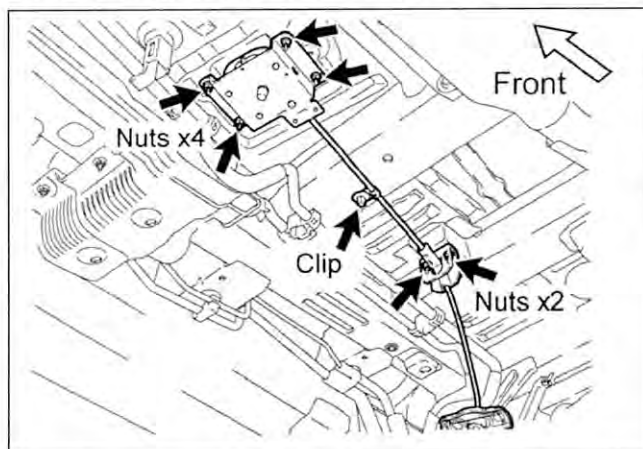
REPLACEMENT OF THE SPARE TIRE CARRIER ASSEMBLY 2004 – 2010 MY *

1. REMOVE THE SPARE TIRE CARRIER

- a) Remove the 6 nuts.
- b) Remove the clip and spare tire carrier.

* 2004-2010 (2nd generation) 2WD Sienna vehicles produced before mid-February 2008 may be equipped with a spare tire carrier assembly utilizing a hexagon (6-sided ☉) type spare tire clamp bolt. The replacement carrier will be equipped with a pentagon (5-sided ☉) type clamp bolt.

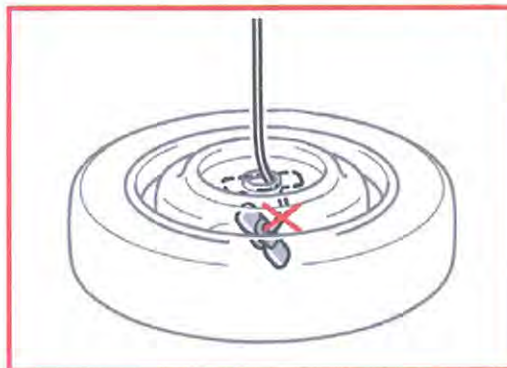
On certain 1998 through 2010 model year Sienna 2WD vehicles equipped with a spare tire, originally sold in or currently operated in severe cold climate areas with high road salt use (Severe Cold Climate States), excessive corrosion may be exhibited on the end of the spare tire carrier cable. In the worst case, the spare tire stowed under the vehicle may become separated from the spare tire carrier.

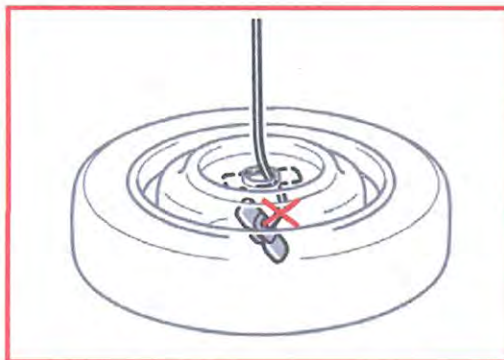
On certain 1998 through 2010 model year Sienna 2WD vehicles equipped with a spare tire, originally sold in or currently operated in severe cold climate areas with high road salt use (Severe Cold Climate States), excessive corrosion may be exhibited on the end of the spare tire carrier cable. In the worst case, the spare tire stowed under the vehicle may become separated from the spare tire carrier.

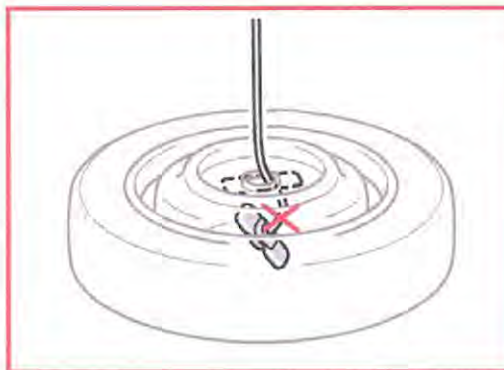
On certain 1998 through 2010 model year Sienna 2WD vehicles equipped with a spare tire, which were originally sold in or currently registered in specific cold climate areas with high road salt use (Severe Cold Climate States*), excessive corrosion may be exhibited on the end of the spare tire carrier cable. In limited instances, the spare tire stowed under the floor may become separated from the spare tire carrier and become a road hazard that could cause a vehicle crash.

A Corrosion Resistant Compound (CRC) will be applied to the end of the spare tire carrier cable. If significant corrosion is found on the spare tire carrier cable, Toyota will first repair the spare tire carrier cable prior to applying the CRC. Both CRC application, and if necessary, cable repair will be performed at **no cost** to the vehicle owner. For additional information on inspection, repair, and CRC application please refer to TIS.

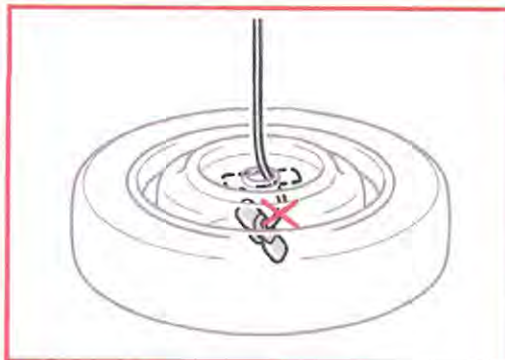
On certain 1998 through 2010 model year Sienna 2WD vehicles equipped with a spare tire, which were originally sold in or currently registered in specific cold climate areas with high road salt use (Severe Cold Climate States*), excessive corrosion may be exhibited on the end of the spare tire carrier cable. In limited instances, the spare tire stowed under the floor may become separated from the spare tire carrier and become a road hazard that could cause a vehicle crash.

A Corrosion Resistant Compound (CRC) will be applied to the end of the spare tire carrier cable. If significant corrosion is found on the spare tire carrier cable, Toyota will first repair the spare tire carrier cable prior to applying the CRC. Both CRC application, and if necessary, cable repair will be performed at **no cost** to the vehicle owner. For additional information on inspection, repair, and CRC application please refer to TIS.

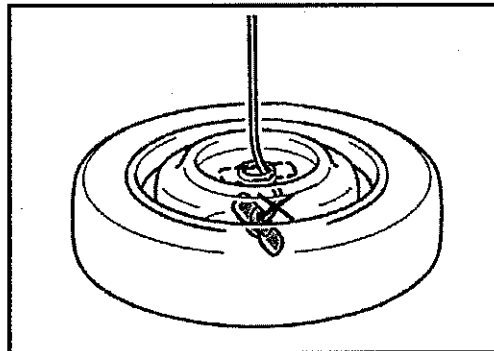
On certain 1998 through 2010 model year Sienna 2WD vehicles equipped with a spare tire, originally sold in or currently operated in severe cold climate areas with high road salt use (Severe Cold Climate States), excessive corrosion may be exhibited on the end of the spare tire carrier cable. In the worst case, the spare tire stowed under the vehicle may become separated from the spare tire carrier.
