INSTRUCTIONS TO PERFORM CAMPAIGN 116

- Certain 2010 model year Winnebago View®/View Profile® and Itasca Navion®/NavioniQ® motor homes.

These motor homes were manufactured from April 27, 2009 through January 21, 2010.

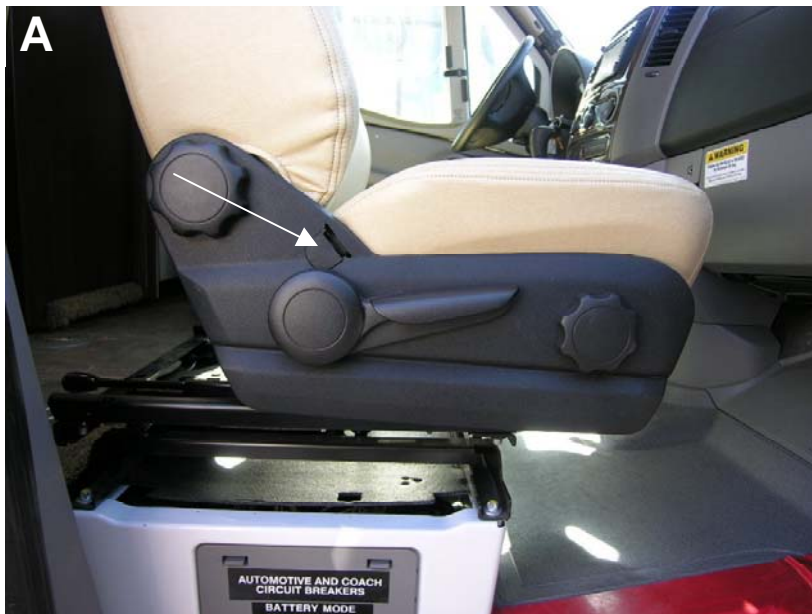
1. Remove bolt cover from outboard side of cab seat. See Photo A.
NOTE: In some models, the seat belt may be attached to the seat.

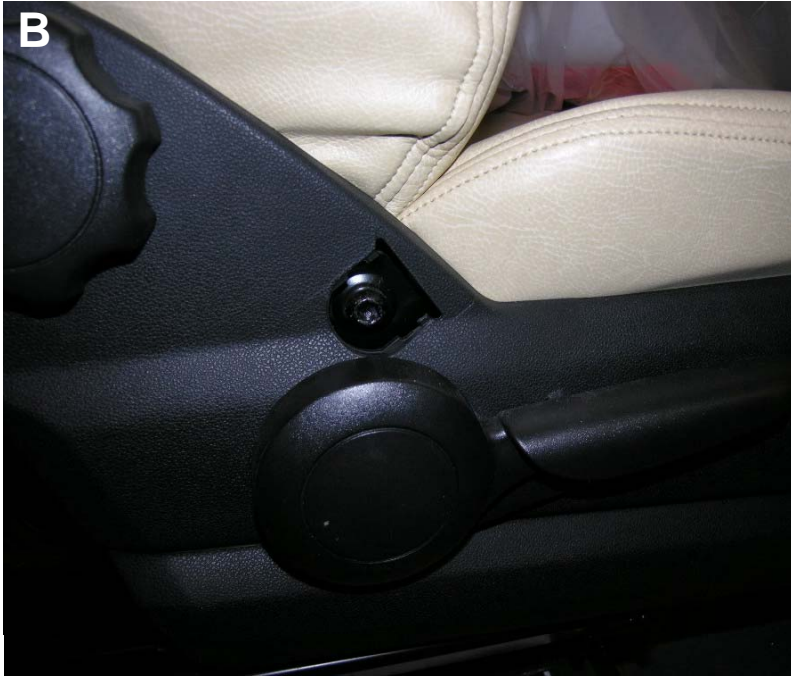
2. Assure seat bolt is present. See Photo B. If seat bolt is present, torque to 37+/-3 ft./lbs. and proceed to Step 4. If seat bolt is not present, continue with Step 3.

3. Install seat bolt and torque to 37+ / -3 ft./lbs.
4. Reinstall bolt cover.
5. Repeat Steps 1 through 4 on second cab seat.
