# Technical Bulletin

Section Title: Engine  
 TSB No. TS 28 07140R

**SUBJECT:** SAFETY RECALL CAMPAIGN: SB, POWER STEERING TENSIONER PULLEY DAMAGE.  
**MODEL(S):** XL-7 (JA627), GRAND VITARA (JB627)  
**YEAR:** XL-7 2005~2006, GRAND VITARA 2006  
**VIN RANGE:**

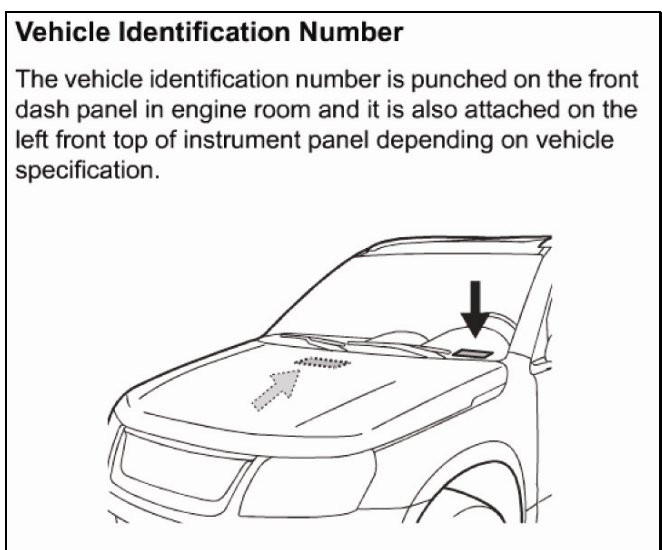
Grand Vitara (JB627)

- 1. Check the vehicle identification number to verify if the vehicle is eligible.

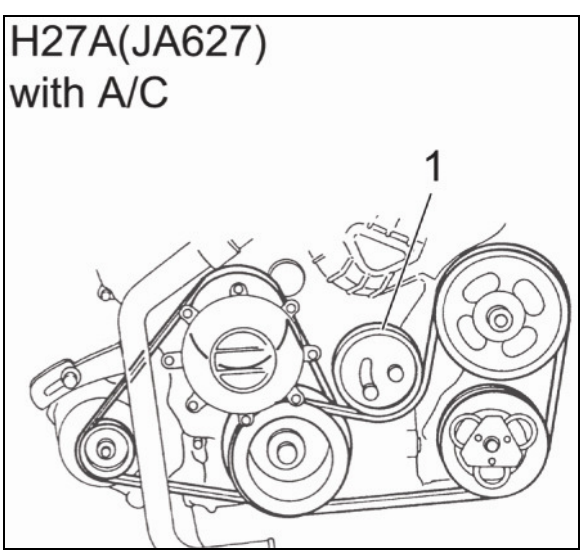
XL-7

- 2. Visually check the tensioner pulley (1) outer race to determine if it is plastic or steel.

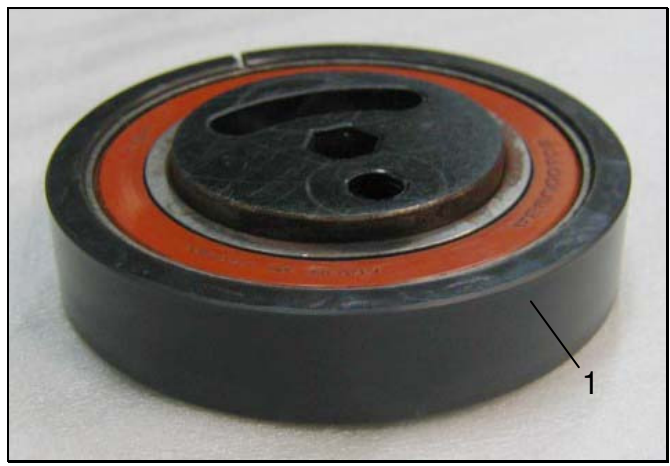
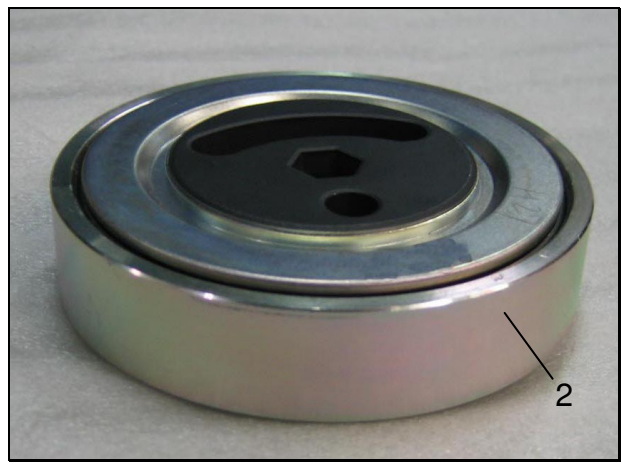
3. They can be easily distinguished by checking the color of the outer race.

Black: Plastic outer race (1)  
(Replace)

Silver: Steel outer race (2)  
(Do Not Replace)

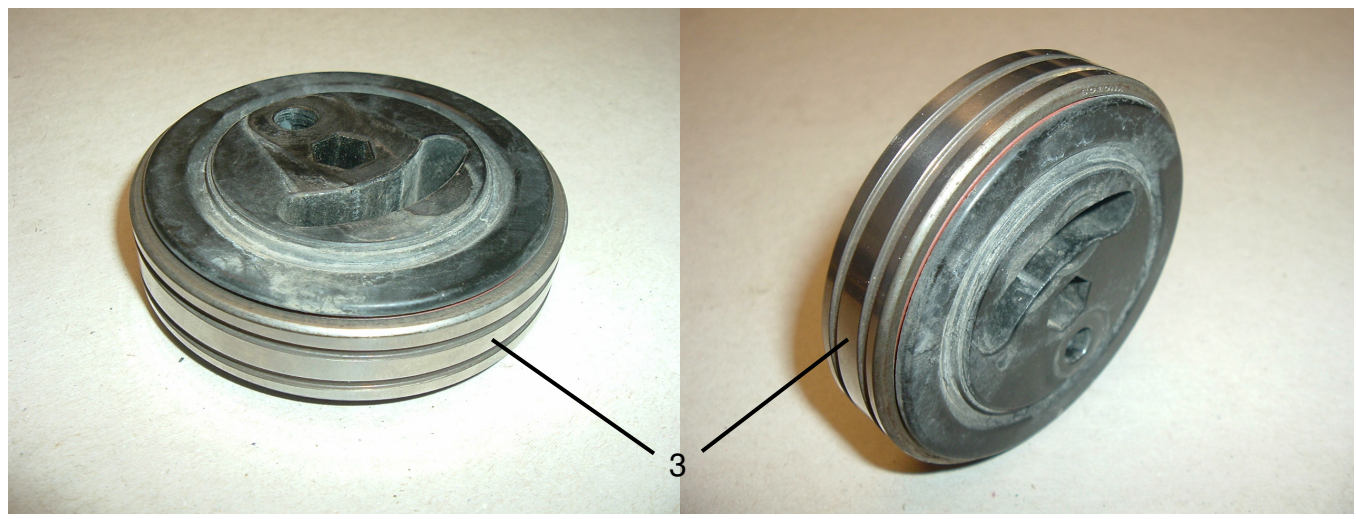
**CONDITION:** The plastic outer race of the power steering tensioner pulley could break, allowing the belt to slip or derail, causing abnormal noise, and in worst cases may result in increased effort to steer the vehicle.

**CAUSE:** Improper material used in the plastic outer race of the tensioner pulley used for adjusting tension of the belt that drives the power steering pump.

Failed: Black plastic outer race missing (3)  
(Replace, this Does Not Pass inspection as OK)

**CORRECTION:** Suzuki dealers are required to inspect and if replacement has not been previously performed with countermeasure part, replace the power steering tensioner pulley. This service will be performed at no cost to the customer for parts or labor.

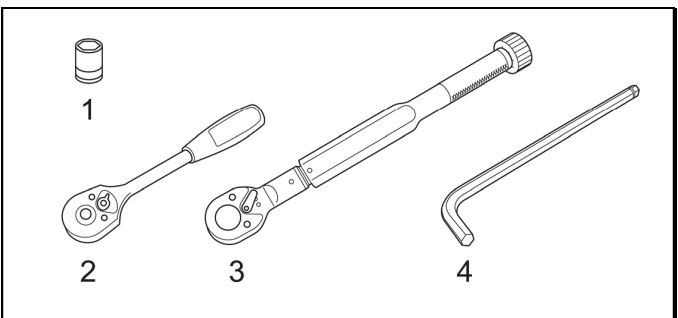
Ref #	Tool Name
1	12 mm Socket ( $\frac{3}{8}$ drive)
2	Ratchet ( $\frac{3}{8}$ drive)
3	Torque wrench ( $\frac{3}{8}$ drive) (7.5-18.5 lbf-ft, 10-25 N·m, 1.0-2.5kgf-m)
4	10mm Hex wrench (Allen)

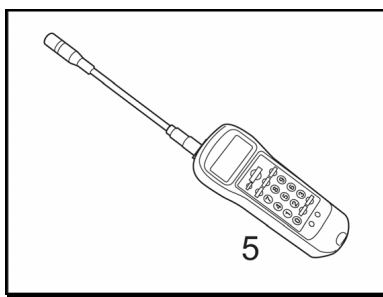
Used only for Grand Vitara (JB627)  
 (\*if available at dealership, can be ordered through SuzukiPitstopPlus.)

Ref #	Tool Name
*5	Sonic tension meter (made by Gates Corporation, Model: 507C w/0205 Mic)
6	10mm Hex socket ( $\frac{3}{8}$ drive)

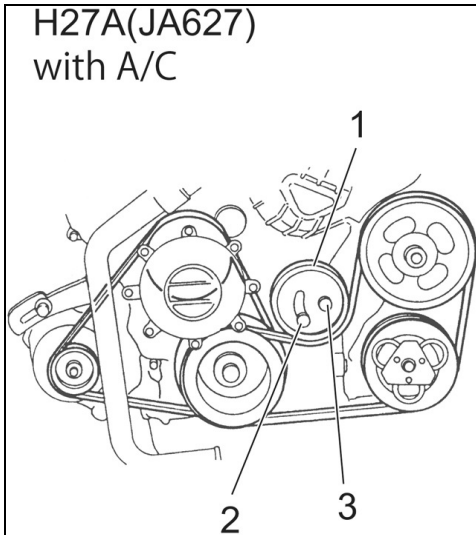
XL-7

- To remove the **Plastic** Tensioner Pulley (1) from the H27A engine, loosen the tensioner pulley adjusting bolt (2) to relieve the tension on the power steering/AC belt, removing it along with the tensioner pulley bolt (3), and then the tensioner pulley.

- Install the new Steel tensioner pulley, tensioner pulley bolt (3) and adjuster bolt, tightening by hand. Based on which vehicle is being repaired and the available tools, select the applicable method to adjust the belt tension from steps 6, 7, or 8, listed below.

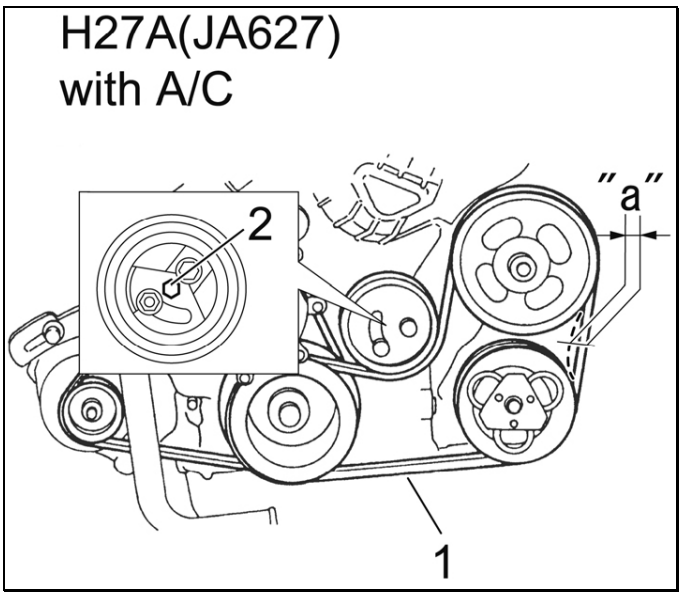
- Insert the 10mm Hex Wrench in the hexagonal hole (2) on the pulley and turn it counterclockwise, increasing the tension of the belt until the deflection reaches the specified value indicated in the table below, and then tighten the adjusting bolt and pulley bolt temporarily. Proceed to step 10.

Drive Belt	Model	Pulley & new Belt installed* Pulley only & Re-adjustment	Deflection spec
Pwr Strg/AC	XL-7 (JA627)	Using a new belt	8 - 10mm (0.31 - 0.39 in.)
		Re-adjustment	10 - 12mm (0.39-0.47in.)
Pwr Strg/AC	Grand Vitara (JB627)	Using a new belt	5 - 6mm (0.19-0.23 in.)
		Re-adjustment	5.5 - 6.5mm (0.21-0.25in.)

**Measuring condition: When pushing on the belt at the center point between pulleys with 100N of force, as shown in the illustration below.**

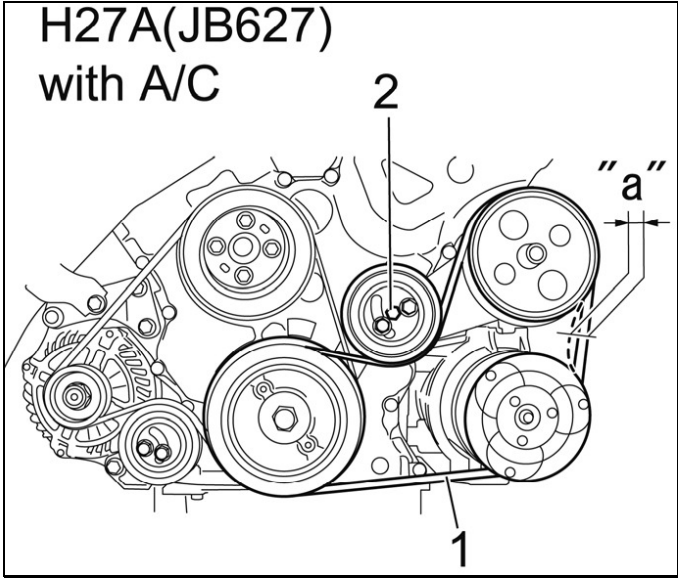
7. Set the Sonic Tension Meter to reflect the “Frequency Filter Setting” values from the table below. Insert the 10mm Hex tool in the hexagonal hole (2) on the pulley and turn it counterclockwise to increase, clockwise to decrease the tension on the belt to achieve the specified value indicated in the table below, and then tighten the adjusting bolt and pulley bolt temporarily. Proceed to step 10.

<b>Frequency Filter Setting</b>		
<b>Mass</b>	<b>Width</b>	<b>Span</b>
61.2	1.0	144.4

<b>Pulley &amp; new Belt installed*</b>	<b>Tool indication specification</b>
Using a new belt	$500 \pm 50$ N
Re-adjustment	$400 \pm 50$ N

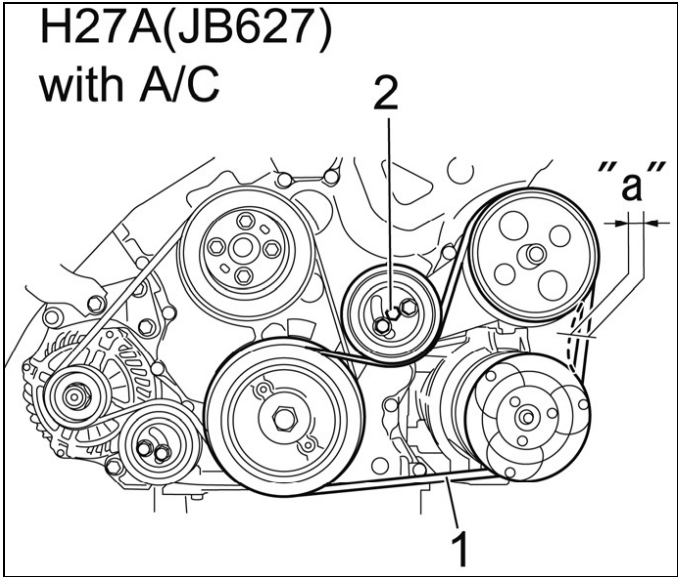
8. Using the 10mm Hex socket and torque wrench from the “tool list”, insert the 10mm Hex tool in the hexagonal hole on the pulley and turn it counterclockwise, increasing the tension until the prescribed amount of torque is being applied to the tensioner pulley as indicated in the table below, and then tighten the adjusting bolt and pulley bolt temporarily. Proceed to step 10.

<b>Pulley &amp; new Belt installed* Pulley only &amp; Re-adjustment</b>	<b>Torque specification</b>		
	Lb-ft	Kgf-m	N·m
Using a new belt	12.5 lb-ft	1.7 kgf-m	17 N·m
Re-adjustment	9.0 lb-ft	1.2 kgf-m	12 N·m
