SERVICE REPAIR
PROCEDURE

Freedman Seating Floor Anchorage Washer Replacement		RECALL # 10V- 277	
BY: Jose Vazquez	DEPARTMENT: Warranty	DATE: 07/26/2010	REVISION: 1

2007 STHF5, STH5 and Universe US Bus Corporation School Bus

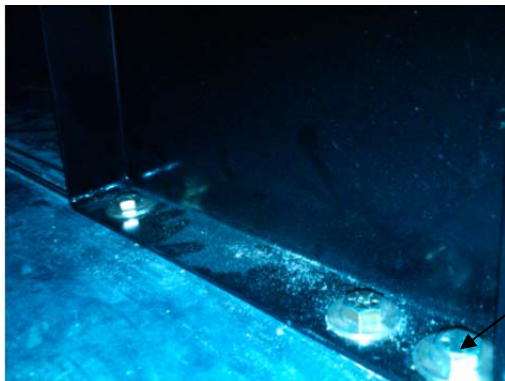
Figure 1
(3 bolts on the floor pedestal)

1) Locate the three 5/8" bolts underneath seat securing the seat pedestal to the floor track mounts and the two 5/8" bolts on the side wall track mount. *See Figure 1 and 2 below.*

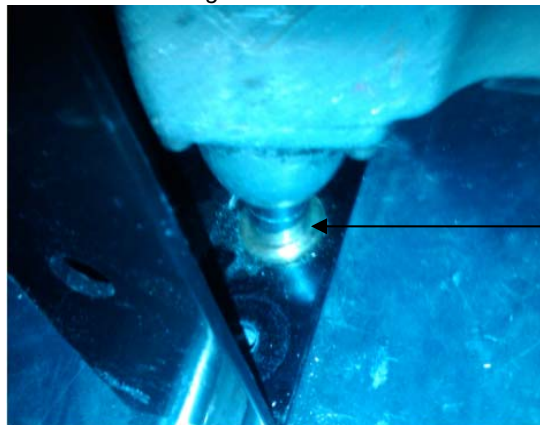
Figure 3

2) Loosen the 5/8" Steel Bolt as shown below and remove the incorrect 3/8" Type A Steel Washer part number 500135. *See Figure 3.*

Loosen the 5/8"
Steel Yellow Zinc
Bolt, using an
electric/ air impact
