Re: Recall No. 10V-303 Supplemental Information

MODEL: 2010 Z1000 (ZR1000DAF/L)
TITLE: Z1000 LEFT FRONT BRAKE HOSE INSPECTION

RECALL

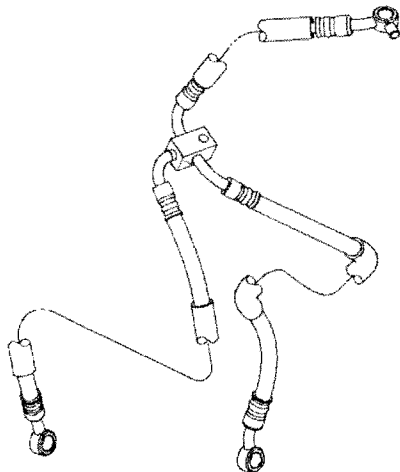
On eligible units, under severe riding conditions the left front brake hose may contact the front brake rotor during extremely heavy application of the front brake. This can cause brake fluid to leak creating the potential for a crash resulting in injury or death.

Kawasaki has initiated a Recall campaign to repair all eligible units. The repair consists of inspecting the front brake hose and replacing it if required. Additionally, the front brake hose will be positioned to prevent contact with the brake rotor.

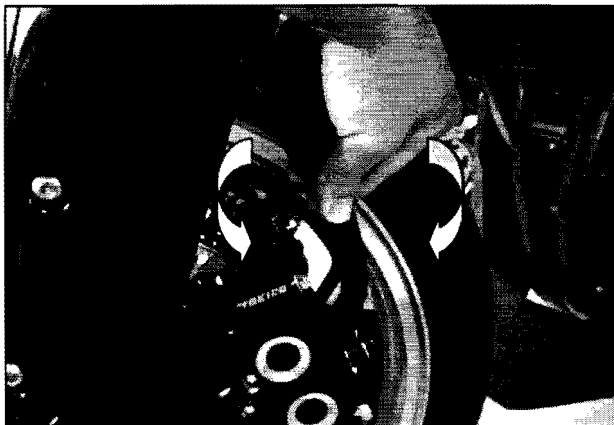
- Inspect the entire circumference of the left front brake hose between the caliper and the fender for damage caused by the brake rotor.

- ★ If the left front brake hose is damaged, replace it as outlined in the "Periodic Maintenance" chapter of service manual 99924-1436-01.

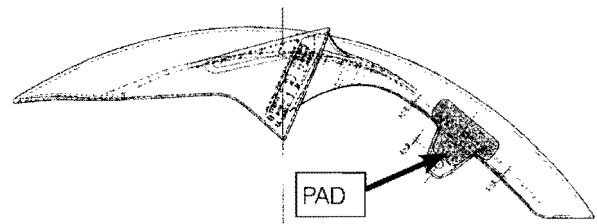
- Apply clear wear pads to right and left sides of front fender as shown in the illustration.

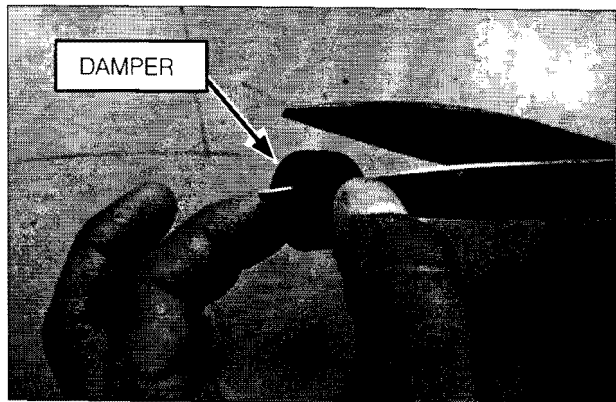
- Cut the damper found in the repair kit as shown in the photo.

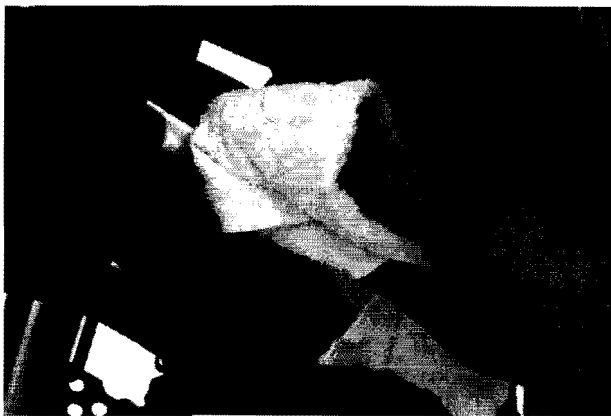
- Clean the brake hose from where it exits the top of the hose clamp to 50mm above the clamp.

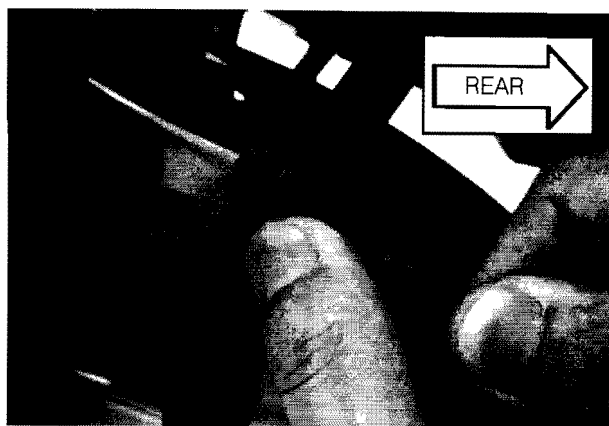
- Secure the damper further with the band supplied in the repair kit making sure the head of the zip tie is facing to the rear of the vehicle.

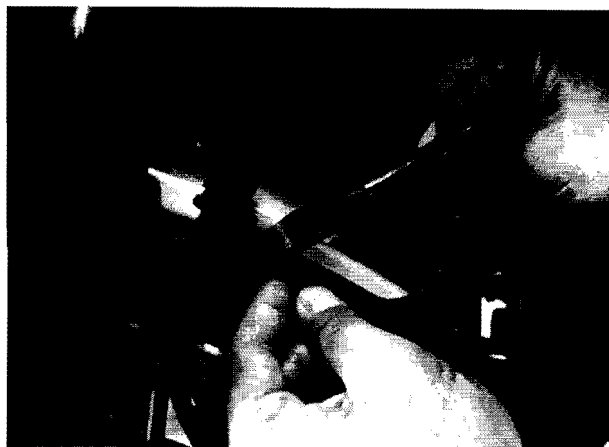
- Clip the unused portion of the band flush with the head of the band.
