RECALL CAMPAIGN BULLETIN

NTB10-088

VOLUNTARY SAFETY RECALL CAMPAIGN 2009 – 2010 cube® FUEL FILLER RECIRCULATION TUBE

APPLIED VEHICLES: 2009 – 2010 cube® (Z12)

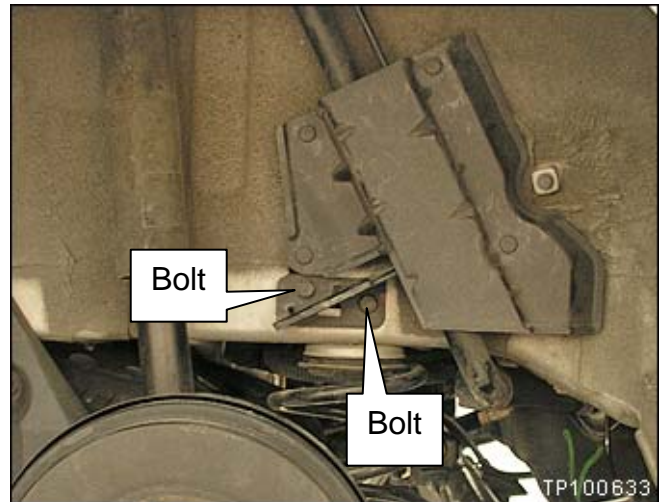
Figure 1

3. Remove 2 bolts from the fuel filler tube bracket.

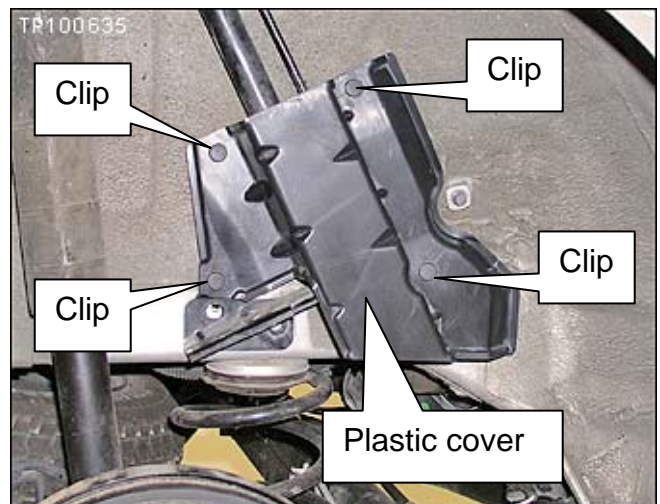
Figure 2

4. Remove the plastic cover (4 clips).

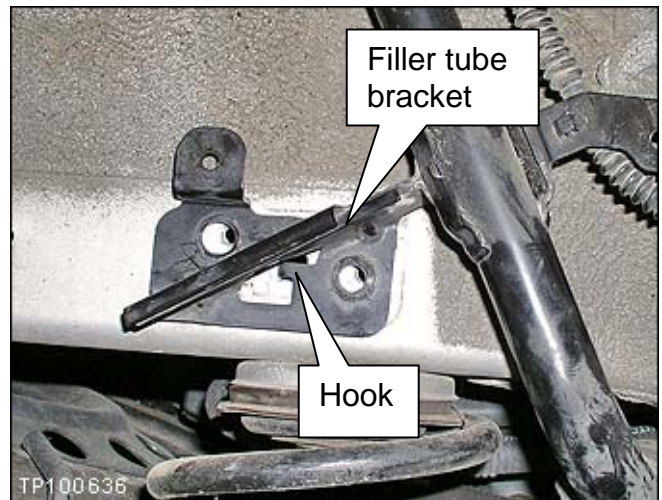
Figure 3

5. Unhook the fuel filler tube bracket from the body.

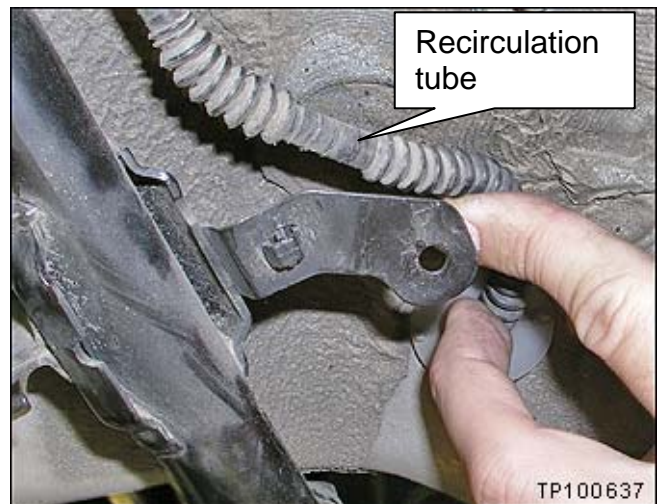
Figure 4

6. Unclip the recirculation tube.

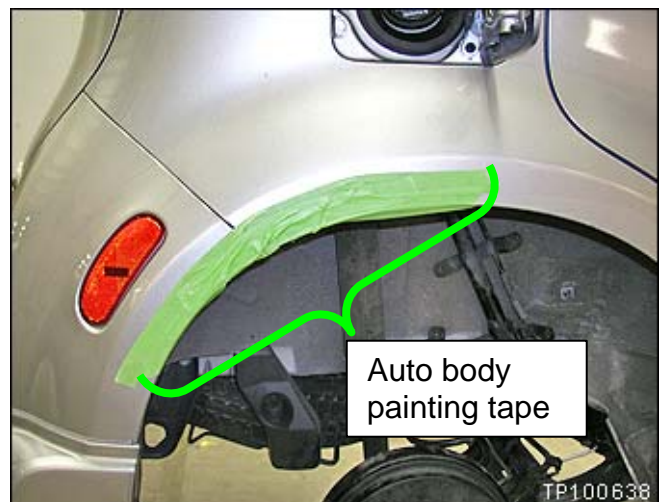
Figure 5

7. Apply auto body painting tape to the top and rear of the wheel opening as shown.

NOTE: This tape will protect the paint during the procedure.

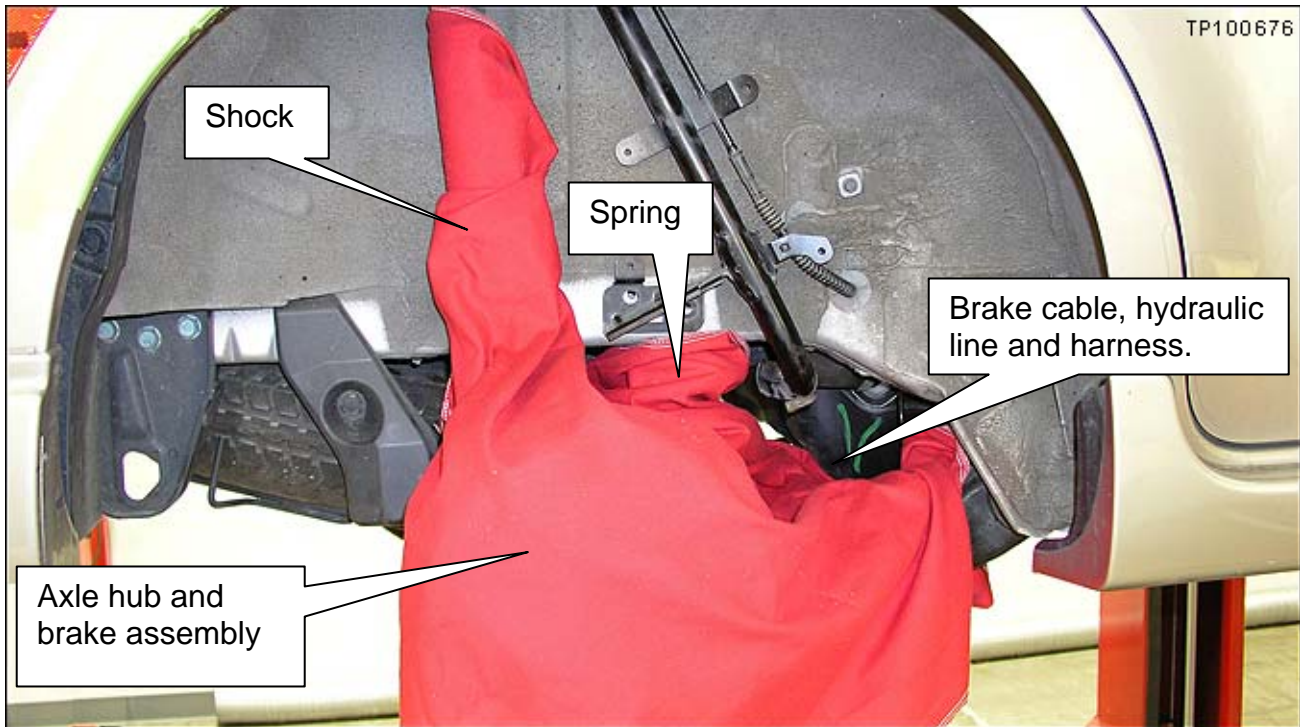
Figure 6

8. Use a protective cloth to cover the items shown in Figure 6.

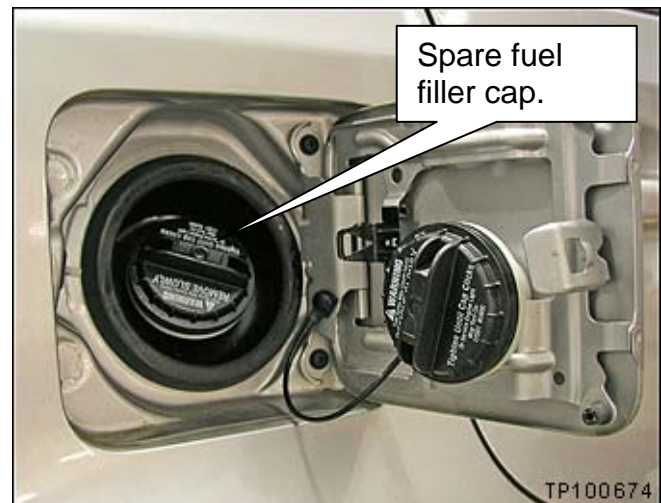
Figure 7

9. Remove the fuel filler cap and install a spare fuel fill cap.

NOTE: If a spare fuel filler cap is not available, disconnect the tether and leave the original cap in place.

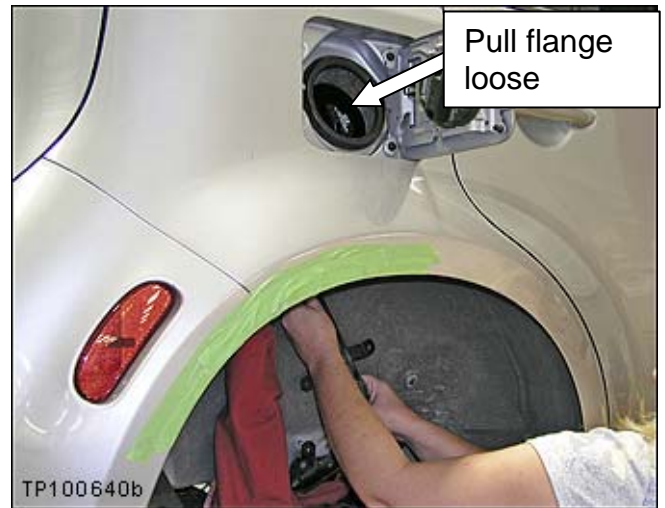
Figure 8

10. Hold the fuel filler tube with both hands and carefully pull the flange loose from the fuel door opening.

WARNING: Make sure the fuel filler cap is installed and tight. If the fuel filler cap is not installed and tight, fuel may leak from the fuel filler tube when it is lowered.

11. Carefully pull down on the fuel filler tube and then pull the top of the tube from the wheel well (see Figure 8).

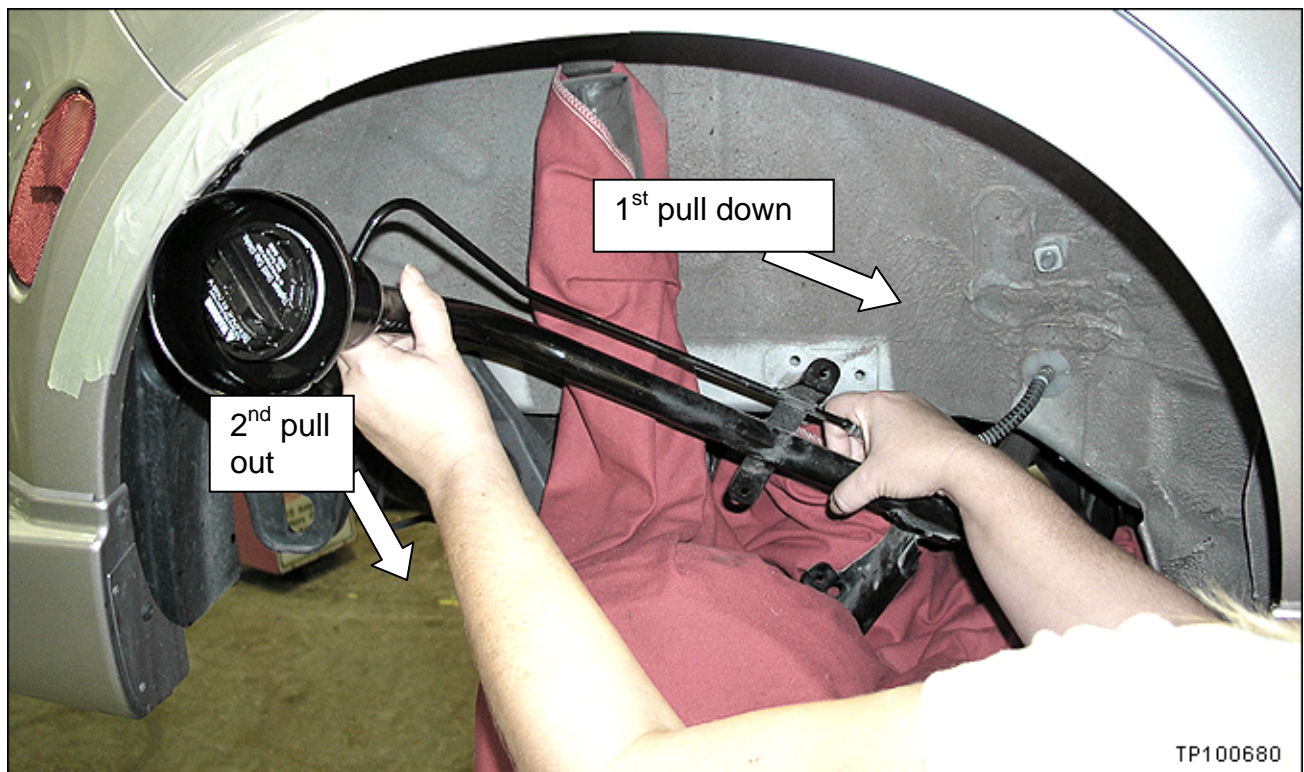
Figure 9

- Do not scratch or chip the fuel filler tube paint.
- Do not pull, stretch, or stress the fuel filler rubber tube.

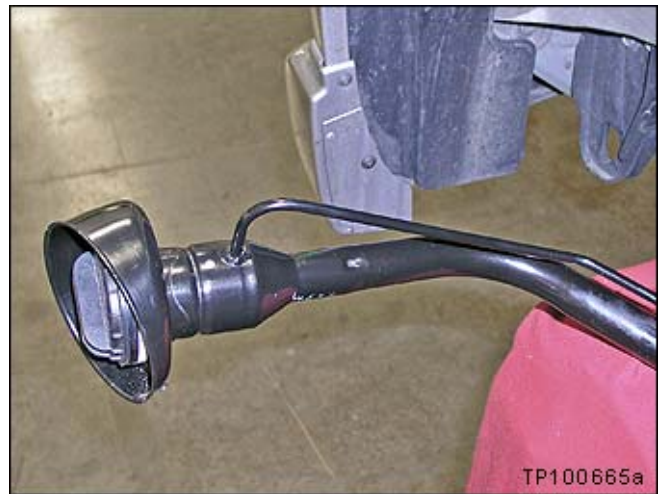
Figure 10

12. Rest the fuel filler tube on the brake drum.

WARNING: Do not remove the fuel filler cap with the fuel filler tube in this position. Fuel may leak from the fuel filler tube.

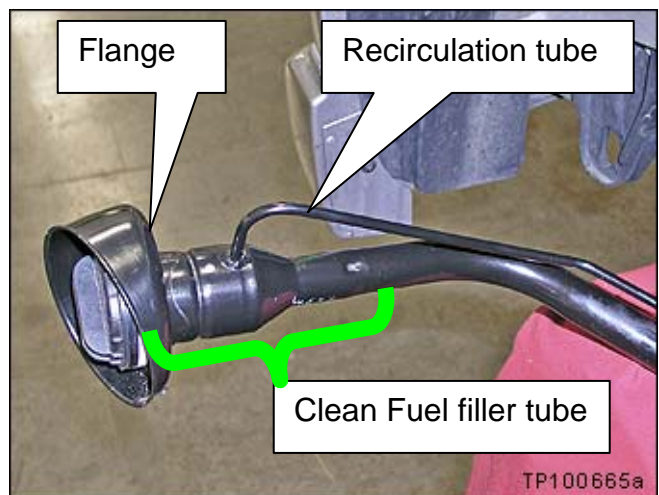
Figure 11

13. Thoroughly clean the following with isopropyl alcohol:

- Flange
- Fuel filler tube, 6 inches from the flange
- Recirculation tube, 6 inches from the flange

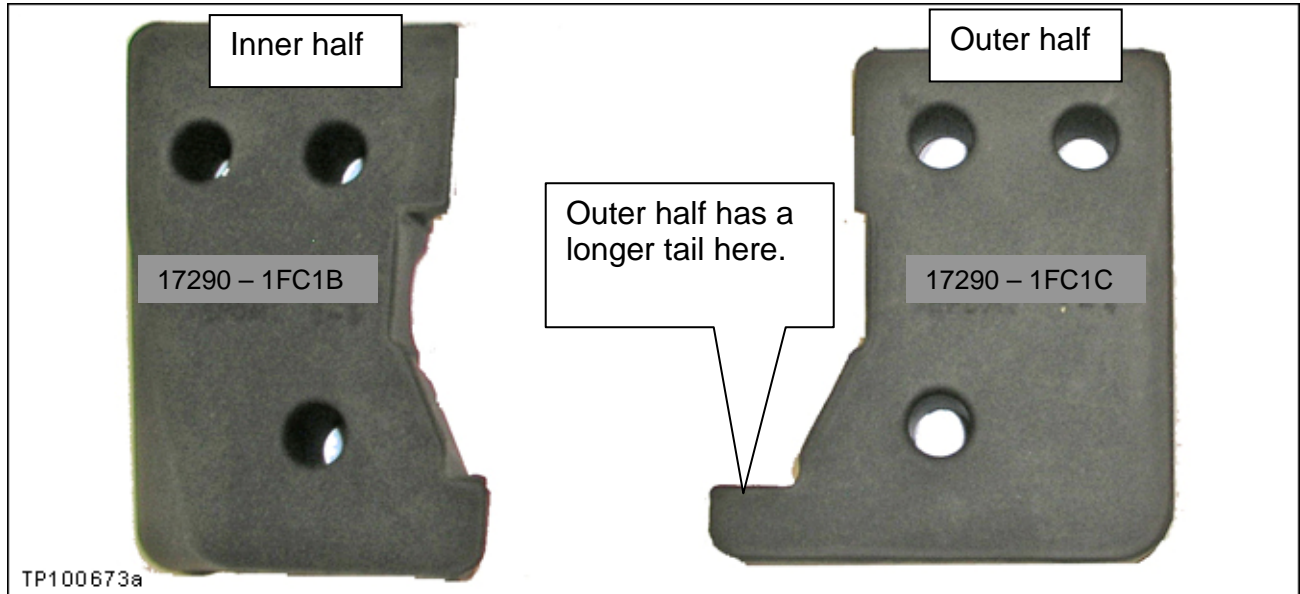
Figure 12

Fuel Filler Tube Protector

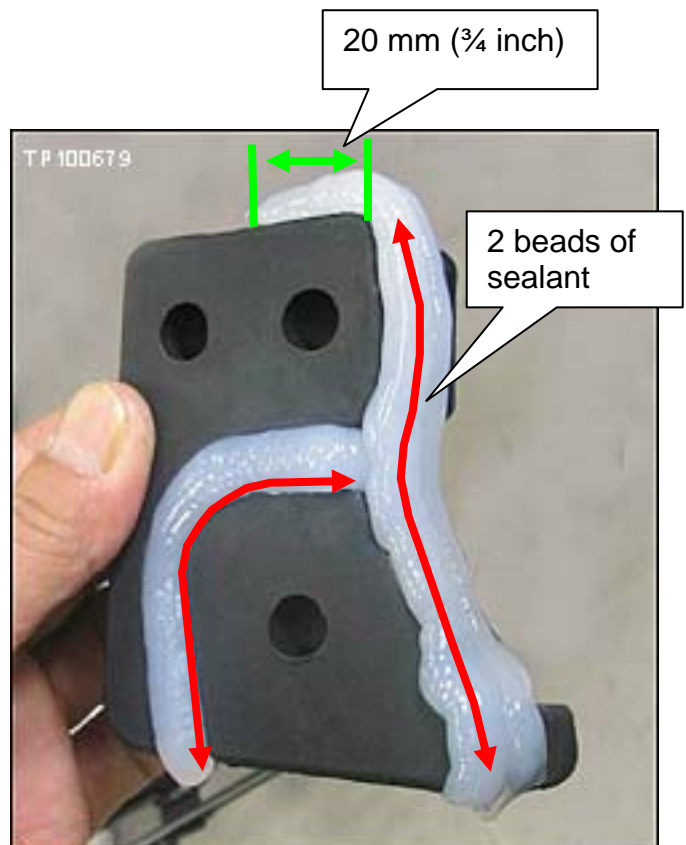
Figure 13

14. Apply adhesive sealant to **both halves** of the Fuel Filler Tube Protector as shown in Figure 13.

IMPORTANT: Use only adhesive sealant P/N 17290 - 1FC2A.

- Use adhesive sealant generously.
- Outer half is shown; inner half is a mirror image.

Two beads of sealant

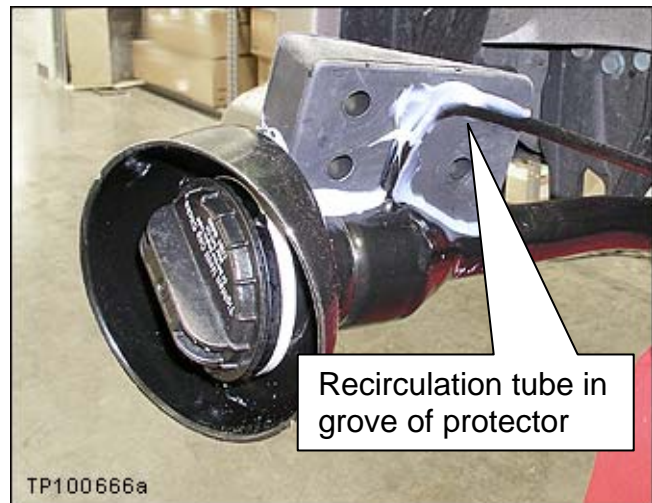
Figure 14

15. Place the inner half of the protector on the fuel filler tube as shown.

16. Make sure the recirculation tube is in the groove of the inner half of the protector.

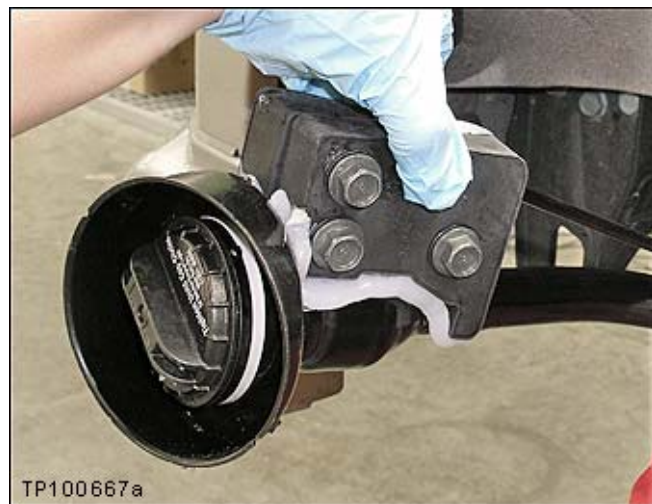
Figure 15

17. Hold the inner half in place while installing the outer half.

18. Install washers and bolts.

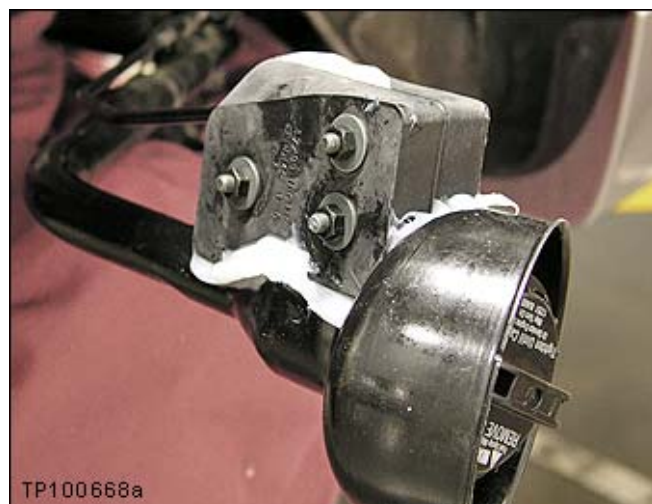
Figure 16

19. Install washers and nuts.

20. Torque the nuts / bolts to:
5.5 N•m (0.56 kg-m, **49 in-lb**)

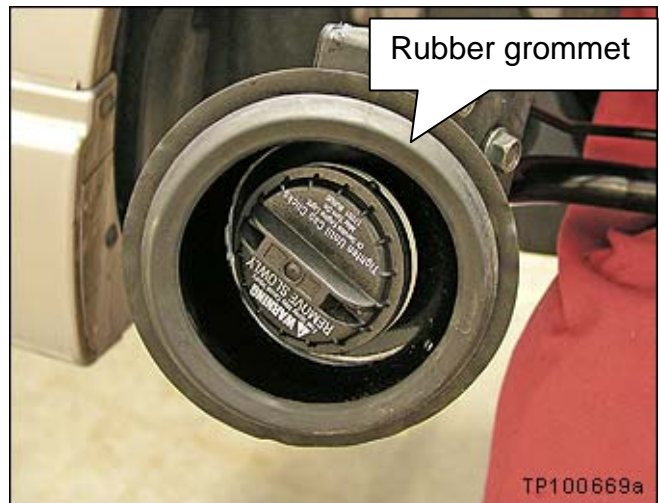
Figure 17

21. Install the rubber grommet on the fuel filler tube flange.

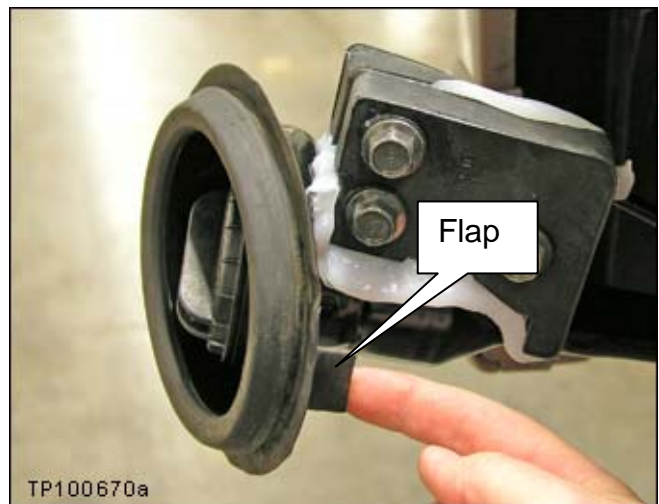
Figure 18

22. Make sure the flap is positioned at the bottom of the flange.

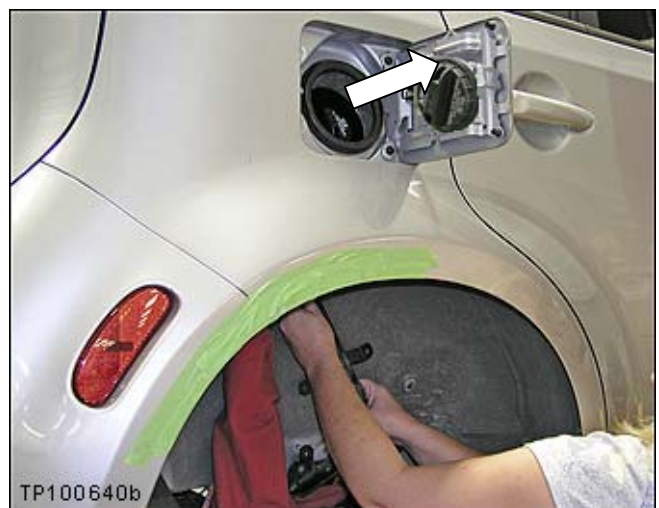
Figure 19

23. Reinstall the flange (with grommet) into the fuel door opening.

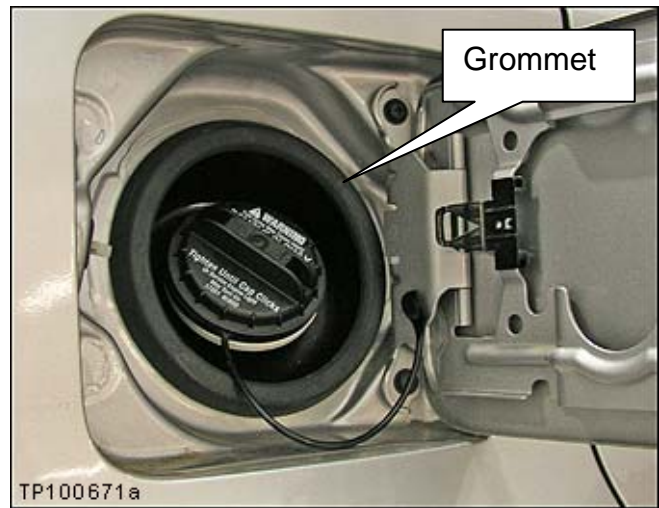
Figure 20

24. Make sure the grommet is properly in place.

25. Reinstall the original fuel filler cap.

NOTE: If tether was removed, make sure it is reattached.

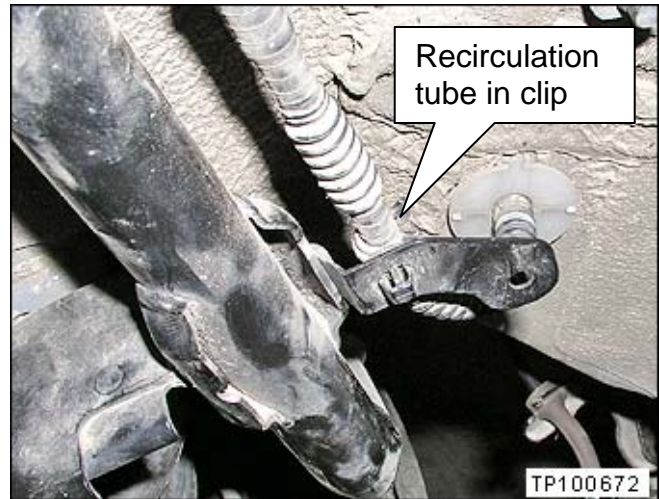
Figure 21

26. Make sure the recirculation tube is snapped into the clip.

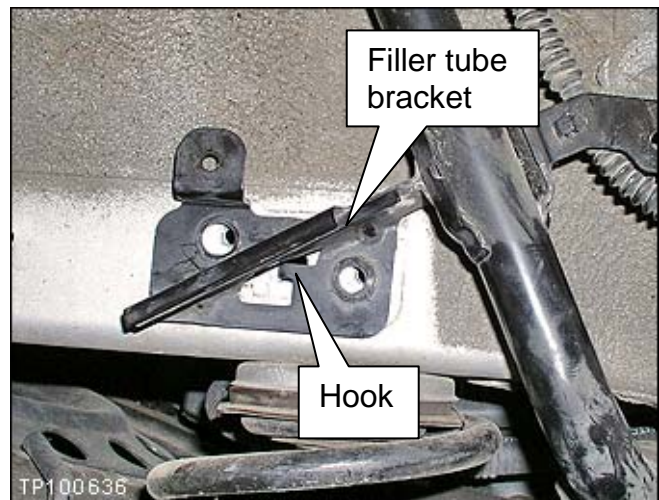
Figure 22

27. Make sure the fuel filler tube bracket is hooked into the body.

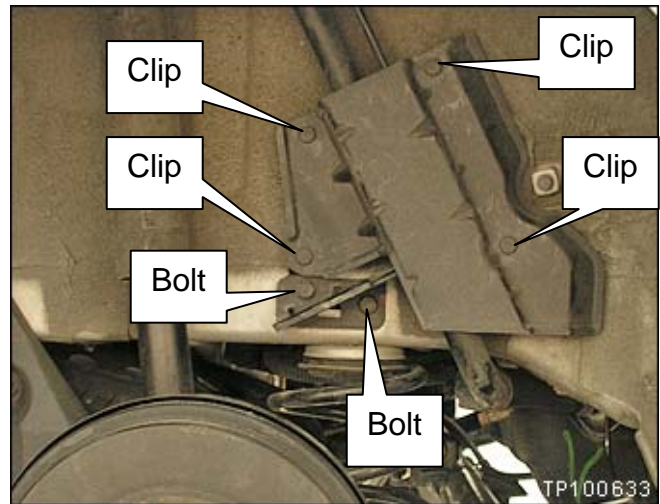
Figure 23

28. Reinstall the 2 bracket bolts.

Bolt torque: 25 N•m (2.6 kg-m, **18 ft-lb**)

29. Reinstall the plastic cover (4 clips).

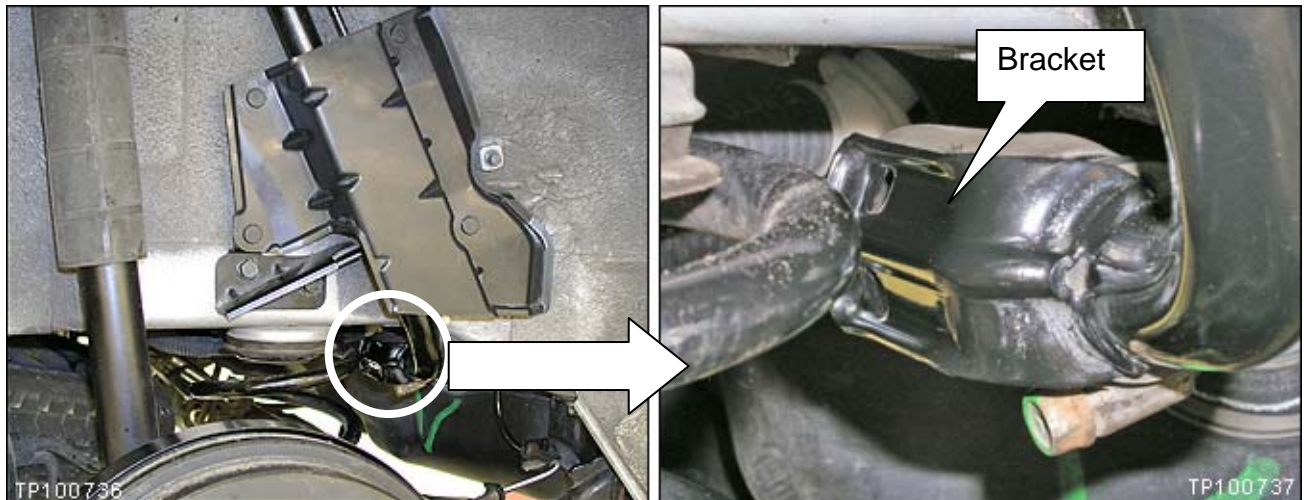
Figure 24

30. Locate the bracket at the lower end of the fuel filler tube (see Figure 24).

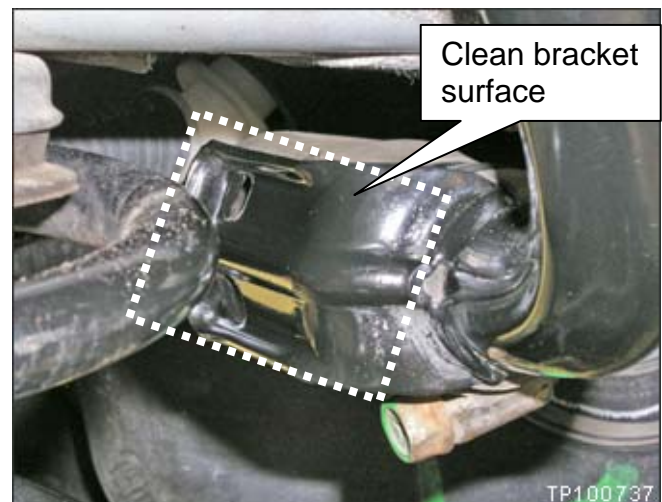
Figure 25

31. Thoroughly clean the entire bracket surface with isopropyl alcohol.

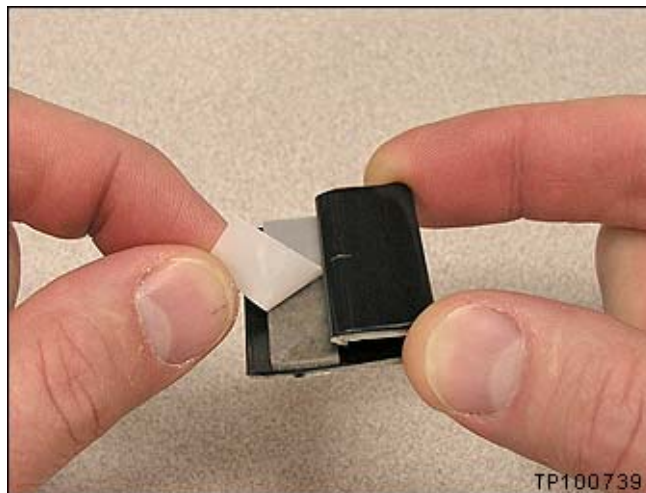
Figure 26

32. Remove the adhesive backing from the bracket protector.

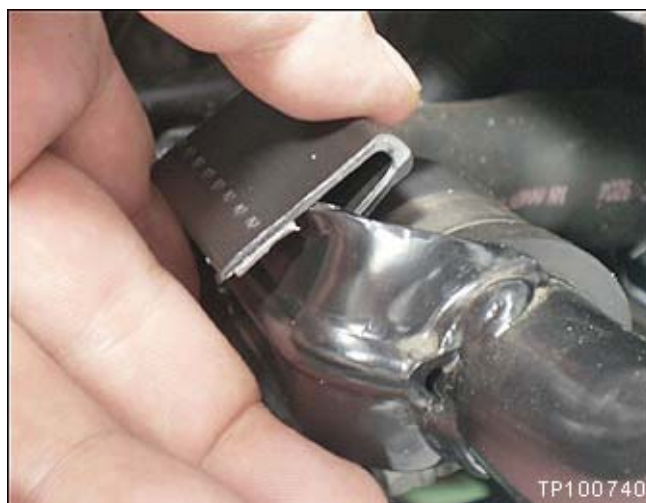
Figure 27

33. Slide the protector over the top of the bracket as shown.

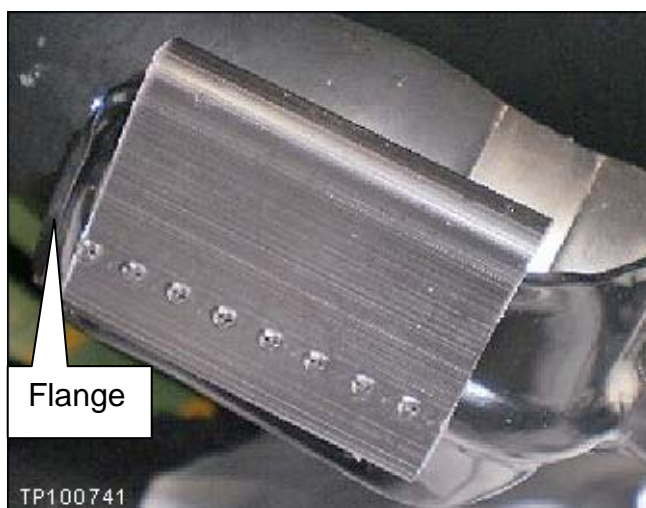
Figure 28

NOTE: Do not let the protector touch the flange at the end of the bracket.

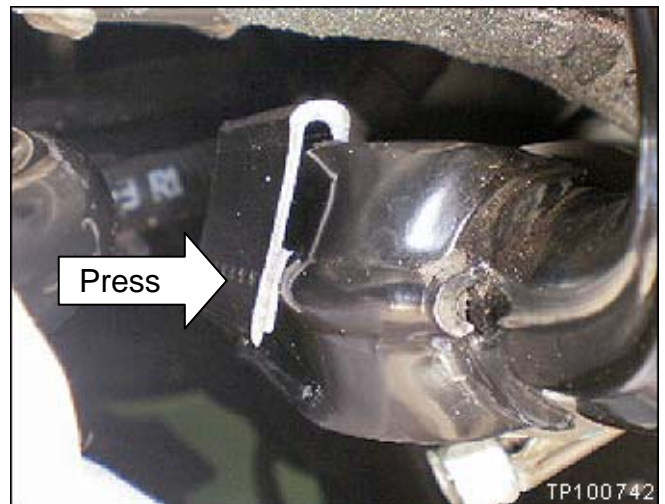
Figure 29

34. Press the protector against the bracket to ensure good adhesion of the adhesive tape.

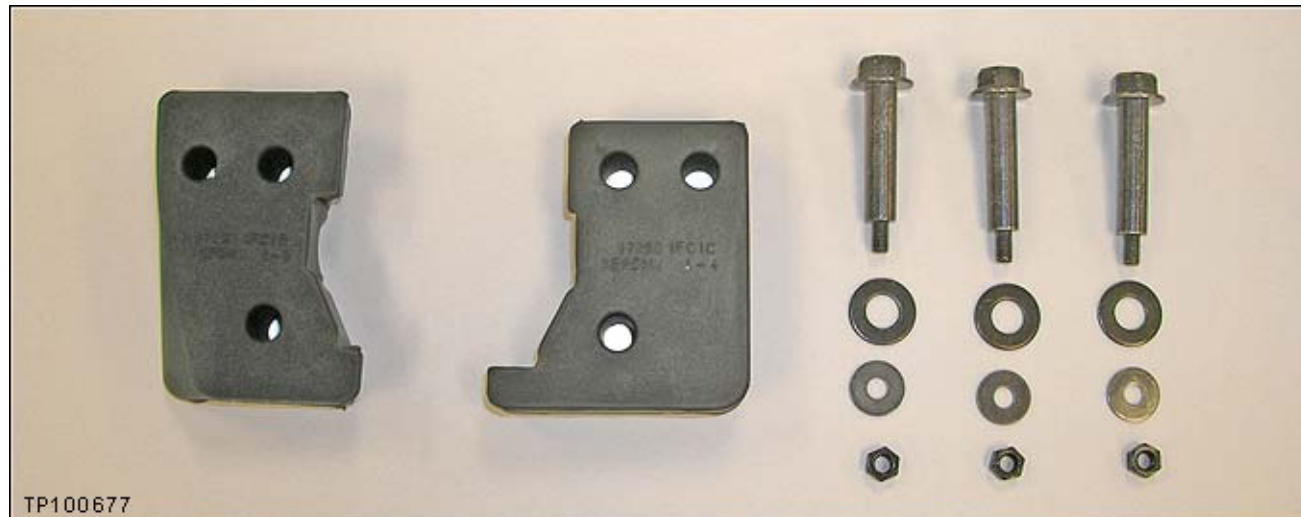
DESCRIPTION	PART NUMBER	QTY
Fuel Filler Recirculation Tube Protector Kit	17290 – 1FC1A	1
Silicone Adhesive Sealant (1)	17290 – 1FC2A	1 tube will service 2 vehicles
Bracket Protector	17290 – 1FC3A	1
