**INSTRUCTION TO SERVICE ITS: 4367**

SECTION: 526  Seating & Stanchions	MODEL: <input type="checkbox"/> 30FT <input type="checkbox"/> 35FT <input checked="" type="checkbox"/> 40FT <input checked="" type="checkbox"/> 60FT  <input checked="" type="checkbox"/> DSL <input type="checkbox"/> CNG <input type="checkbox"/> LNG <input checked="" type="checkbox"/> ELEC	TYPE: <input type="checkbox"/> HIGH FLOOR  <input checked="" type="checkbox"/> LOW FLOOR	WRITTEN BY: Jeff Kosheluk
---	---	---	------------------------------

R & R current grab straps with new upgraded grab straps (NF PN: 057991) with metal clasp.

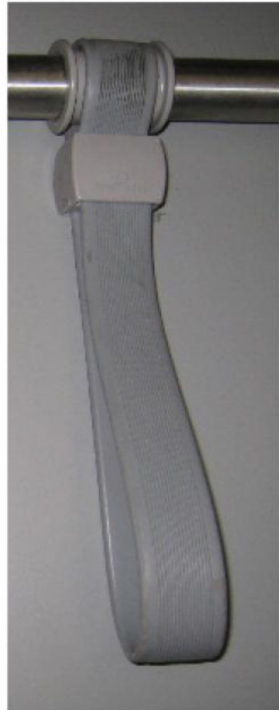
Grabstrap comparison

Existing Grabstrap with plastic clip

New Proposed Grabstrap with metal clip

**FIGURE 2: COMPARISON SHOWING THE EXISTING GRAB STRAP AND THE NEW GRAB STRAP WITH METAL CLIP (NF PN: 057991).**

4. Install the new grab strap (**NF PN: 057991**) on the existing collar. Before installing the 5/8" L Phillips screw inside of the metal clasp, apply 1 to 2 drops of Loctite – 638 (**NF PN: 392127**) approximately 1/8" from end of screw. Install screw into metal clasp and grab strap to secure in place over collar. Tighten screw in place and **torque screw to 24 IN/LBS. Refer to Figure 2.**

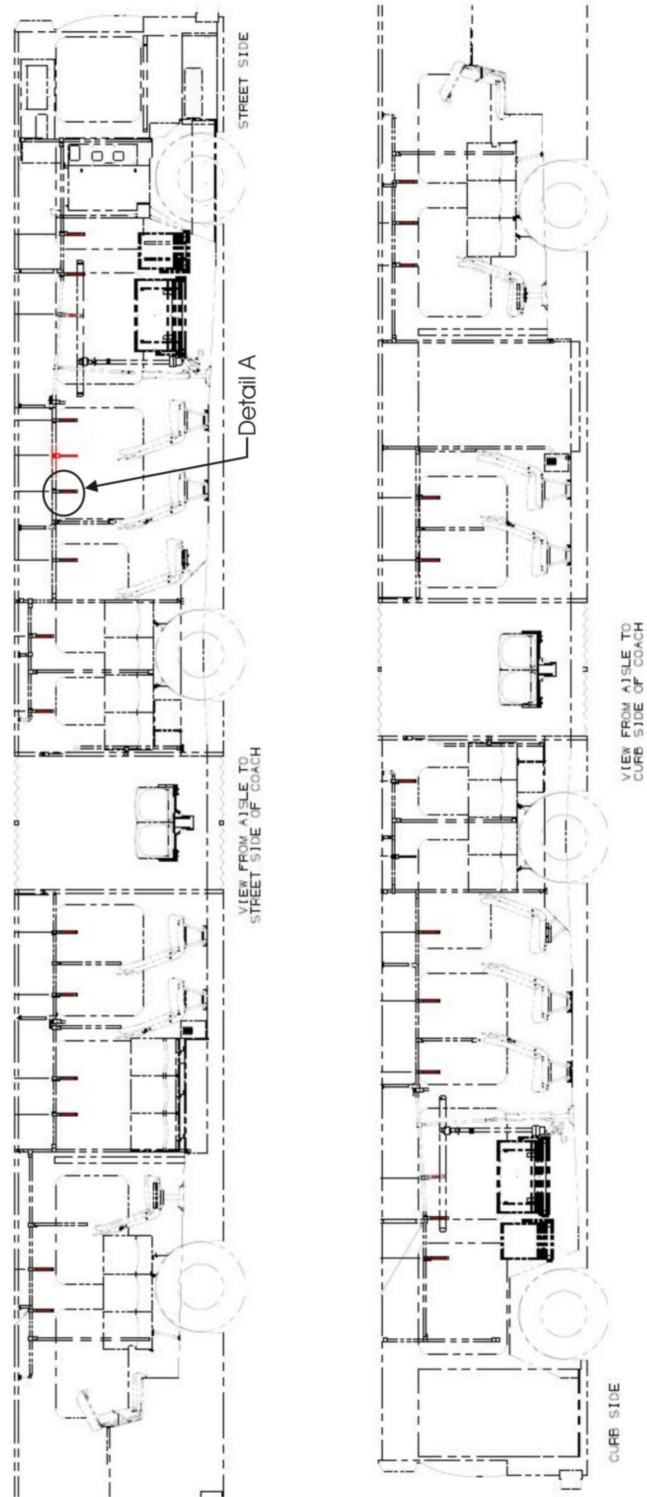
**FIGURE 1:** LOCATION OF GRAB STRAPS.

1. Turn the main battery disconnect switch to the "OFF" position.
2. Locate all grab straps on the front section of the coach. Start with the first grab strap. For steps 2 & 3, **Refer to Figure 1.**
3. Cut off grab strap leaving the existing collar around the overhead stanchion. **Note: Cut off the grab strap above the clasp only cutting on the one side so that the strap comes off as one piece.**

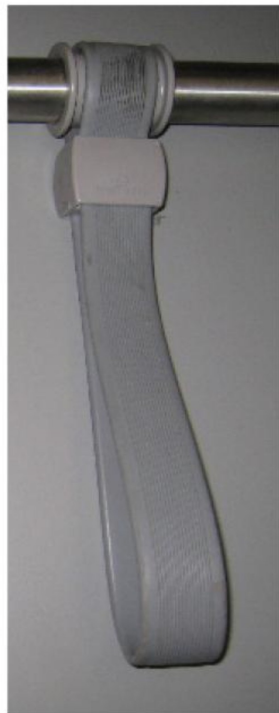
Grabstrap comparison

Existing Grabstrap with plastic clip

New Proposed Grabstrap with metal clip

**FIGURE 2: COMPARISON SHOWING THE EXISTING GRAB STRAP AND THE NEW GRAB STRAP WITH METAL CLIP (NF PN: 057991).**

4. Install the new grab strap (**NF PN: 057991**) on the existing collar. Before installing the 5/8" L Phillips screw inside of the metal clasp, apply 1 to 2 drops of Loctite – 638 (**NF PN: 392127**) approximately 1/8" from end of screw. Install screw into metal clasp and grab strap to secure in place over collar. Tighten screw in place and **torque screw to 24 IN/LBS**. Refer to **Figure 2**.

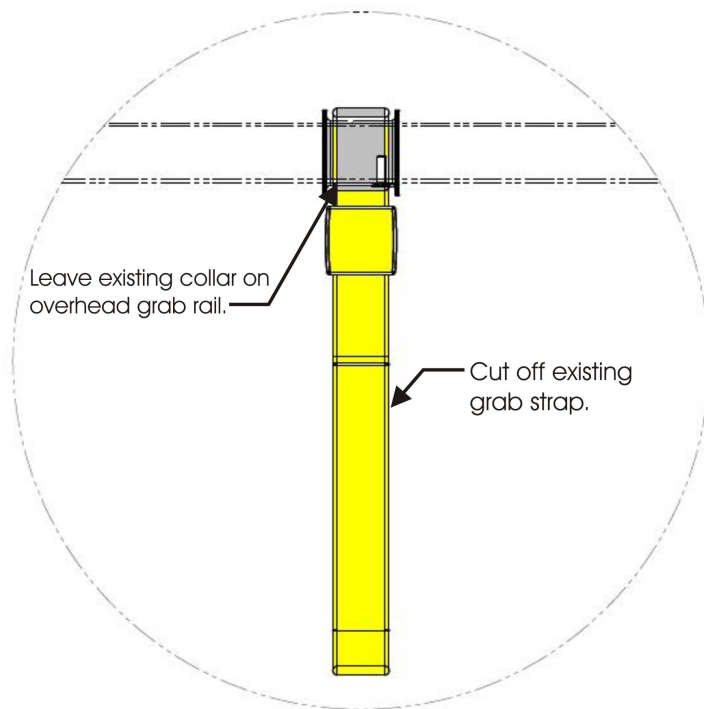
DETAIL A

**FIGURE 1A: CUT OFF THE EXISTING STRAP AS SHOWN BUT LEAVE ON THE COLLAR AT THE OVERHEAD STANCHION.**

1. Turn the main battery disconnect switch to the "OFF" position.
2. Locate all grab straps on the front section of the coach. Start with the first grab strap. For steps 2 & 3, **Refer to Figure 1.**
3. Cut off grab strap leaving the existing collar around the overhead stanchion. **Note: Cut off the grab strap above the clasp only cutting on the one side so that the strap comes off as one piece.**

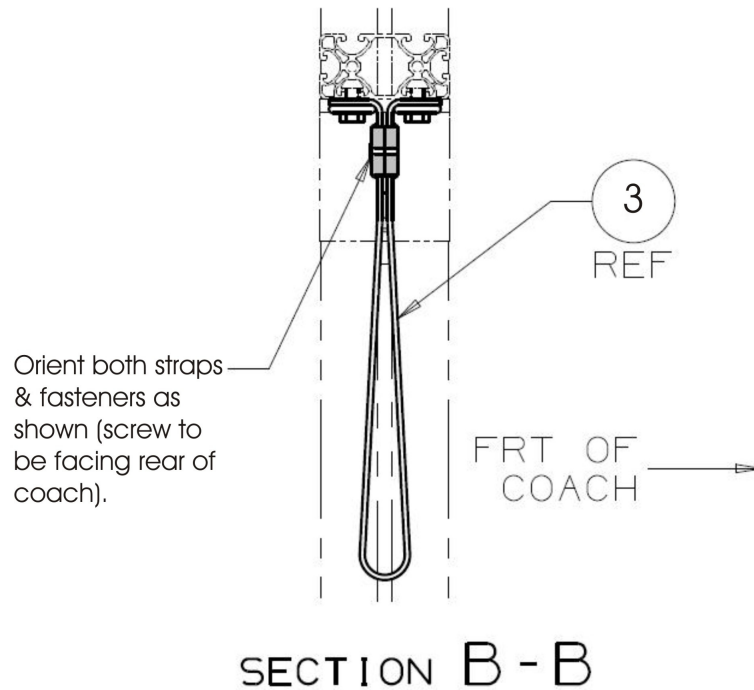
**FIGURE 2B:** INSTALL GRAB STRAP AS STATED WITH SCREW TO BE FACING REAR OF COACH.

5. Torque M8 bolts to 14.7 FT – LBS wet for both strap assists.
6. Before installing screw into grab strap, add 1 to 2 drops of Loctite-638 to the threads. Install screw and torque to 24 IN/LBS.

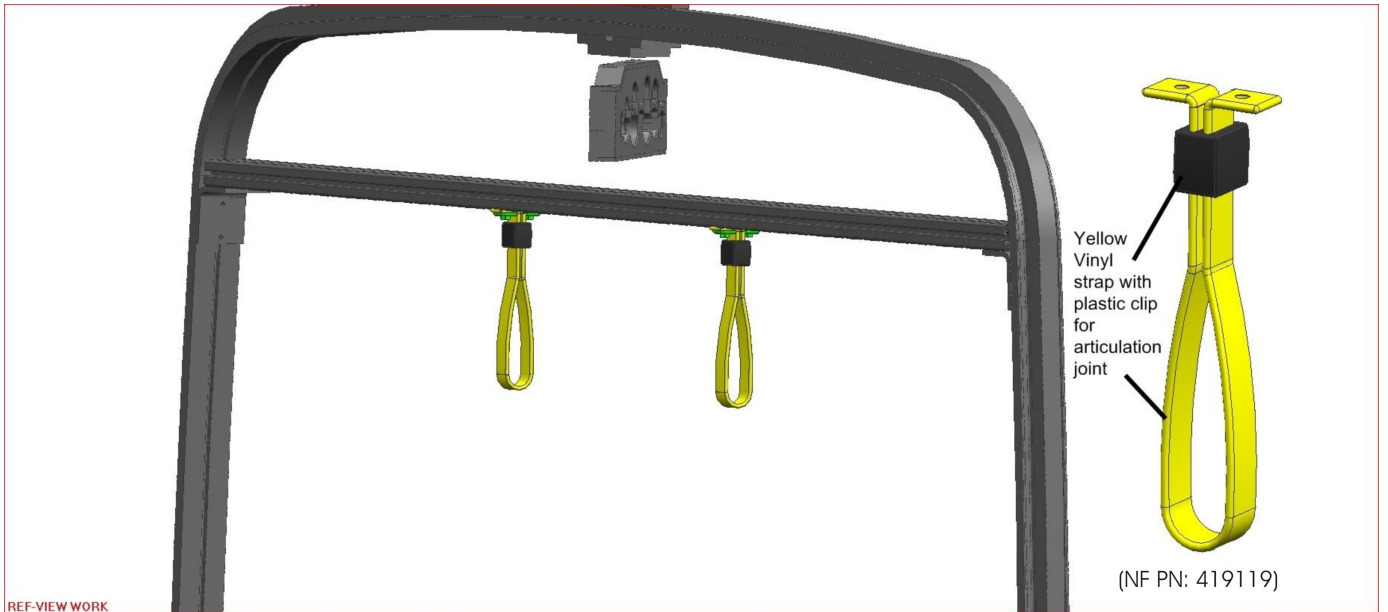
**FIGURE 3:** SHOWN VIEW OF THE NEW STRAP-ASSIST INSTALLED ON THE CENTER HOOP AT THE ATG JOINT.

4. Proceed to install the new strap assists. Install mating plate and strap assist (**NF PN: 419119**) using M8 bolt & supplied groove nut in ATG center hoop. Apply 1 to 2 drops of Loctite-638 (**NF PN: 392127**) to threads of M8 bolt before installation.
