# Starter Cable and Wiring Harness May Contact Engine Fan Hub

# RECALL

**Models Affected:** 2007 – 2011 All American (A3FE) and Commercial Series (C3FE), and 2010-2011 All American (D3FE) equipped with Cummins ISB Engines

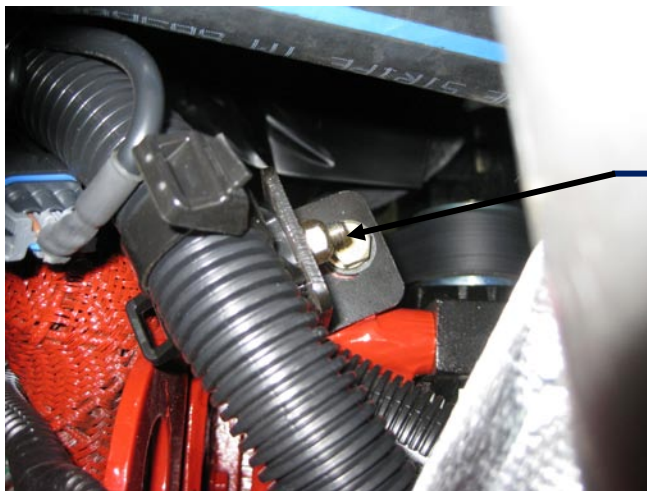
Replace with new locknut and flat washer (Note: new locknut shown)

- 6 One starter cable and wiring harness support is located on the right side of the engine between the alternator and engine fan.
- 7 Remove and discard the ¼" serrated nut (and flat washer if installed). Install the new ¼" locknut (0145847) and flat washer (01247709) provided. Torque nut to 60-85 in. lbs. Note: two complete threads must extend completely through the nut.

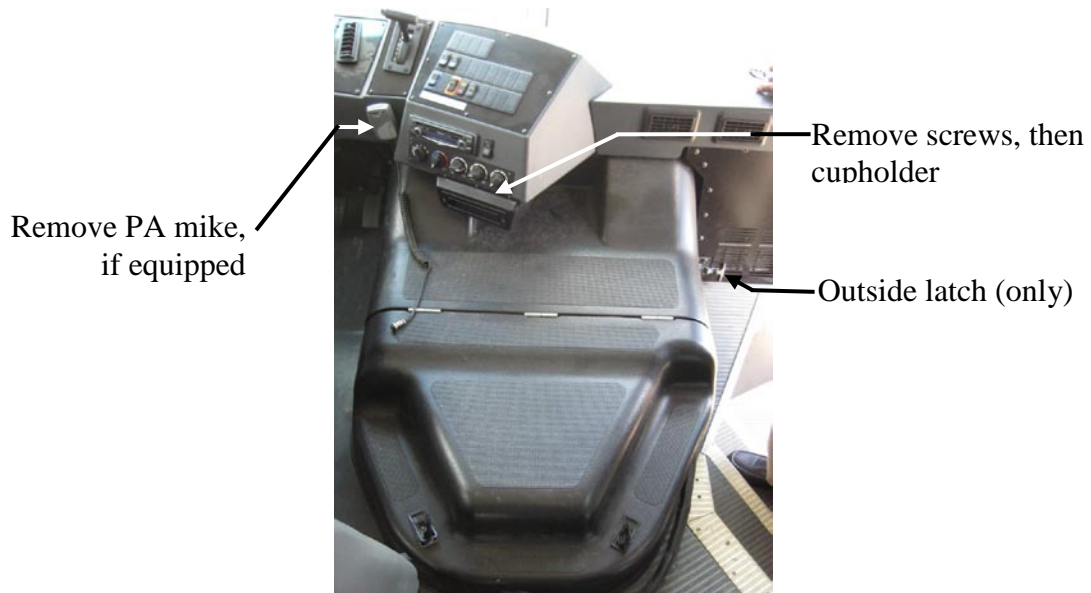
1. Park bus on a level surface, applying parking brake, switch engine off, remove ignition key and chock wheels. Disconnect batteries. **Always remove negative cable first.**
2. To remove engine cover assembly to access front of engine:
  - a. Remove cup holder by removing the Phillip head screws on the front of center console.
  - b. Remove the PA microphone if equipped.
  - c. Pull to release the rubber handle latch anchor located at the right hand lower front wall of the engine cover assembly.
  - d. Open hood and locate the four latches on the inside of hood. One is located on the driver's side toward the front, one on each side and one at rear center. Release these latches and remove engine cover assembly for access to front of engine.
