SERVICE PROCEDURE

**G-10514
DECEMBER 2010**

**SUBJECT: SAFETY RECALL
WINDSHIELD WIPER LINKAGE AND MOTOR on
certain ProStar and LoneStar models built 1/2/07
thru 5/17/10.**

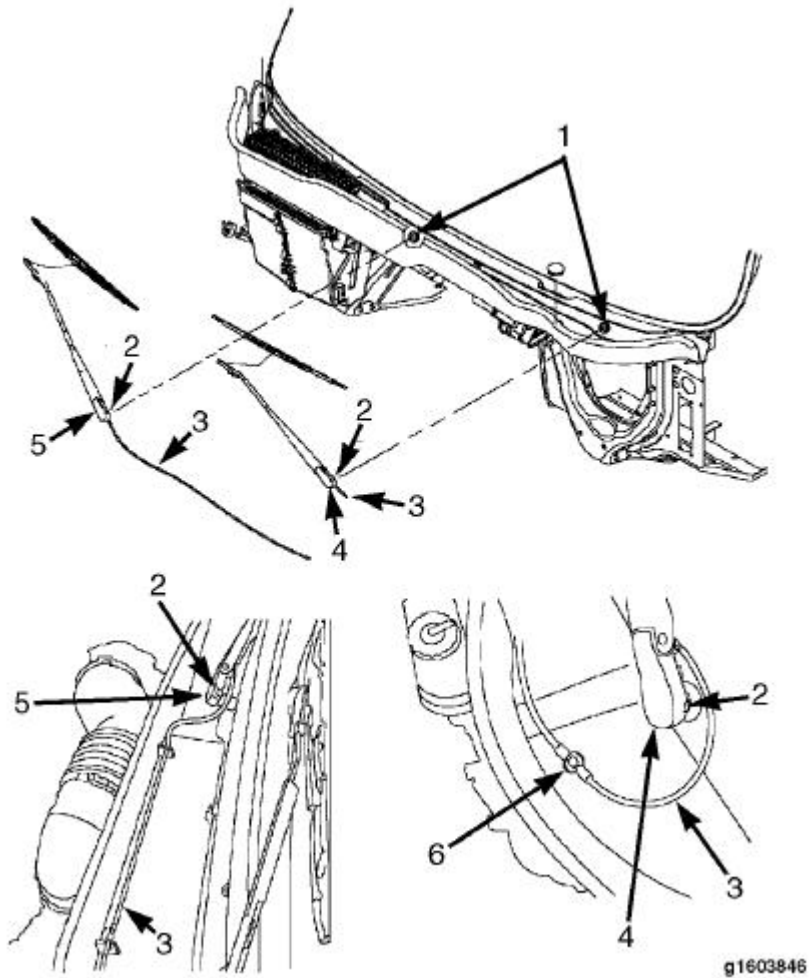
2, 8

- 1. WIPER PIVOT POST
- 2. LOCK LEVER
- 3. WASHER HOSE
- 4. DRIVER SIDE WIPER ARM AND BLADE ASSEMBLY
- 5. PASSENGER SIDE WIPER ARM AND BLADE ASSEMBLY
- 6. T-FITTING

1. Unlatch and open the engine compartment hood.
2. Remove both windshield wiper arm/blade assemblies.
3. Remove cab cowl tray.
4. Remove and discard the windshield wiper drive motor/linkage assembly.
5. Install windshield wiper linkage/motor assembly. Tighten the nuts to 16 Lbf-ft (22 N•m); DO NOT exceed 18 Lbf-ft (24 N•m). Connect electrical connector to windshield wiper motor. Secure wiring harness and connector with wire tie as needed.
6. Cycle the engine ignition key on and off to ensure that the wiper motor is parked.
7. Install the cab cowl tray. Tighten fasteners to 16 Lbf-ft (22 N•m), DO NOT exceed 18 Lbf-ft (24 N•m).
8. Install both windshield wiper arm/blade assemblies.
9. Close and latch engine compartment hood.

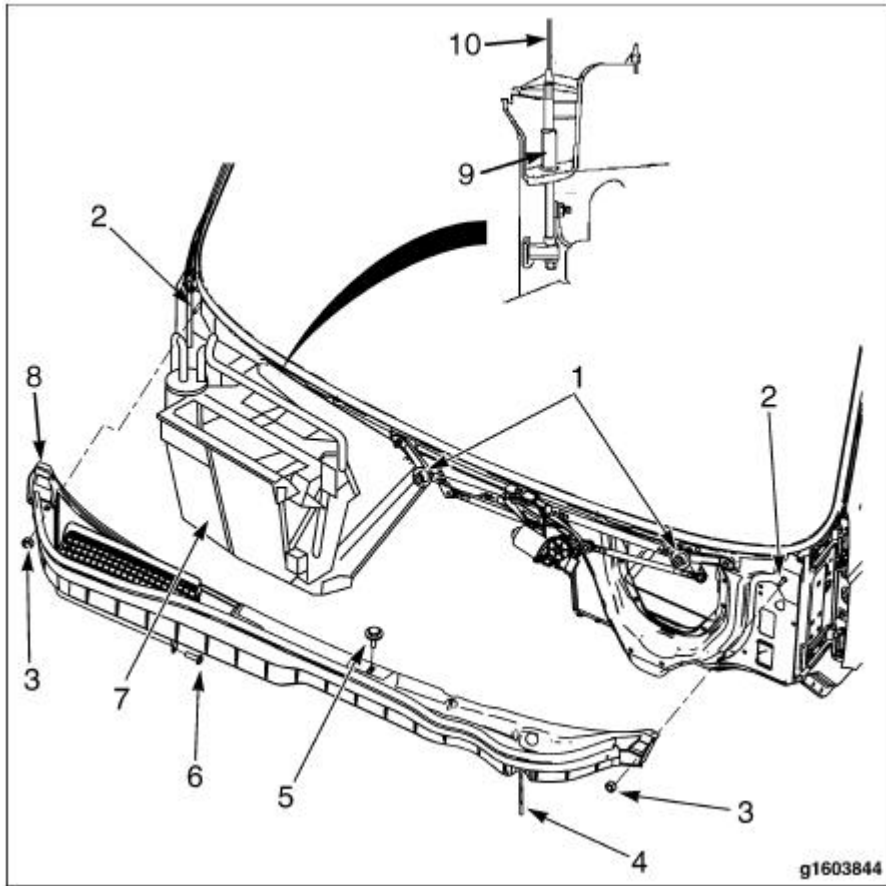
3, 7

1. WIPER PIVOT POST
2. MOUNTING STUDS
3. MOUNTING NUT
4. WASHER HOSE
5. CENTER MOUNTING BRACKET BOLT
6. SCREW
7. EVAPORATOR BOX
8. COWL TRAY
9. RUBBER SEAL
10. ANTENNA
