**SUBJECT: Campaign #117 – Add Driveshaft Close-out Panel**

## INSTRUCTIONS TO PERFORM CAMPAIGN 117

- 2011 Model E35F Winnebago Vista® and Itasca Sunstar® motor homes.

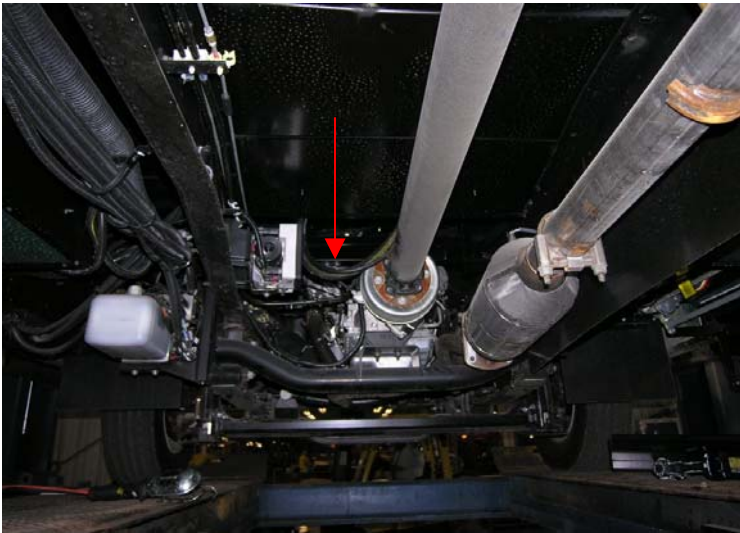
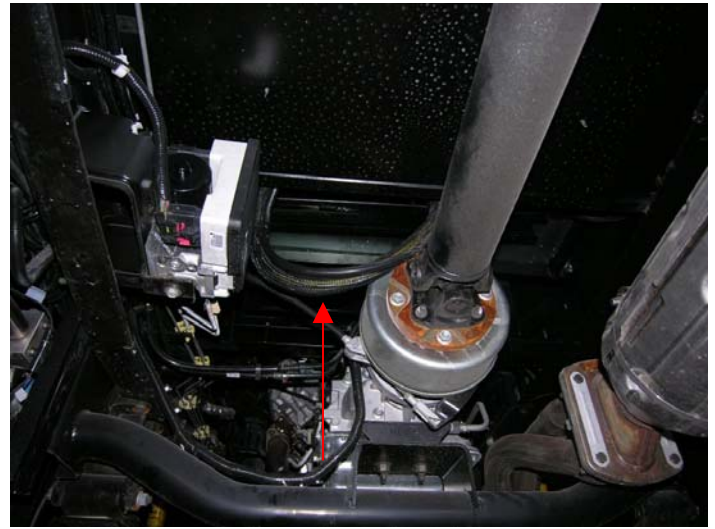
These vehicles may have the potential for a cable that powers the slideout room to make contact with the driveshaft when the slideout is retracted. If this cable makes contact with the driveshaft, it could wear the protective jacket and insulation off the cable exposing the conductors to the driveshaft and energizing the chassis, which could result in personal injury or death.

**Unsecured Slideout Wire Harness  
(View looking toward front of chassis)**

1. Inspect slideout wire harness and ensure that there is no damage. If the slideout wire harness is not damaged, proceed to Step 2.

*NOTE: If damage has occurred to the slideout wire harness, contact Tech Service at (866) 653-4329 for direction.*
