**February 24, 2017**

05890 Version 2

**Safety Recall: Front Passenger's Airbag May Not Deploy Correctly****Supersedes 10-056, Dated September 11, 2010; See REVISION SUMMARY****AFFECTED VEHICLES**

Year	Model	Trim	VIN Range
2010	Crosstour	ALL	Check the iN VIN status for eligibility

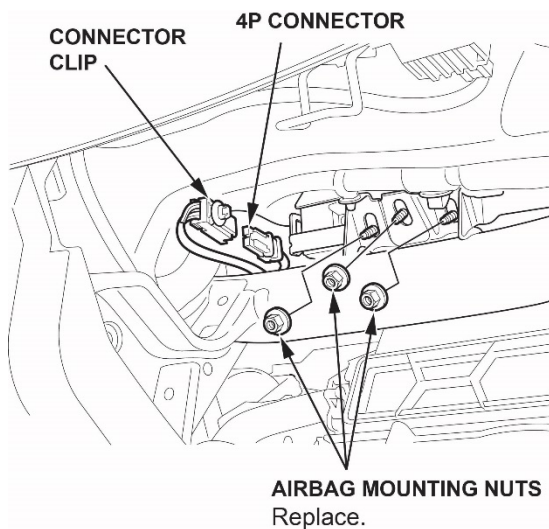
5. Detach the connector clip, then disconnect the front passenger's airbag inflator 4P connector. Remove the airbag mounting nuts. The nuts will not be reused.

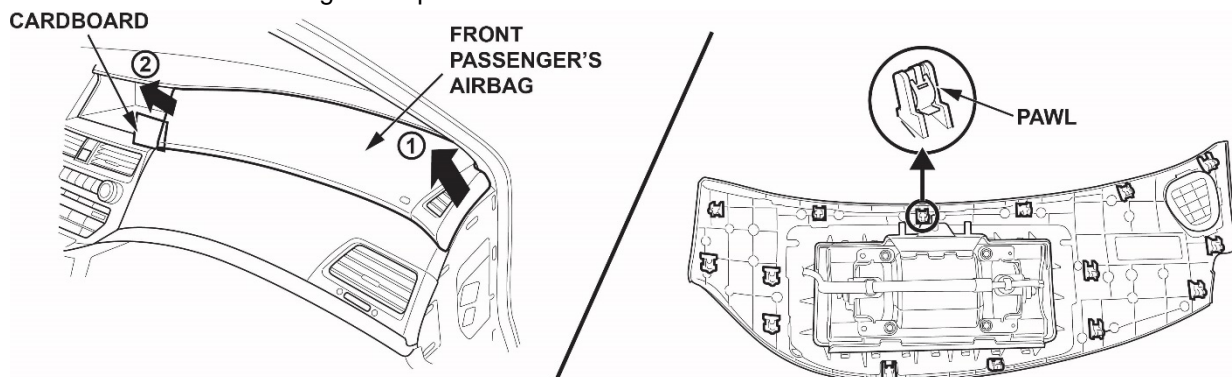
6. Insert a small piece of cardboard between the center display visor and the front passenger's airbag. Using only your hands, first lift the right side, then lift the left side, and remove the front passenger's airbag from the dashboard.

NOTE: The lid of the airbag has clips on each side where it attaches to the dashboard.

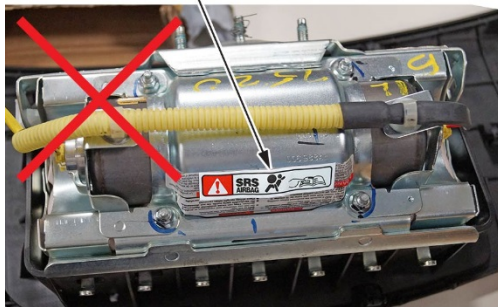
NON-STANDARD SAFETY LABEL

- If there is nothing unusual about the airbag or the inflator, go to step 8.
- If there are any unusual markings, like an incorrect label or a model year written in marker, the airbag and inflator may not be the correct airbag and/or inflator for the vehicle or it may be a counterfeit part. For more information about counterfeit airbags, you can refer to [safercar.gov](http://safercar.gov), enter keywords **MANAGING COUNTERFEIT**, and select **Recommended Dealer Guidance for Managing Counterfeit Air Bags** from the list. **If you suspect that the airbag or inflator is counterfeit, do not continue this procedure.** Contact your DPSM for assistance.

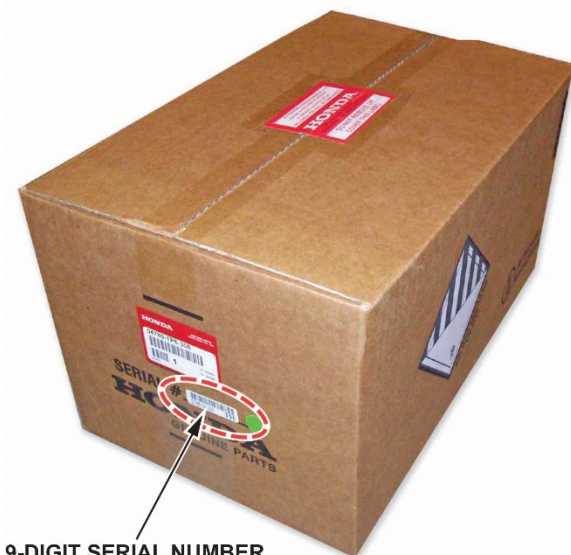
9-DIGIT SERIAL NUMBER

8. Write down the 9-digit serial number located on the right side of the new airbag's box. (There are two rows of numbers on the serial number sticker; the top row is the serial number.) For the warranty claim to be paid, your warranty clerk must enter this 9-digit serial number in the claim.

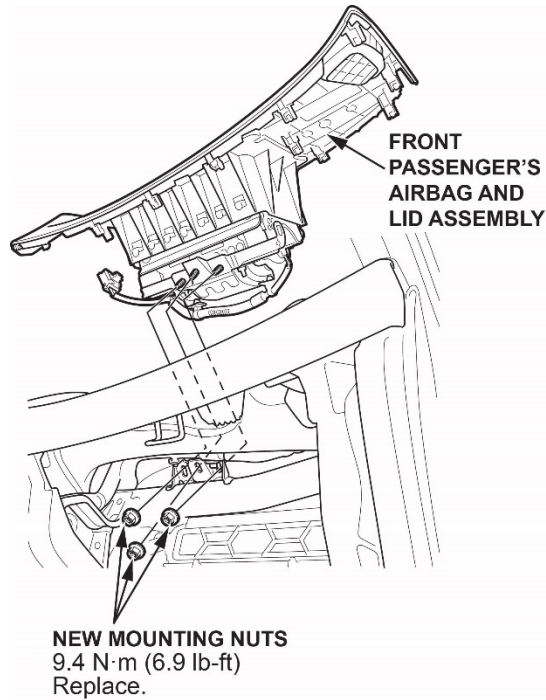
9. Place the front passenger's airbag and lid assembly into the dashboard. Torque the front passenger's airbag new mounting nuts to **9.4 N·m (6.9 lb-ft)**.

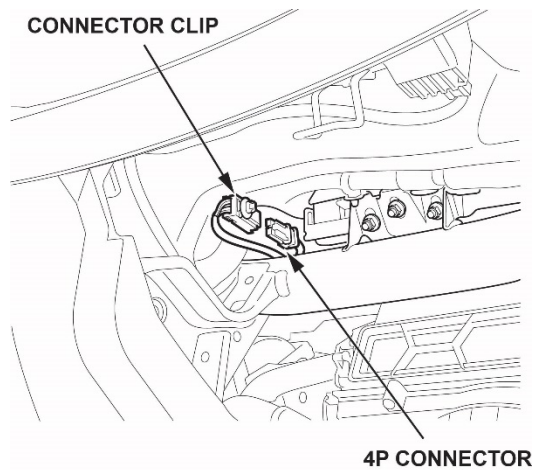
10. Connect the front passenger's airbag inflator 4P connector, then install the connector clip.
11. Reinstall the passenger's dashboard side panel.

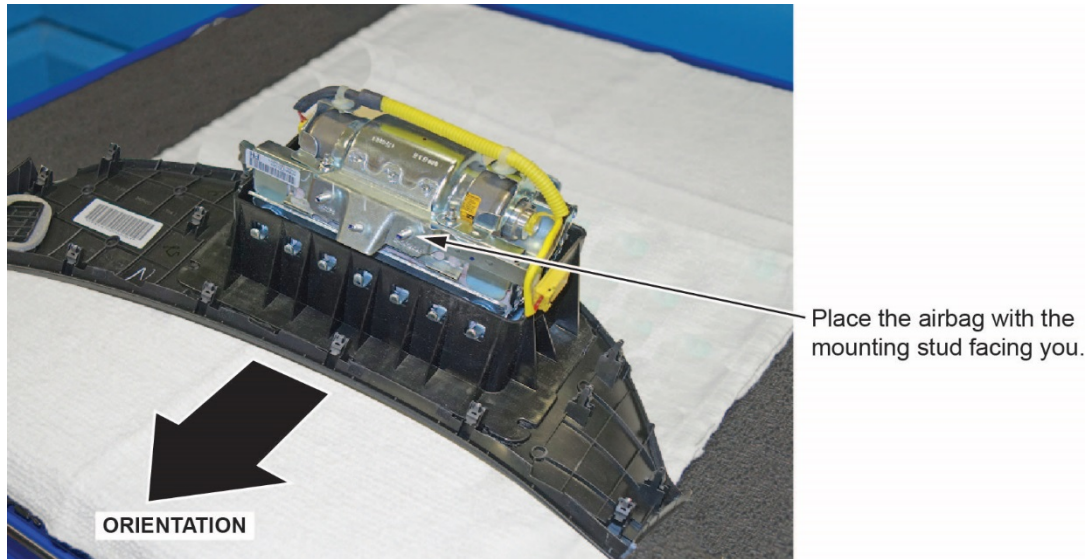
1. Place the airbag, face-down as shown.

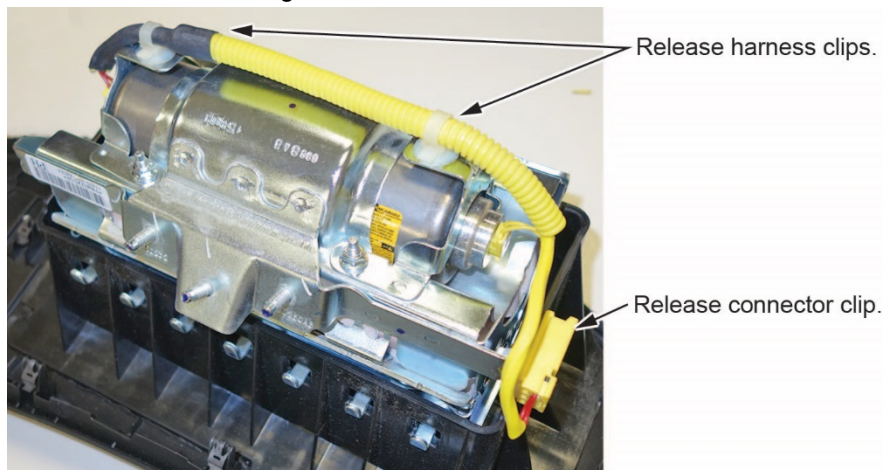
2. Remove the harness from both ends of the inflator bracket and release the connector clip.  
NOTE: Orient the airbag as shown to make sure the correct side of the harness is cut and shorted.

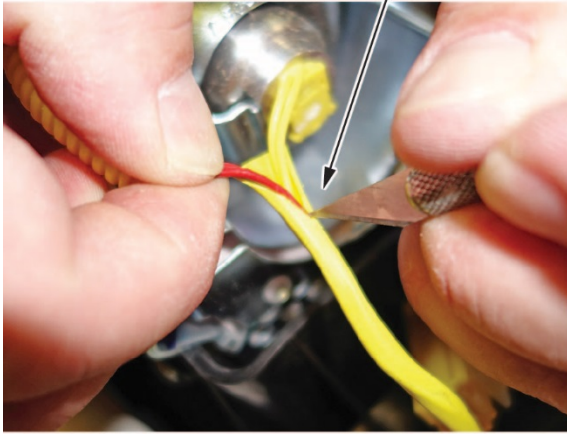
Cut open the protective tubing to expose the yellow wires.

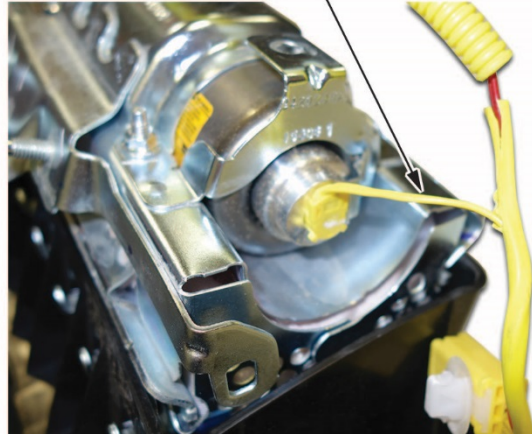
Expose enough of the yellow wires to easily cut.

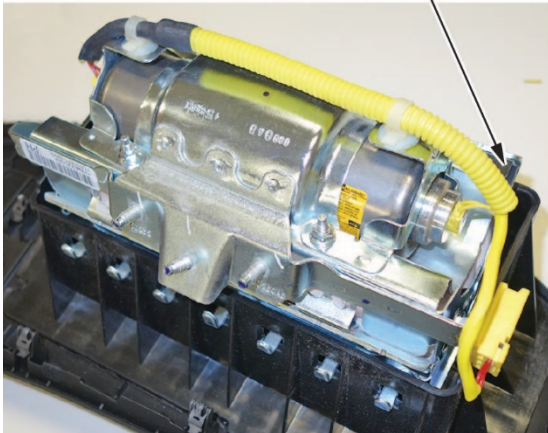
- Cut the yellow wires as shown.

Cut the yellow wires on this side of the inflator.

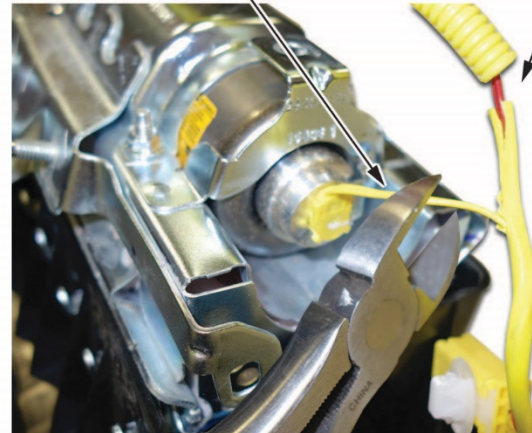
Cut only the yellow wires.

Do not cut the red wires.

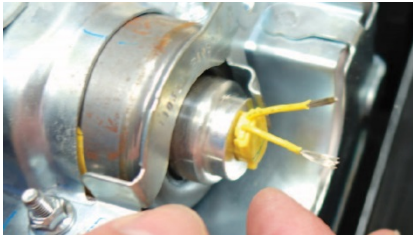
- Strip away about 1 inch of the yellow wire insulation, then twist the wires together.

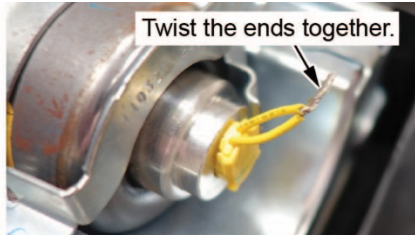
Twist the ends together.

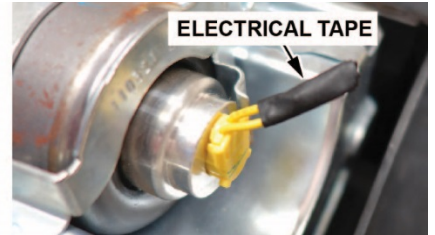
ELECTRICAL TAPE

- Tape the twisted ends with electrical tape.

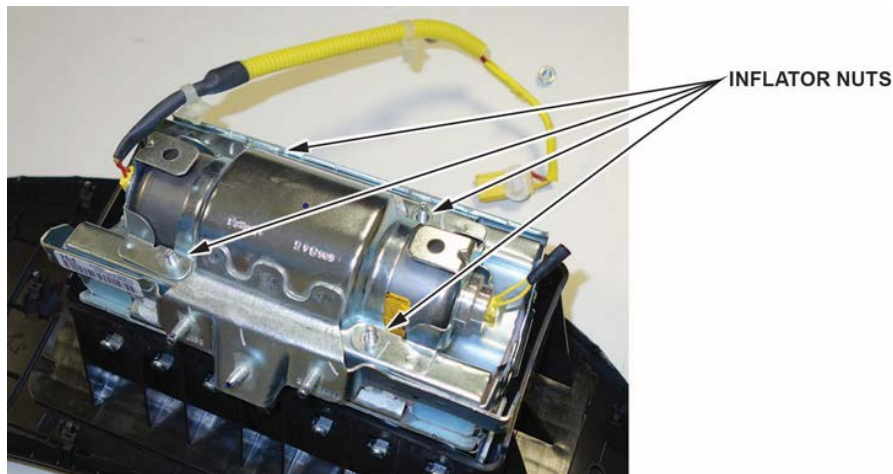
5. Remove the four inflator nuts.

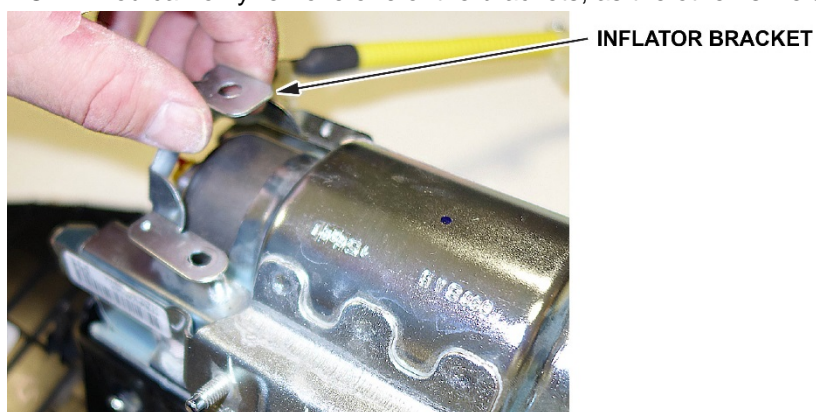
6. Remove the inflator bracket.

NOTE: You can only remove one of the brackets, as the other is welded to the airbag housing.

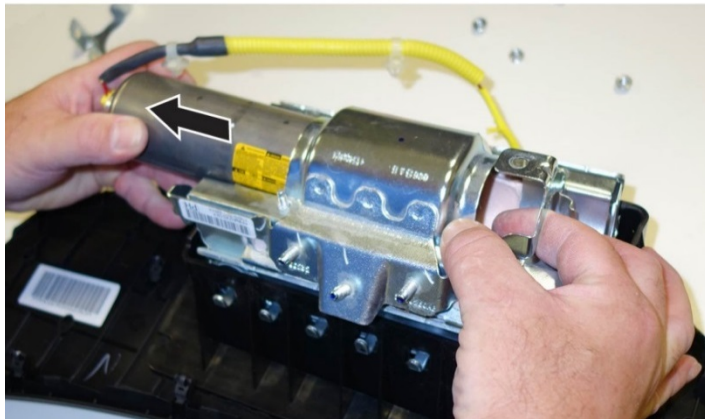
7. Remove the inflator by pulling it out.
