# Service Bulletin No. 349

MODEL D4005 / D4505 Series Coaches	TYPE Field Change Program	SECTION/GROUP 3-Body	DATE Sept. 15, 2010
SUBJECT NATIONAL SEATING DRIVER'S SEAT STABILUS BLOC-O-LIFT SHOCK			
CONDITIONS

Technical Service Bulletin  
NSC22955401  
Seat Shock Replacement

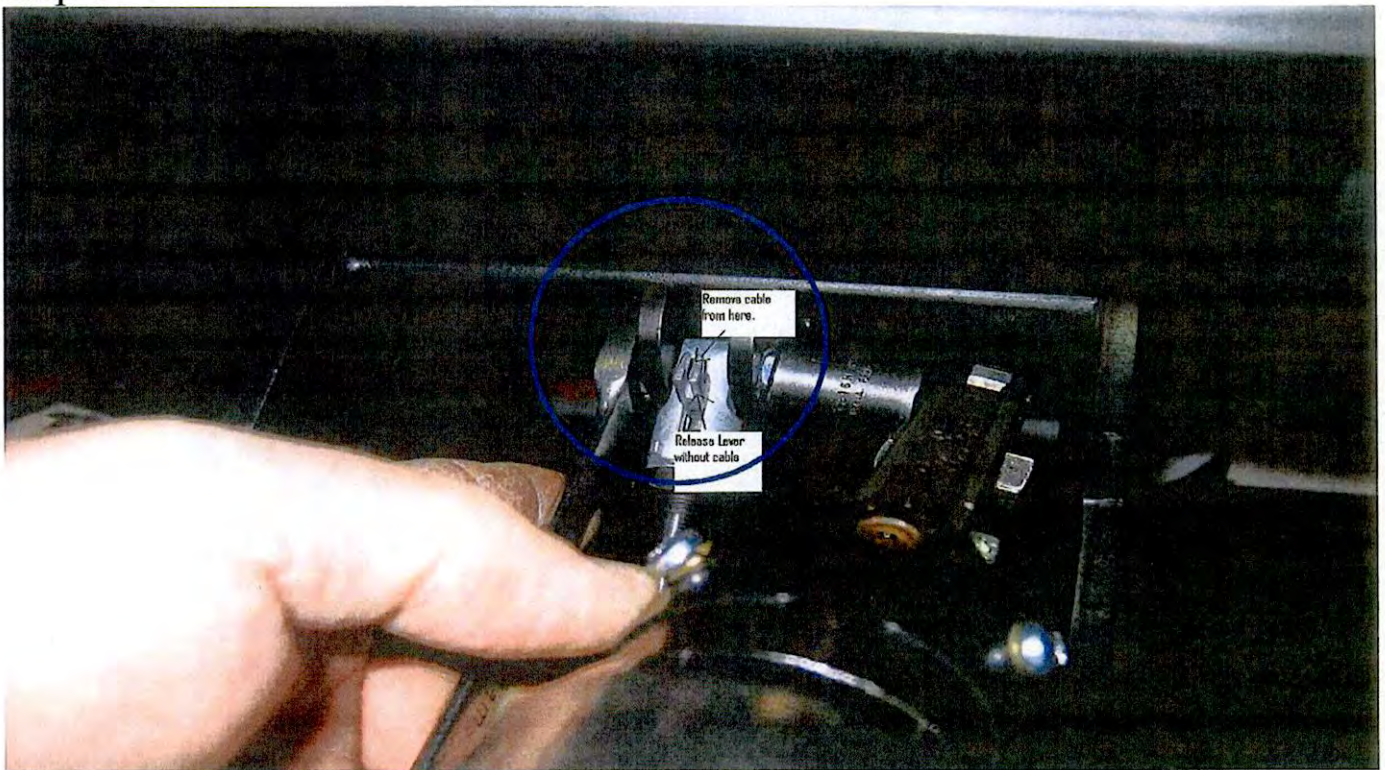
## Step 4

Remove the nut and bolt from top shock mount using (2) ½” wrenches. Then remove the bolt from the bottom mount and remove the shock from the base.

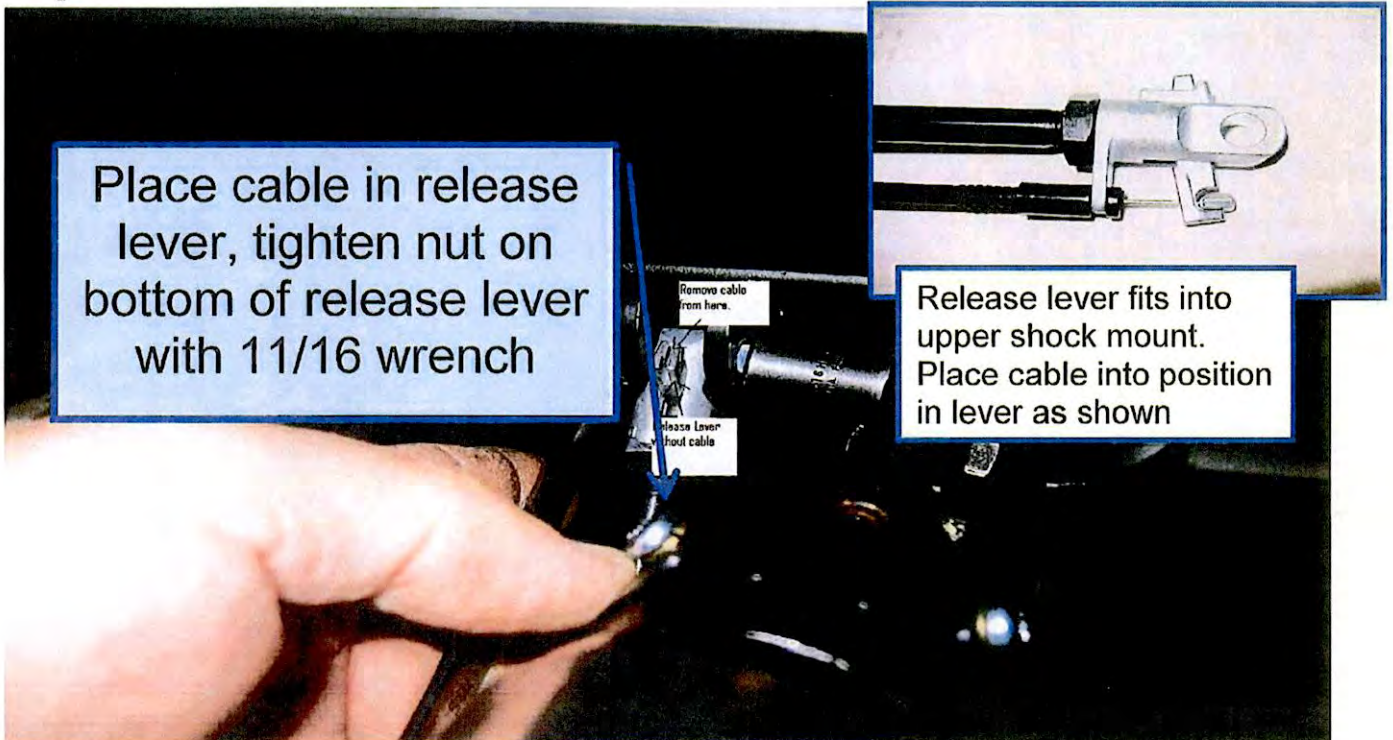
Place cable in release lever, tighten nut on bottom of release lever with 11/16 wrench

Release lever fits into upper shock mount. Place cable into position in lever as shown

Install shock to upper shock mount in base torque should be a minimum of 10 FT-LB to a maximum of 14 FT-LB. Do NOT over tighten!
