# Passport Pre-Recall Inspection

## WARRANTY CLAIM INFORMATION

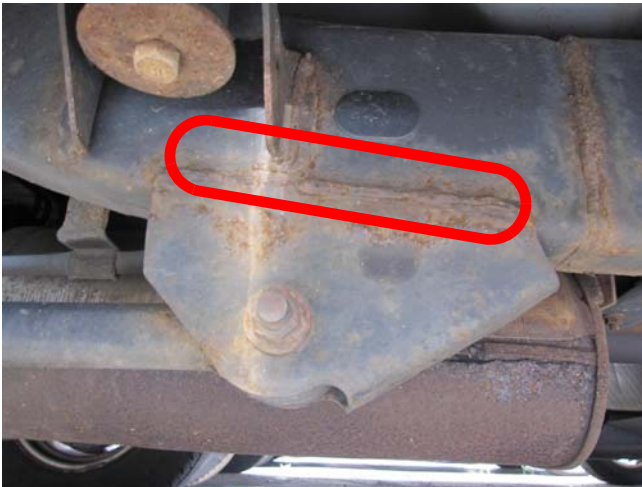
1. Raise the vehicle on a lift. Make sure the rear lifting points are at least 12 inches (300 mm) ahead of the rear trailing link front mounting bolts to allow enough clearance for the inspection.
2. Visually inspect the trailing link front brackets (where they attach to the frame) for cracks or holes in the red circled area.
  - If there are no cracks or holes, go to step 3.
  - If you see cracks or holes, remove the side steps or running boards (if applicable), then go to step 6.

3. Compare the vehicle's bracket area to the photo above.
  - If the vehicle's bracket area is rusted to a similar or lesser degree than the bracket shown in the photo, no further action is needed at this time.
  - If the vehicle's bracket area is rusted to a greater degree than that in the photo, go to step 4.

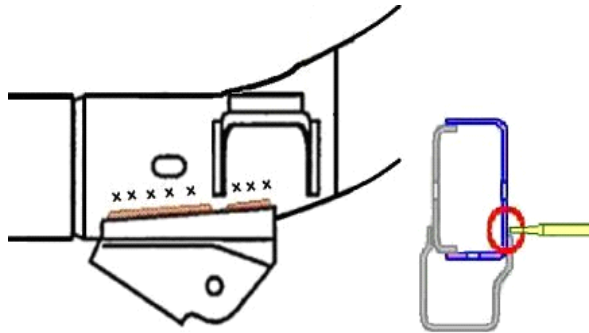
4. If the vehicle has side steps or running boards, remove them.
5. Use a 3/16 in. x 9 in. flat punch and a 10–12-oz. hammer to strike the frame areas marked X in the illustration below. Swing the hammer with a 10 to 12 in. stroke to be sure enough force is applied to the punch.

- If the punch doesn't poke a hole in any of the X-marked areas on the frame, no further action is needed at this time. Reinstall the side steps or running boards (if removed).
- If the punch pokes a hole in any of the X-marked areas, go to step 6.

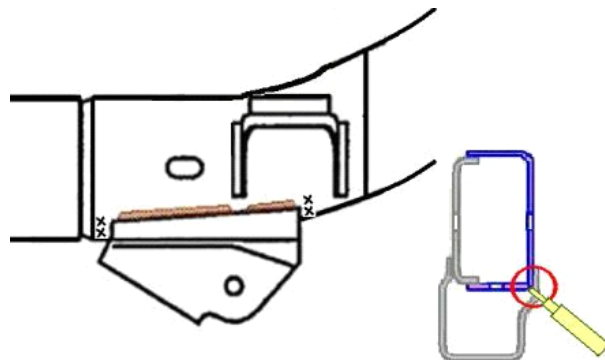
6. Use the punch and the hammer to strike the frame corners on each of the X-marked areas in the illustration below. Again, swing the hammer with a 10 to 12 in. stroke to be sure enough force is applied to the punch.
  - If the punch doesn't poke a hole in any of the X-marked areas, no further action is needed at this time. Reinstall the side steps or running boards (if removed).
  - If the punch pokes a hole in any of the X-marked areas, **the vehicle is unsafe to drive.** For further instructions, call Honda Automobile Customer Service at 800-999-1009, and select option 4.
