SUBJECT: Campaign #120 – Model 32H Dinette Seat Belt Anchorages

INSTRUCTION TO PERFORM CAMPAIGN # 120

INSTRUCTIONS TO PERFORM CAMPAIGN 120

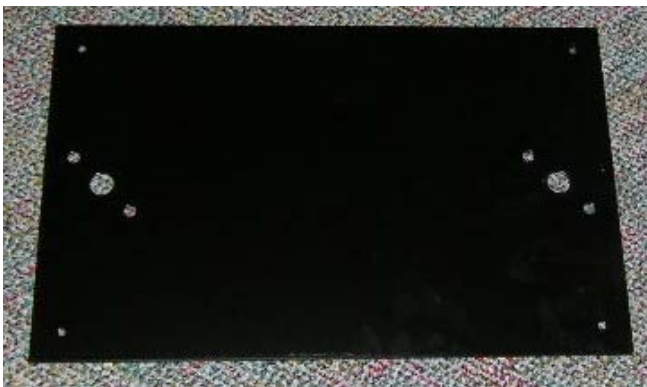
Anchorage Reinforcement Plate A

Install three separate anchorage reinforcement plates.

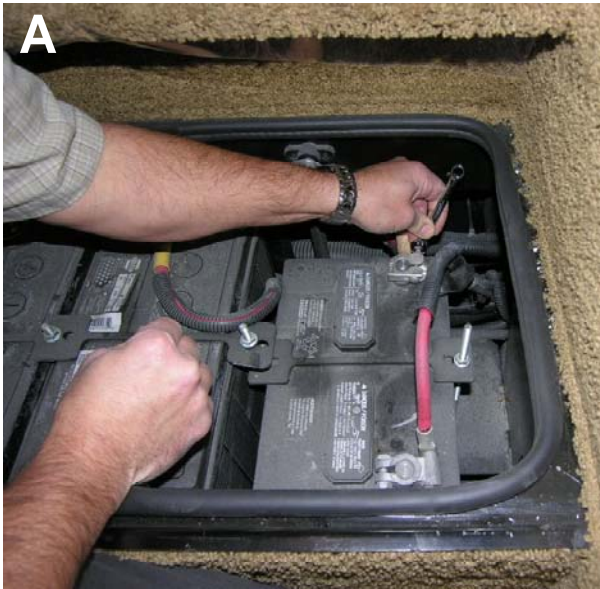
1. Unfasten entrance step retainer and lift step cover upward and remove to access chassis and house batteries.
2. Using a 3/8" wrench, disconnect the negative chassis battery cable. See Photo A.

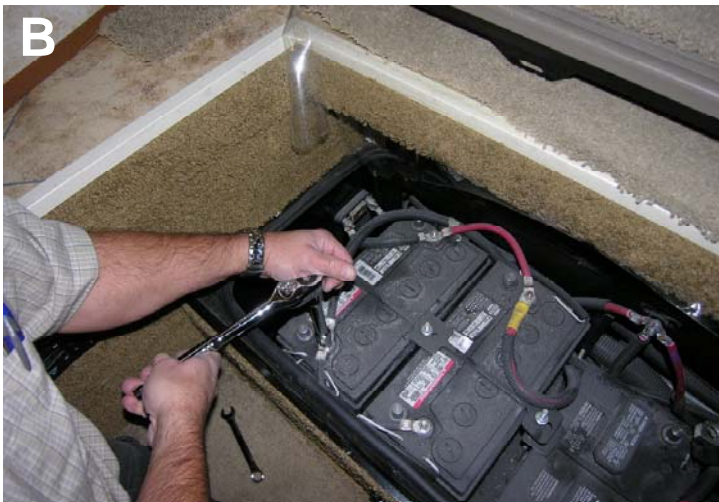
3. Using a 1/2" socket, disconnect the negative house battery cable. See Photo B.

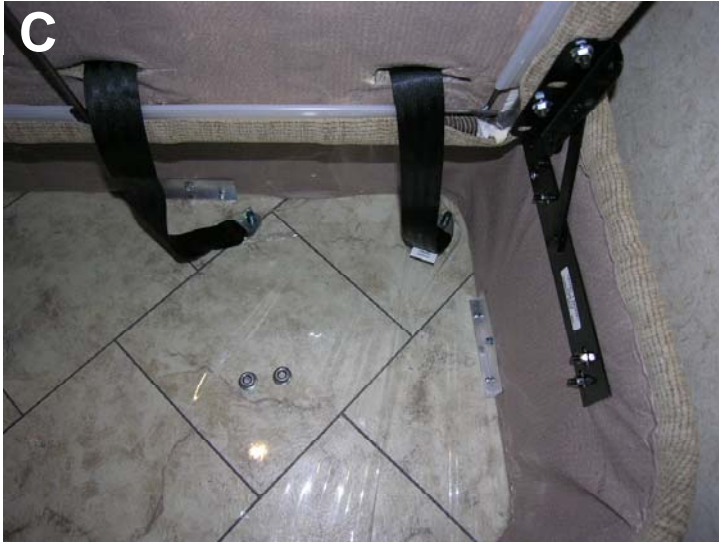
5. Using a $\frac{3}{4}$ " socket, remove nuts from both anchorages and set aside. See Photo C.

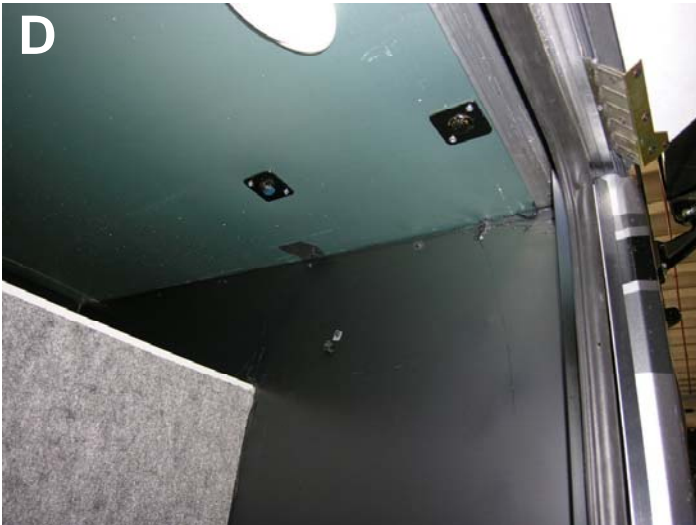
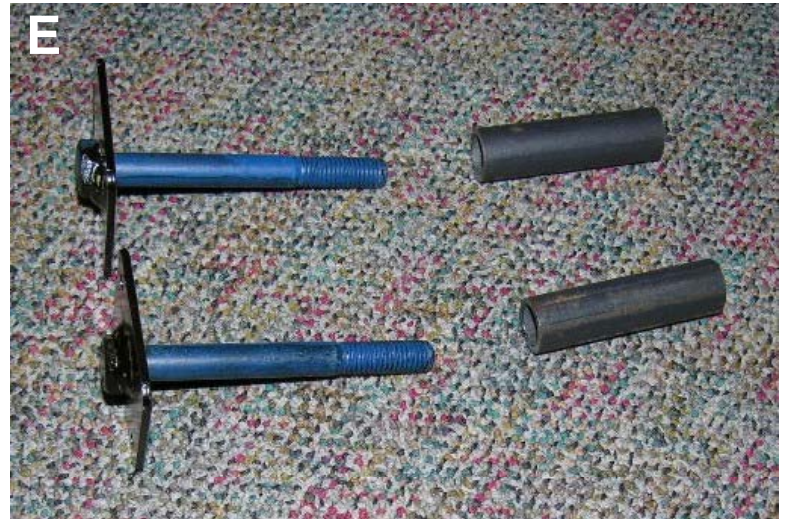
6. Outside the coach (in passenger side compartment ahead of entrance door), remove the screws holding the two anchorages with a screw gun. Separate the collars from the anchorages and set aside. See Photos D and E.

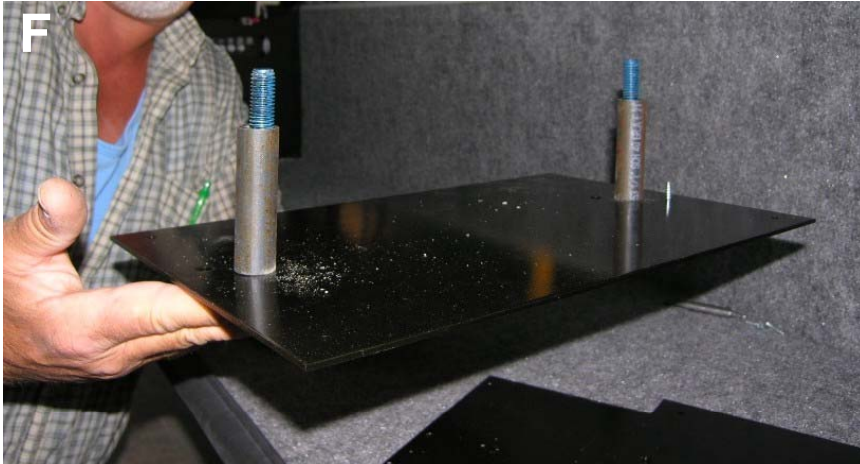
7. Take one Anchorage Reinforcement Plate A (from the kit) and insert the two anchorages (that were removed in Step 6) through the bottom of the plate and install collars. See Photo F.

NOTE: Throughout the process, if fitting the reinforcement plate with collars is difficult, remove collars and have an assistant insert them from above the floor.

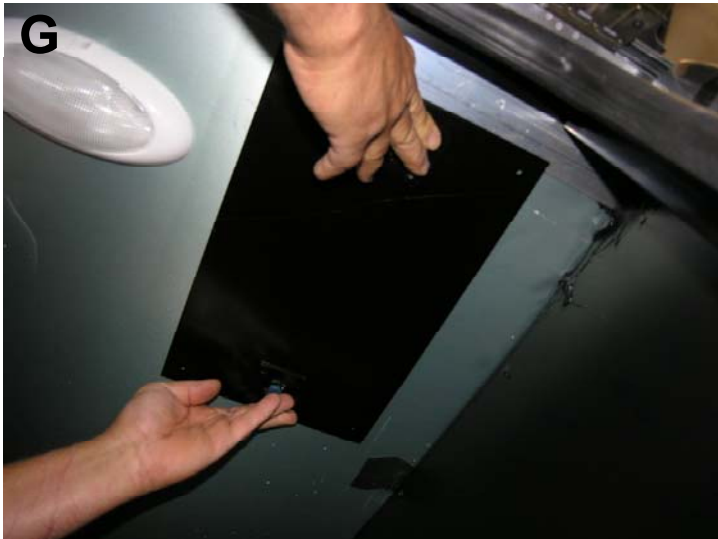
8. Insert and hold the assembly up through the compartment ceiling, ensuring bolts are accessible from inside the coach. See Photo G.

NOTE: If only one person is available to perform this recall repair procedure, there are pre-drilled holes on the corners of each of the anchorage reinforcement plates to secure the plates in place with screws while the remaining steps are being completed.

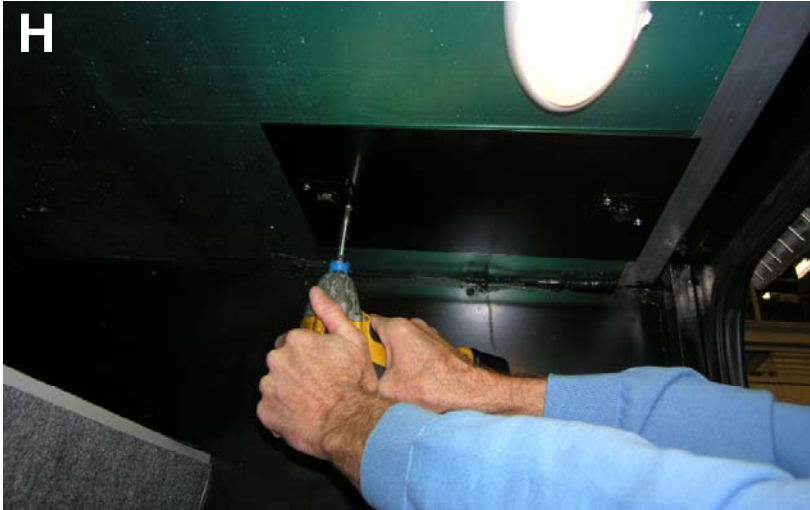
9. Align holes in each anchorage with the holes in the reinforcement plate and reinstall screws (that were removed in Step 6). See Photo H.

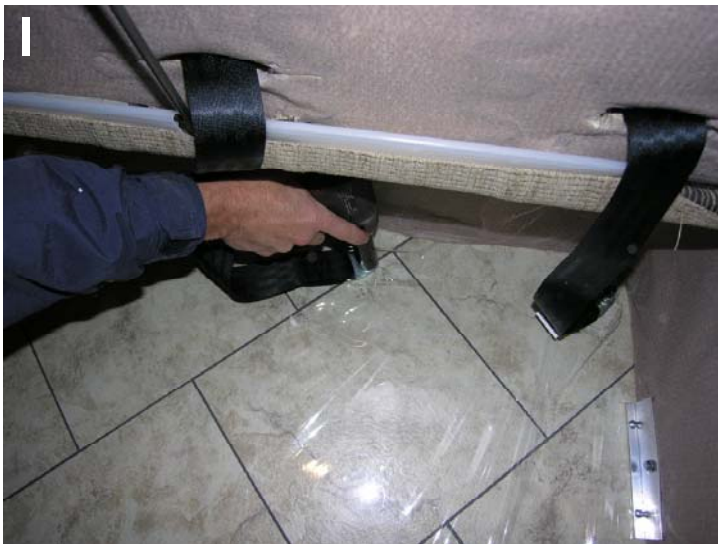
10. Install both seat belts to the newly installed anchorages. Finger-start nut (that was removed in Step 5) on each anchorage and tighten with $\frac{3}{4}$ " socket. See Photo I.

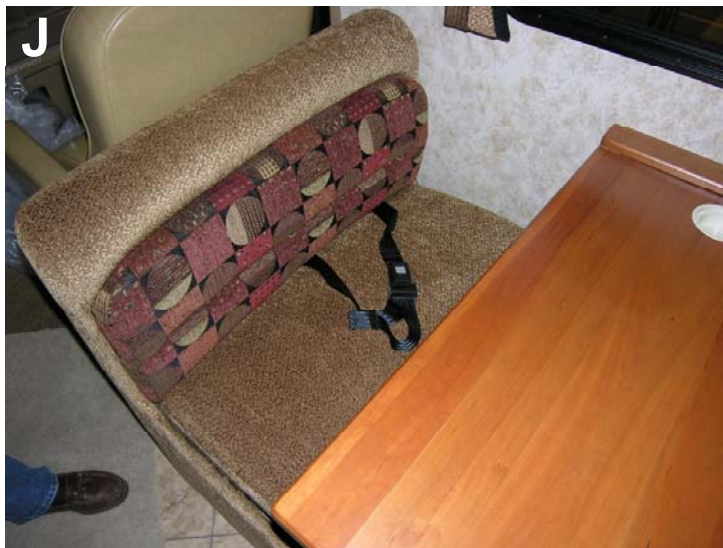
11. Lower dinette seat and reinstall seat back cushion, ensuring seat belt is accessible and ready for use. See Photo J.

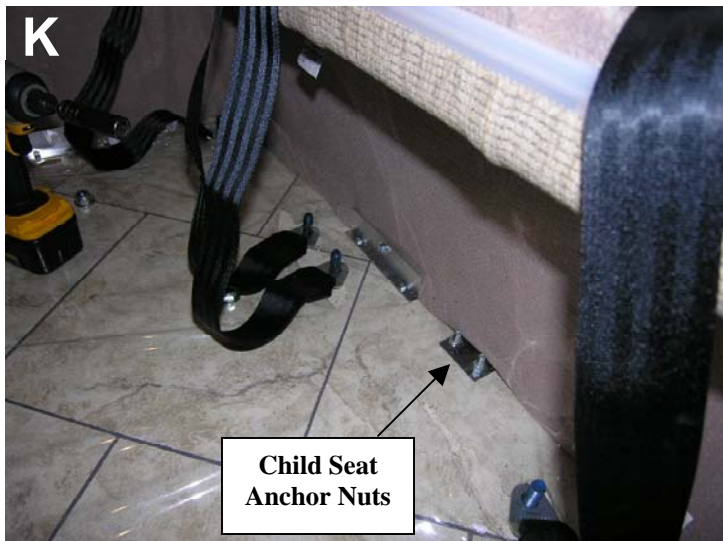
13. Remove nuts from the four anchorages (3/4" socket) and the two child seat anchor nuts (1/2" socket) and set aside. See Photo K.

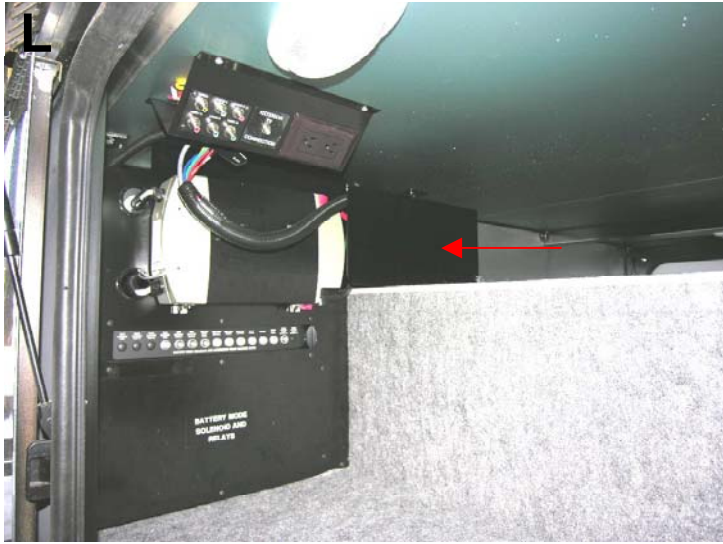
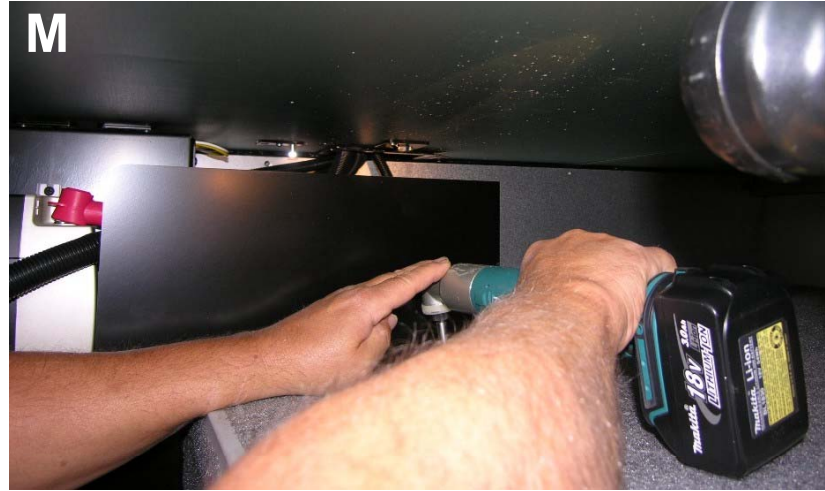
14. Outside the coach (in passenger side compartment ahead of entrance door), remove black cover using an angled screw gun. Set screws aside. See Photos L and M.

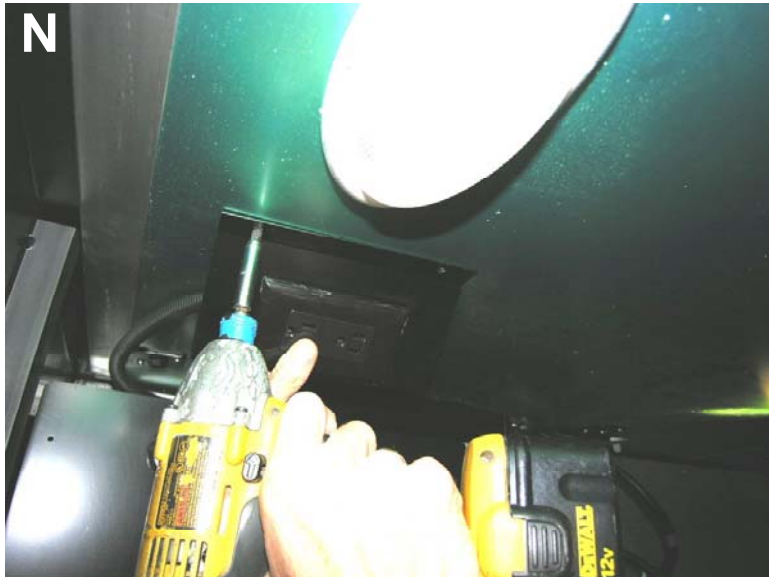
15. Using a screw gun, remove the electrical outlet assembly from the compartment ceiling and allow to hang loosely. See Photo N.

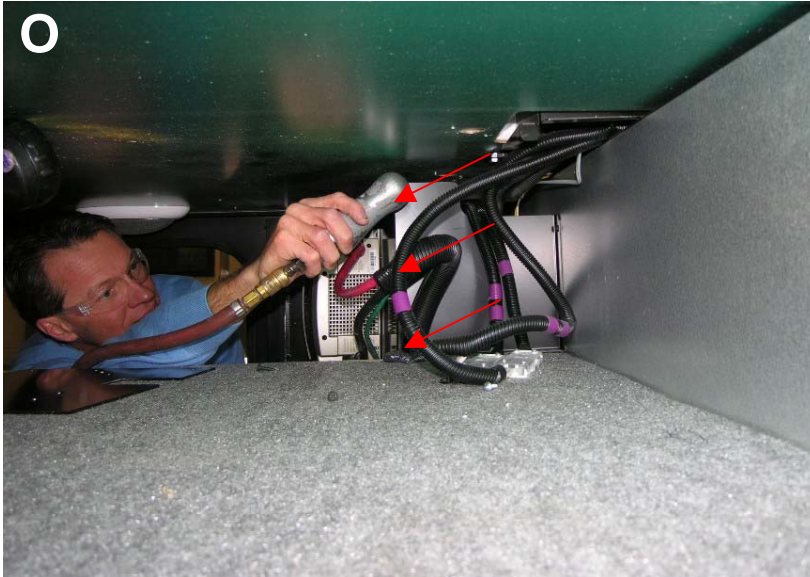
16. Remove three side panel screws and set aside. See Photo O.

(View shown through compartment door on opposite side of coach)

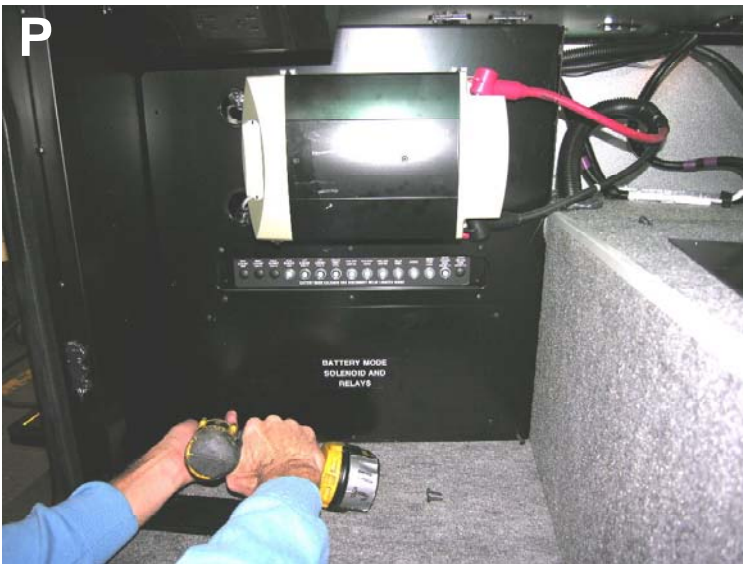
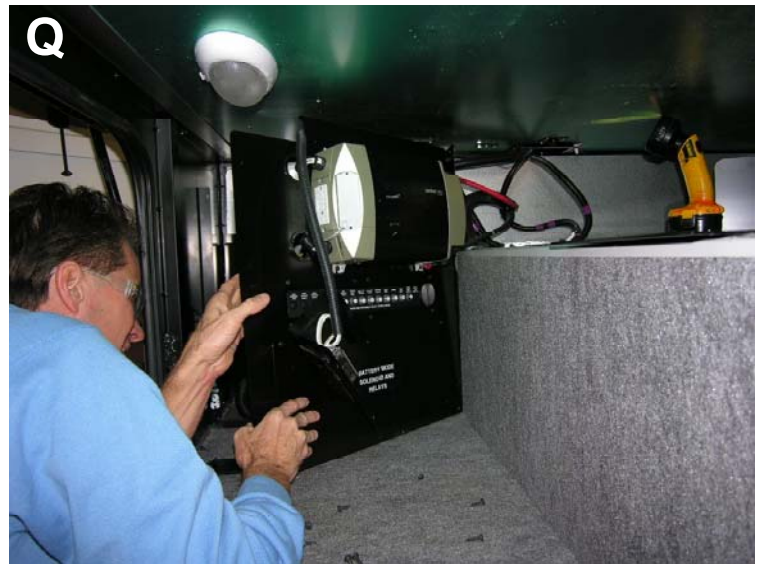
17. Remove outer faceplate screws and set aside. Partially pull out faceplate to access the four anchorages. See Photos P and Q.

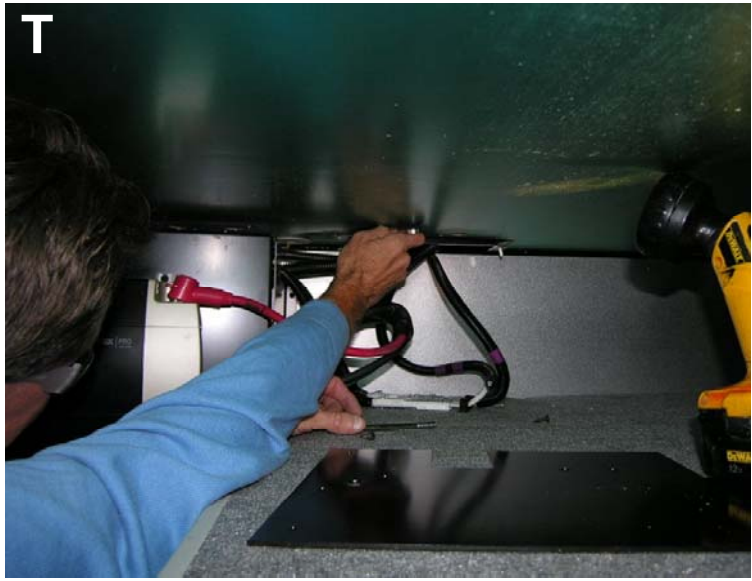
19. Using a 1/2" wrench, remove the two child seat anchor bolts (with an assistant to hold the bolts above the floor). Separate collars and plate from the bolts and set aside. See Photo T.

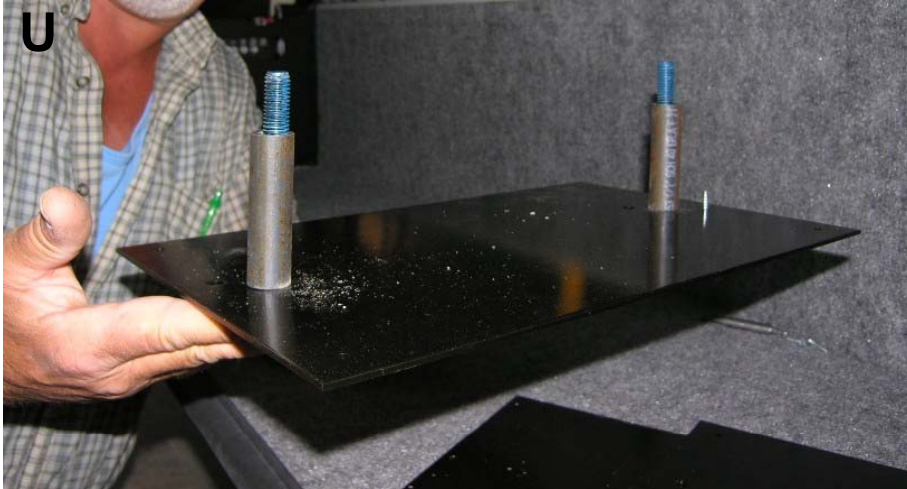
20. Take the second Anchorage Reinforcement Plate A (from the kit) and insert the two anchorages (that were removed in Step 18) through the bottom of the plate and install collars. See Photo U.

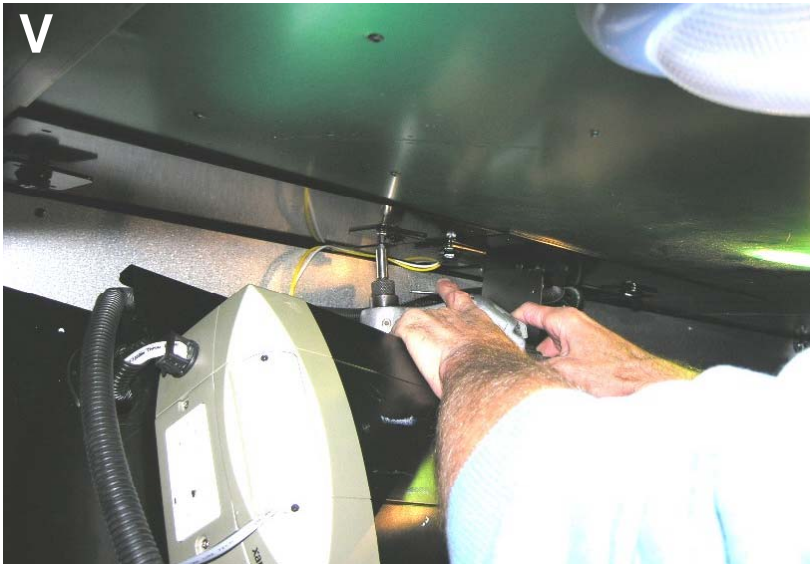
21. Insert and hold the assembly up through the outboard compartment ceiling, ensuring bolts are accessible from inside the coach.
22. Align holes in the anchorages with the holes in the reinforcement plate and reinstall screws (that were removed in Step 18). See Photo V.

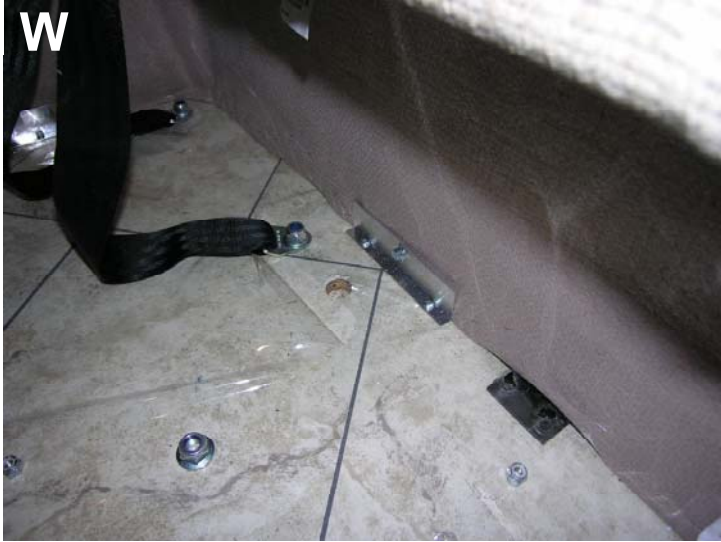
23. Install the two outboard seat belts to the newly installed anchorages. Finger-start nut (that was removed in Step 13) on each anchorage and tighten with $\frac{3}{4}$ " socket. See Photo W.

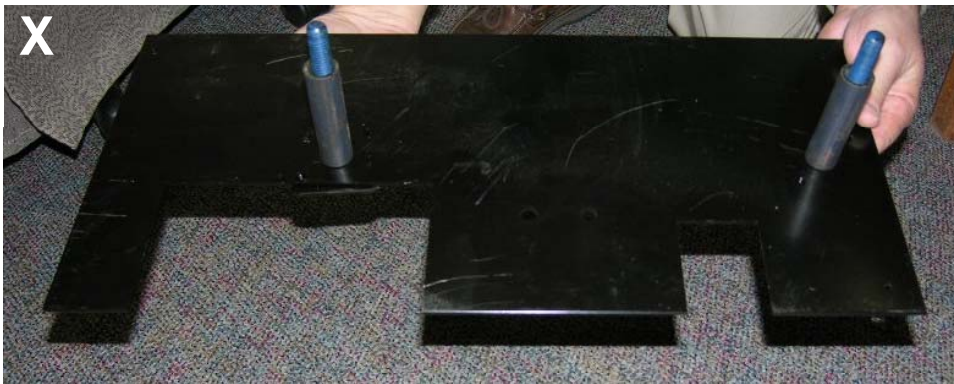
24. Take Anchorage Reinforcement Plate B (from the kit) and insert the remaining two anchorages (that were removed in Step 18) through the bottom of the plate and install collars. See Photo X.

NOTE: The "notch-out" side of the plate faces the rear of the coach towards the entrance door.

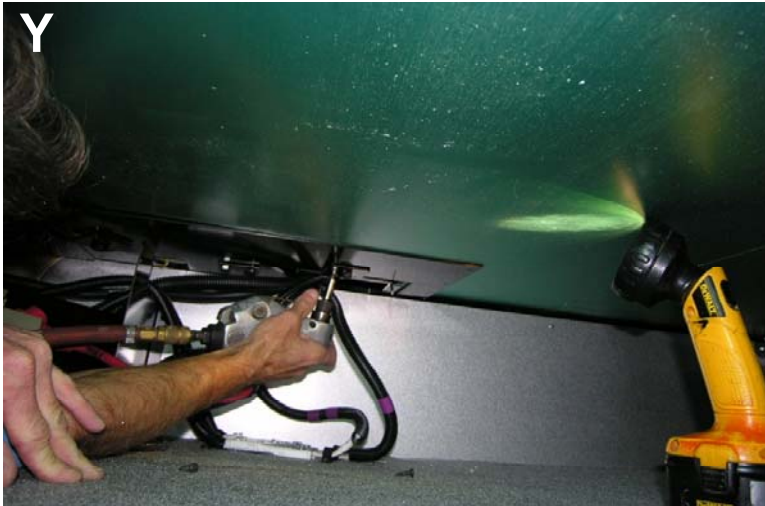
26. Align holes in the anchorages with the holes in the reinforcement plate and reinstall screws (that were removed in Step 18). See Photo Y.

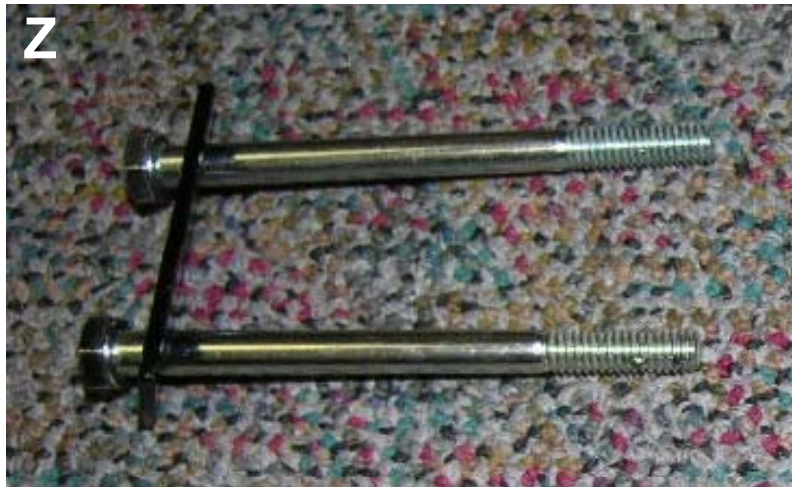
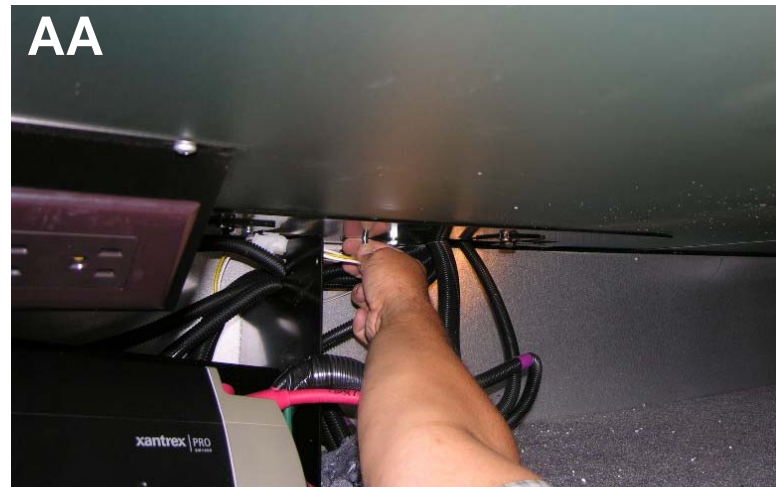
27. Reinstall the two child seat anchor bolts (that were removed in Step 19) through the plate and up through new assembly, ensuring the bolts are accessible from inside the coach. See Photos Z and AA.

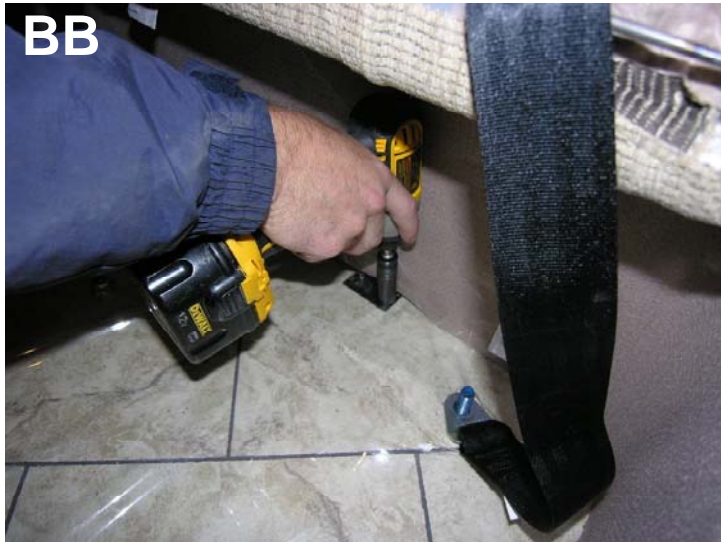
28. Install the two collars (that were removed in Step 19) onto the child seat anchor bolts from above the floor.
29. Reinstall the child seat anchor nuts (that were removed in Step 19). Finger-start nut on each child seat anchor bolt and tighten with $\frac{1}{2}$ " socket. See Photo BB.

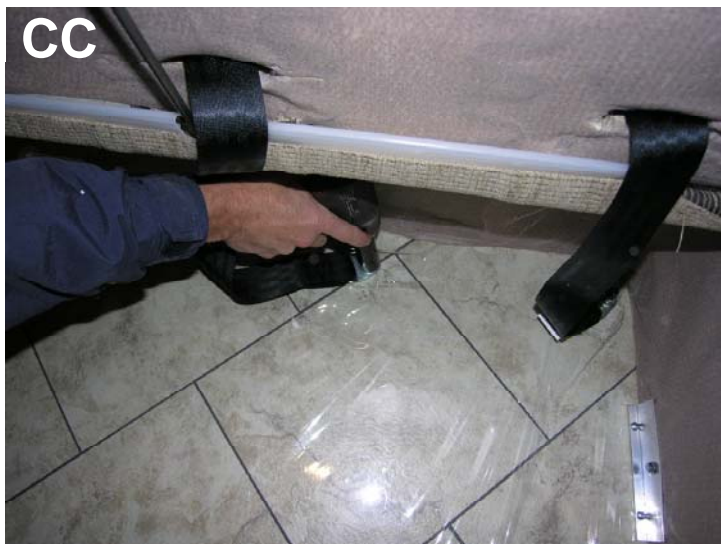
30. Install the two inboard seat belts to the newly installed anchorages. Finger-start nut (that was removed in Step 13) on each anchorage and tighten with $\frac{3}{4}$ " socket. See Photo CC.

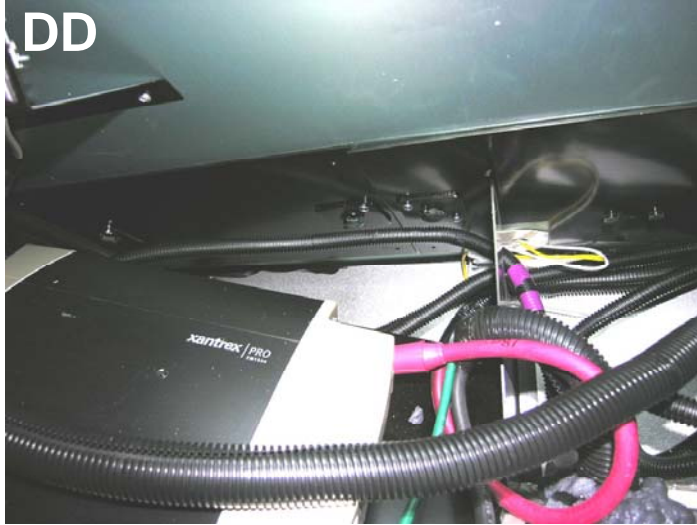
31. Reinforcement Plate installation complete. See Photo DD.

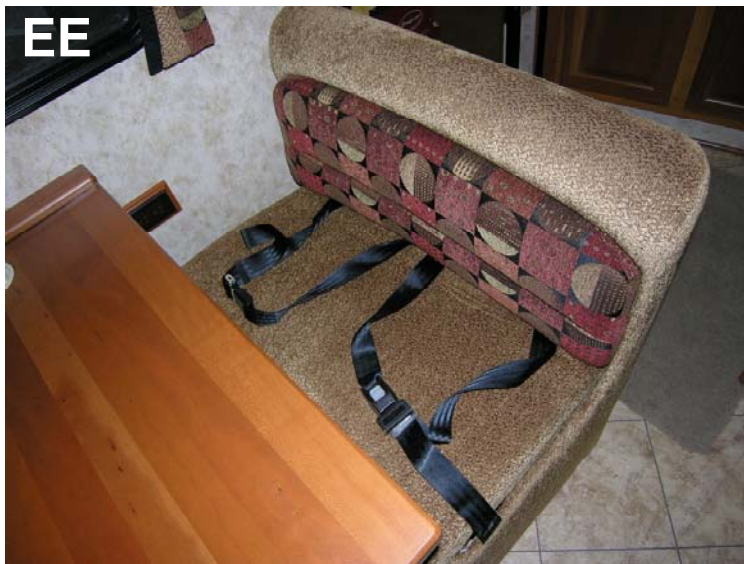
33. Lower dinette seat and reinstall seat back cushion, ensuring seat belts are accessible and ready for use. See Photo EE.
