Technical Bulletin

Section Title: Body, Cab, and Accessories
 TSB No. TS 06 10250

SUBJECT: SAFETY RECALL CAMPAIGN: SK, THE HEAD PORTION OF THE OUTSIDE MIRRORS BECOMING LOOSE.

MODEL(S): SX-4 (RW420)

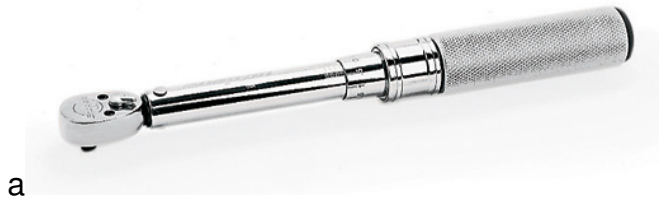
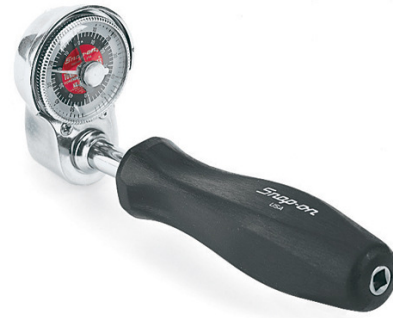
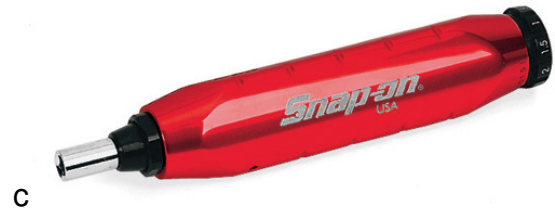
Acceptable Torque Tools:

(Snap-on Tools and stock numbers shown, equivalent tools from other manufacturers can also be used)

- a. (1) 1/4" drive Torque wrench 10-50 in. lb. (Stock # QD1R50)
- (2) 1/4" drive Torque wrench 40-200 in. lb. (Stock # QD1R200)
- b. Torqometer (Stock # TQSC4FUA)
- c. Torque Screwdriver (Stock # QDRIVER4)
- d. #2 Phillips 1/4"drive socket (Stock # TMP22E)

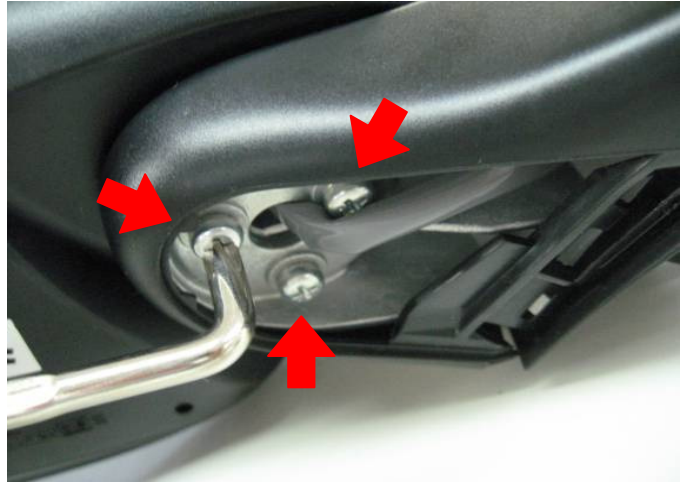
8. Using the #2 phillips screwdriver, **one at a time, remove and replace the three (3) screws that secure the head portion to the mounting arm**, with new screws pre-coated with adhesive (thread lock), making sure that the screws are tight.

**Prescribed tightening torque: 3.4 to 3.9 Nm
30 to 35 lbf-in**

CAUSE: Due to the absence of a pre-coated adhesive, known as thread lock on the three (3) mounting screws on the outside rear view mirror base, the screws may loosen and cause vibration of the mirror itself resulting in decreased visibility performance and increasing the risk of a crash.

CORRECTION: DO NOT replace the Mirror assembly! Please remove the three screws that attach the head portion of each mirror, and replace them with the countermeasure parts.

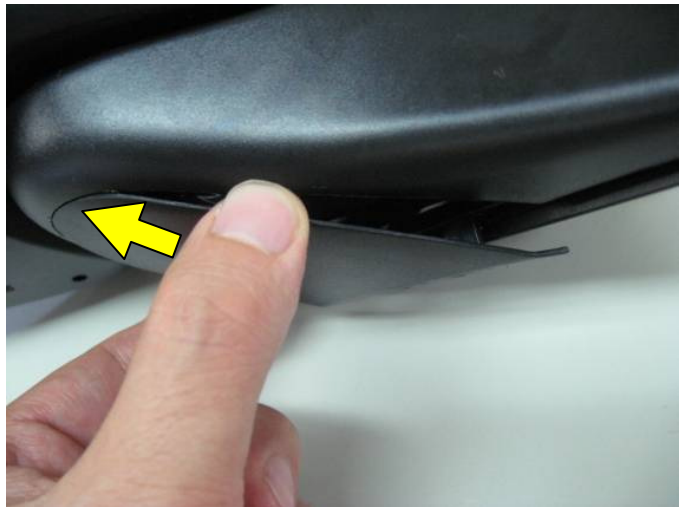
9. Reinstall the mirror base cover by first inserting the outer end, making sure to engage the tab inside the housing.

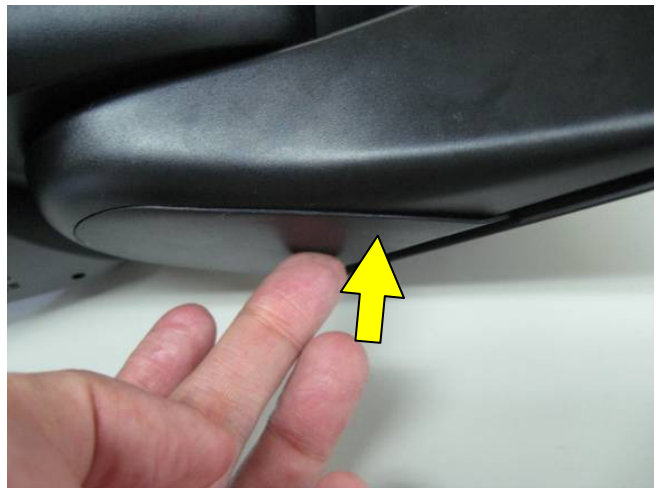
10. Once the outer end is properly in place, press upward on the inner side nearest the door, to snap in the retaining tabs.
