SERVICE ADVISORY # 10-152**Siemens and Murray Circuit Breaker**

Keystone is conducting a voluntary RECALL notification campaign in accordance with the National Highway Transportation and Safety Act. It has been decided the Siemens and Murray one inch plug-in circuit breakers, single pole 15 and 20 amp and double pole 50 amp with a June 2010 date code "0610" or July 2010 date code "0710", may have a non-conforming "spring clip" plug-in assembly that breaks or fails to provide sufficient force to maintain a proper electrical connection in the panel board. Over time, this condition could lead to excessive temperature, arcing or thermal damage at the connection point leading to an increased risk of fire.

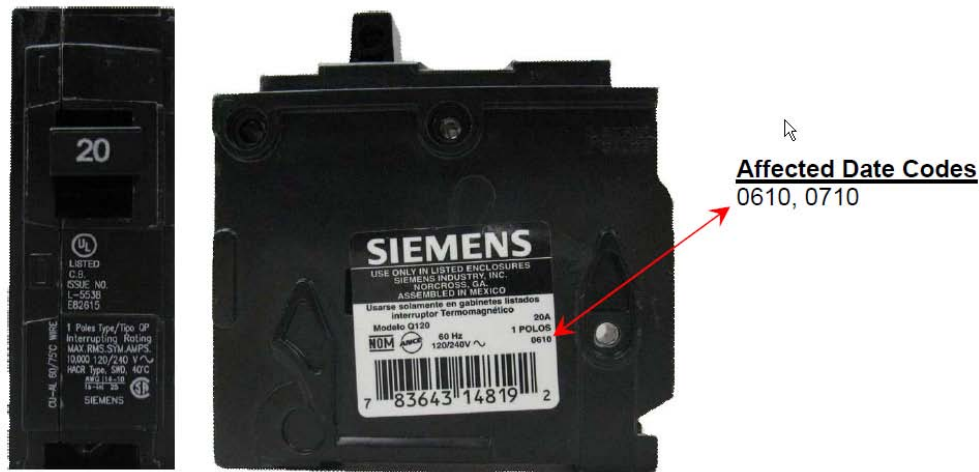
Fig.1

- Step 3** Remove all single 20 amp and double 50 amp breakers. Sprinter Only – Remove all single 15 amp breakers.
- Step 4** Inspect the breaker for the name “Siemens” or “Murray” and the date code “0610” or “0710” as shown in Figure 1 and replace if so found.

Breaker

- Step 5** If the breakers do not need to be replaced, reinstall them and file a claim for inspection only.
- Step 6** Reinstall the panel cover removed in Step 1.
- Step 7** Turn the generator breakers to the on position.
- Step 8** Reconnect other power sources as required.
