Applies To: 2007–08 Fit – ALL

January 7, 2011

Safety Recall: 2007–08 Fit Low Beam Headlights May Not Work

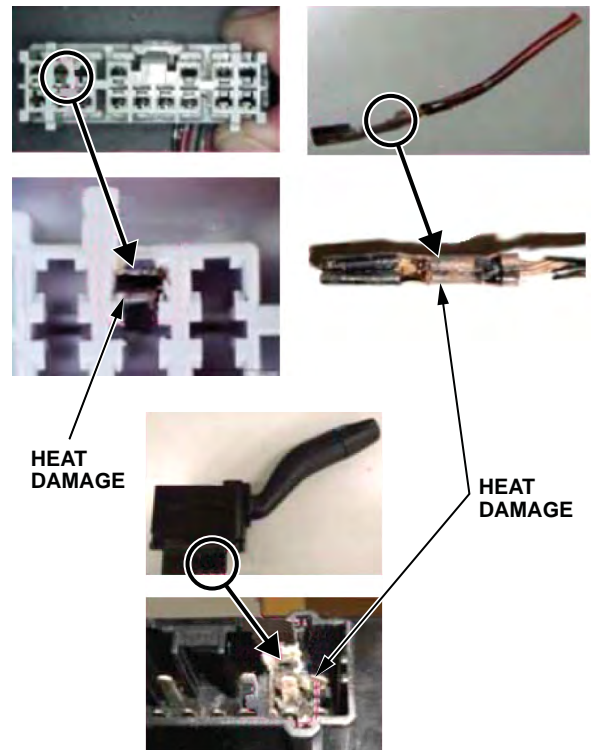
11. Using the photos below, check for signs of heat damage on the 16P connector, the terminal end of the RED/WHT wire, and the 16P terminals of the combination light switch.

- If you don't find any signs of heat damage, *retain the combination light switch* because you'll only be installing a Combination Light Switch Wire Kit. Go to step 14.
- If you do find signs of heat damage, *discard the combination light switch* because you'll be installing a Combination Light Switch Repair Kit. Go to step 12.
