**MOTOR COACH
INDUSTRIES**

SUBJECT: SAFETY RECALL OF DOGA WINDSHIELD WIPER MOTORS

Service Bulletin No. 344C

MODEL E / J Series Coaches	TYPE Field Change Program	SECTION/GROUP 3–Body	DATE Feb. 25, 2011
SUBJECT DOGA WINDSHIELD WIPER MOTOR			
CONDITIONS

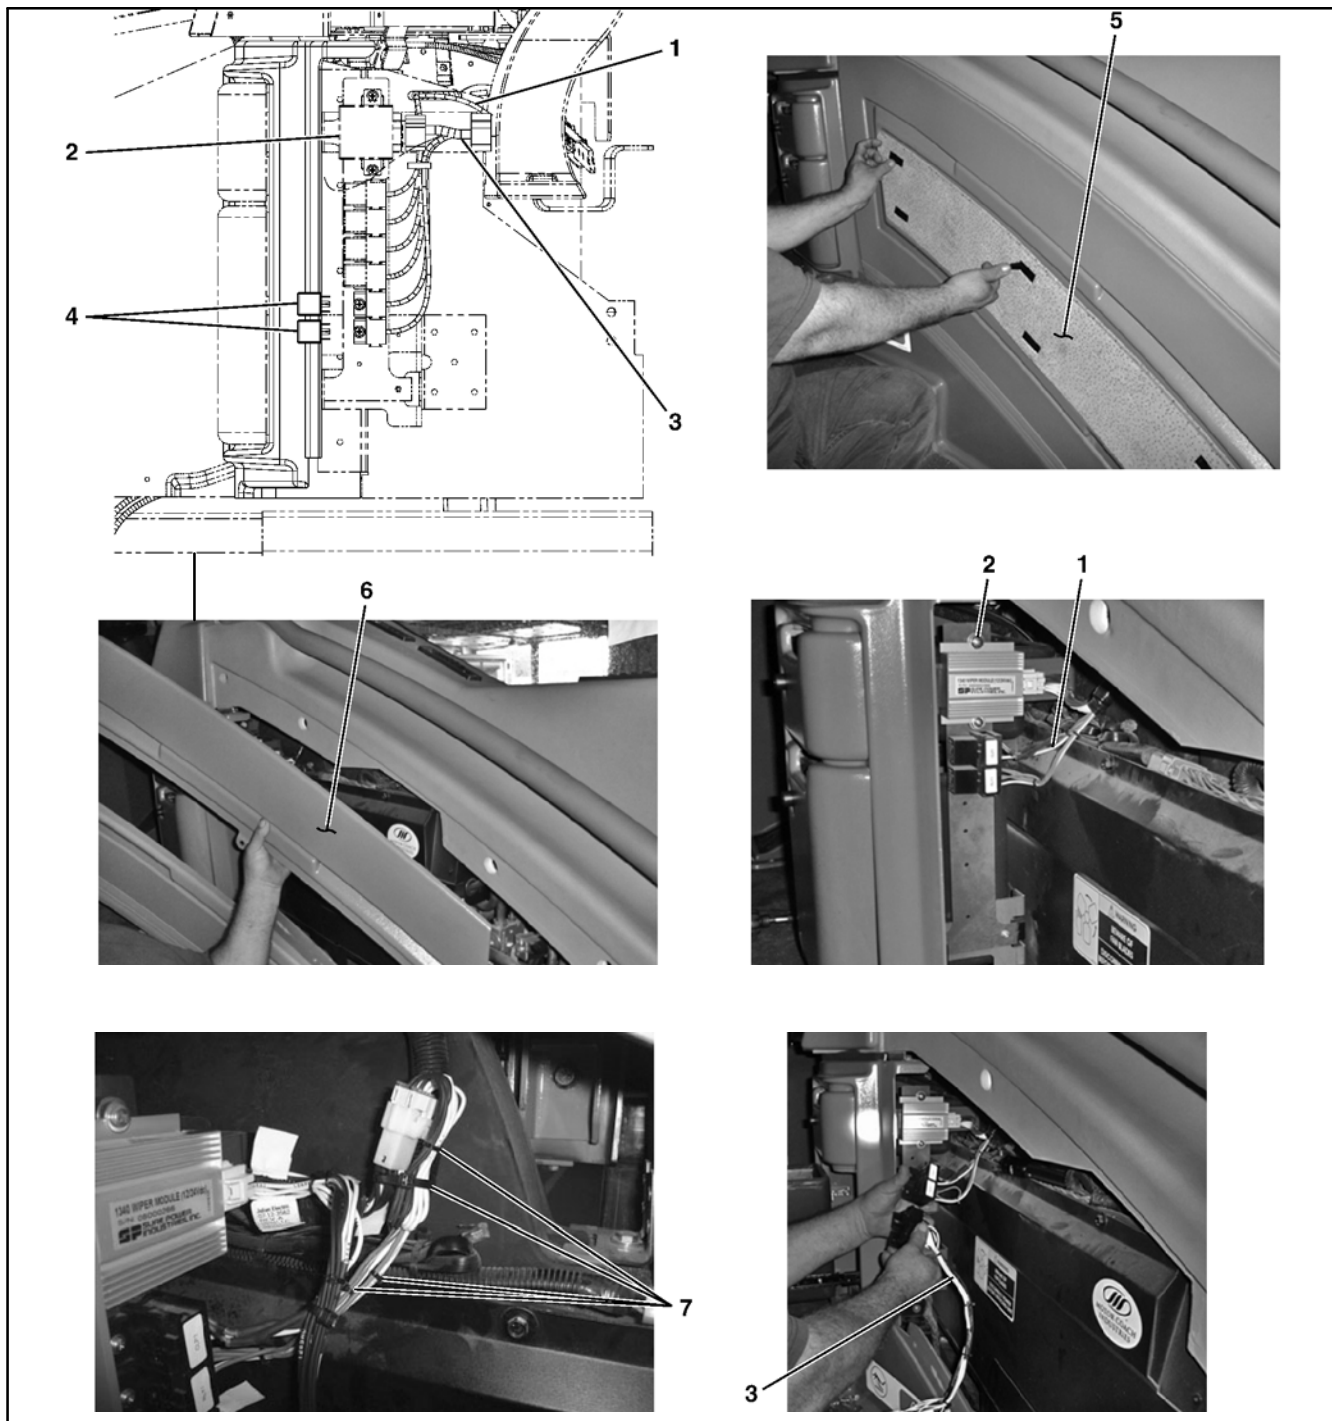
Figure 2. Relay Installation

ITEM	DESCRIPTION
1	Dash harness
2	Wiper controller
3	Wiper controller adapter harness
4	Relay, 24V
5	Fabric return air panel
6	Return air panel
7	Tyrap locations

8. Remove the fabric return air panel and the return air panel (refer to Figure 2).
9. Locate dash harness Plug X145 (J1R). Unplug Plug X145 (J1R) from the wiper controller (refer to Figure 2).
10. Connect the male adapter P145B of the wiper controller adapter harness, p/n 07-12-3664 to Plug X145 (J1R) of the dash harness.
11. Connect the female adapter P145A of the wiper controller adapter harness, p/n 07-12-3664 to the wiper controller. Secure to dash harness using tyrap, p/n 19-11-258.
12. Using the screw, p/n 19-1-696 and washer, p/n 19-2-7, install the relay base section of the wiper controller adapter harness. Install the two relays, p/n 7L-5-79, into the relay base.
13. Using the hardware removed in Step 8, secure the fabric return air panel and the return air panel. Proceed to the front of the coach.

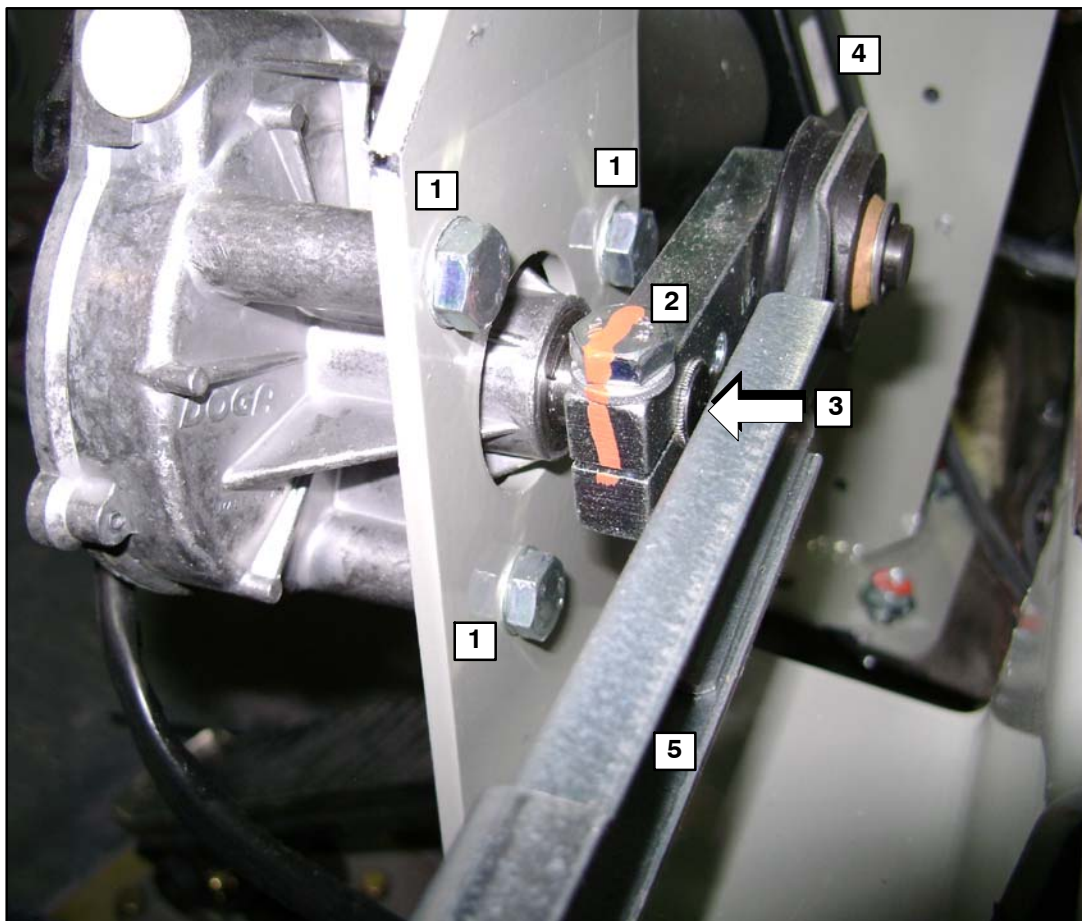
Figure 6. Rear View of Wiper Motor Installation

<u>ITEM</u>	<u>DESCRIPTION</u>
1	Wiper motor mounting bolts, Qty. 3
2	Wiper motor crank nut
3	Wiper motor shaft
4	Motor Linkage
5	Main wiper linkage

19. Locate the three wiper motor mounting bolts securing the wiper motor to the bracket (refer to Figure 6).
20. Loosen the wiper motor crank nut (refer to Figure 6).
21. Carefully push the linkage off the wiper motor shaft, Figure 6, ensuring no damage to the splines.
22. Using a 1/2" wrench or socket, remove and retain the three wiper motor mounting bolts (refer to Figure 6). Remove and discard the wiper motor.

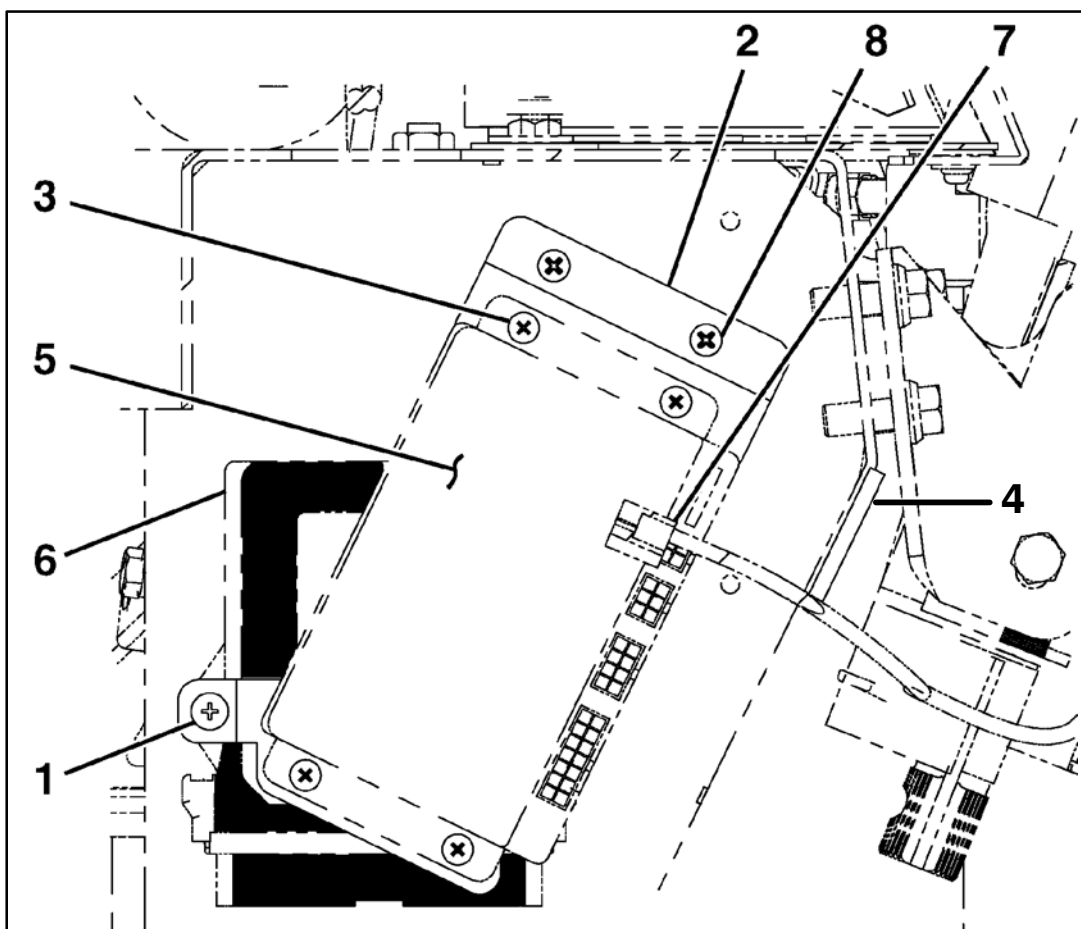
<u>ITEM</u>	<u>DESCRIPTION</u>
1	Bottom bracket assembly
2	Top bracket assembly
3	Screw, p/n 19-1-605
4	Trimlock
5	VIP controller
6	Pocket Gateway
7	Steer angle sensor harness connector
8	Screw, tapping, p/n 19-1-696

25. Disconnect the steer angle sensor (SAS) connector (refer to Figure 12).
26. Grab the dash foam hood assembly on both ends. Lift straight up to remove (refer to Figure 8). Place aside to be re-installed at a later step in this procedure.

32. Cut to length and install trimlock, p/n 21-7201-10, on bracket edge as shown in Figure 12.

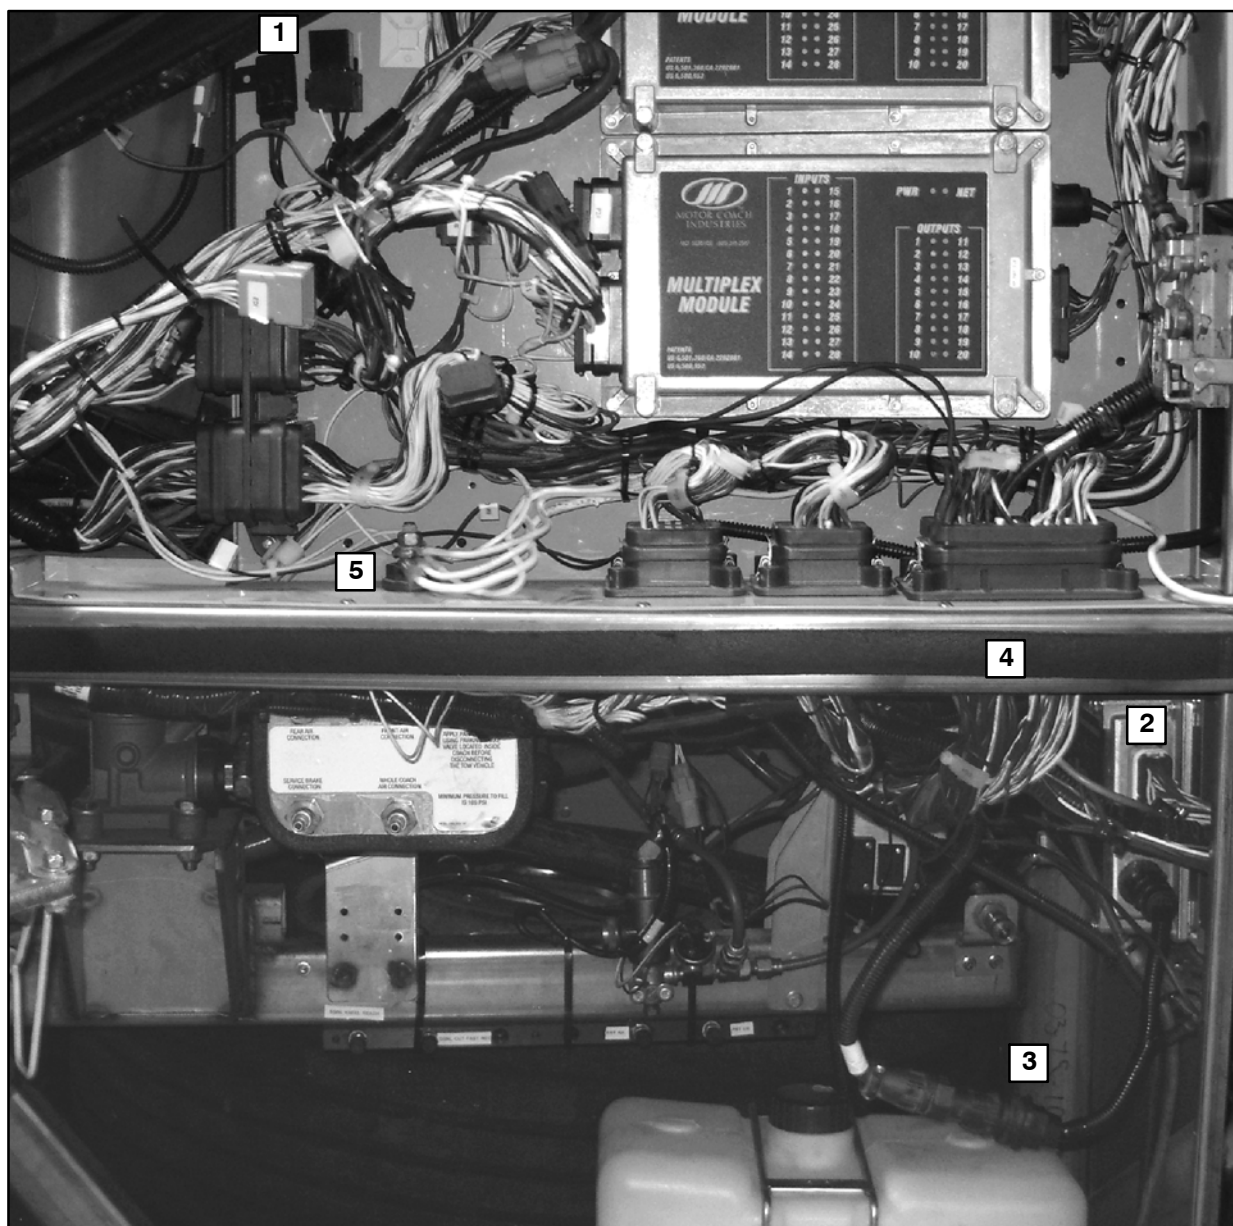
Figure 18. Front junction box and drag link compartments.

<u>ITEM</u>	<u>DESCRIPTION</u>
1	Adapter harness relay base and relay
2	PDM1
3	PDM1 Adapter Harness, p/n 07-12-3668
4	Plug 32 (Plug connections in both front junction box and drag link compartment)
5	Front junction box Ground stud

52. Connect ring terminal of wire 12441 onto Ground stud in the front junction box (refer to Figure 18).
