Subject: Safety Recall 9LG (Interim 92G) - Phase 3 - **Preliminary Notice**  
2008 Through Certain 2011 LX570 Vehicles  
Potential Floor Mat Interference with Accelerator Pedal

Safety Recall 9LG - Phase 3  
2008 Through Certain 2011 LX570 Vehicles  
Potential Floor Mat Interference with Accelerator Pedal Q&A  
February, 2011

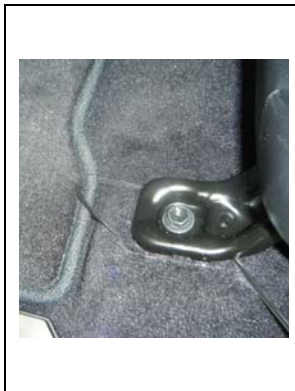
### 2. Locate, align & punch driver's floor mat.

- a) Align & punch directly in front of the driver's seat outboard mounting bracket in the location shown (see red circle in illustration).
- b) Punch the hole into the lower left driver's floor mat as indicated in step 2a. If necessary, enlarge the hole with a thin flat-head screwdriver.

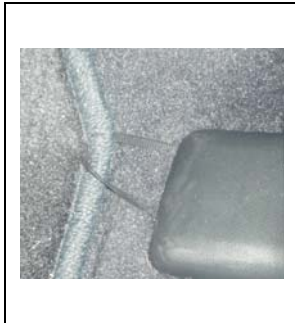
### 3. Route & fasten self-locking nylon tie-wraps.

**STOP** Self-locking nylon tie-wraps must be rated at 50 pounds minimum, be 0.19 inches wide and 17 inches long.

**Two tie-wraps to joined in series may be required to complete routing.**

- a) **Confirm clearance to electrical wiring connectors and any moving components.**
- b) Verify the self-locking nylon tie-wraps are not too loosely or too tightly fastened as illustrated.
- c) Verify the floor mat does not interfere with the accelerator pedal throughout its range of travel.
