## Federal Recall Information

11KWC

Kenworth Truck Company

T440 Quick Release Valve Missing

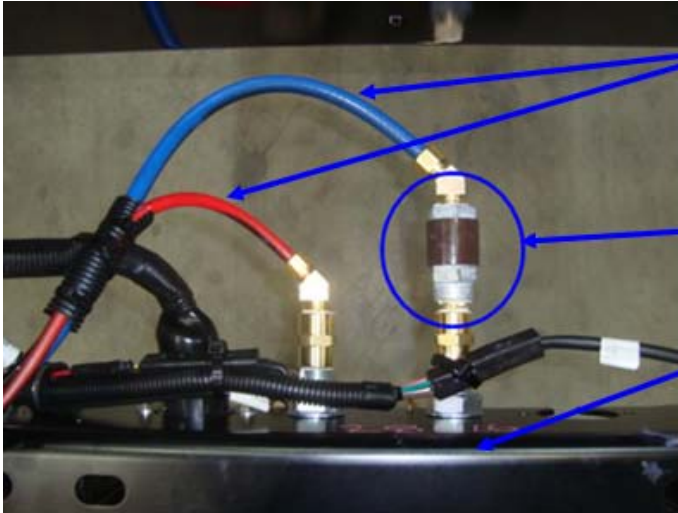
The quick release air valve required in the full truck service brake air line gladhand connection may have not been installed in certain vehicles (Ref. Figure 1). The absence of the quick release air valve may allow the full truck service brake air line gladhand release timing to exceed the threshold of 0.75 seconds failing to comply with the requirements of FMVSS 121.

Service And Emergency  
Brake Air Lines For Full  
Truck Gladhand Connections

Brown Valve Shown May  
Have Not Been Installed

End Of Frame Crossmember  
(Gladhands On Opposite Side  
Of Crossmember Not Shown)

The remedy of the recall will involve installation of the quick release air valve in the full truck service brake air line with gladhand connection as shown above in Fig. 1.

Install the quick release valve per Fig. 1 above.
