# Safety Recall

Code: 26G8

Subject: 2011-2012 Jetta Sedan (6<sup>th</sup> Generation)  
Accessory Exhaust Tips

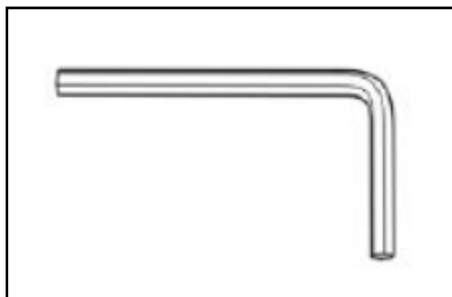
- 4mm hex key

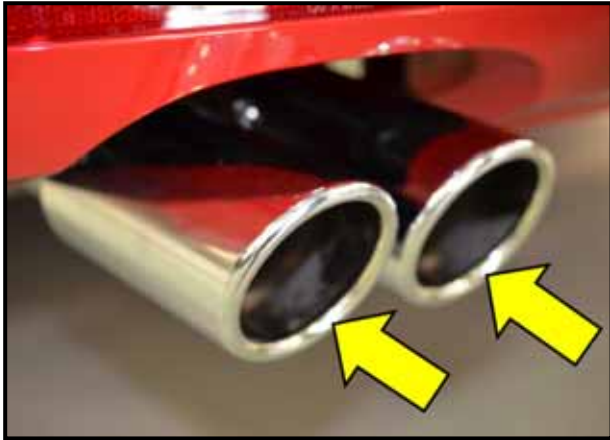
### Section A – Exhaust Tip Inspection

- ⇐ Inspect for presence of chrome exhaust tips <arrows>
- If chrome exhaust tips <arrows> are present, continue to Section B to remove exhaust tips
- If chrome exhaust tips <arrows> are NOT present, continue to Section C to install campaign label

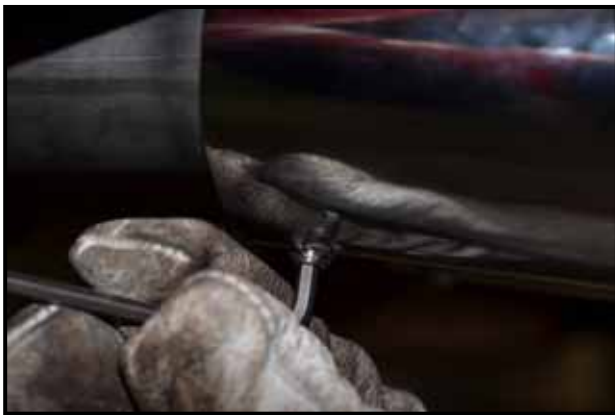
### Section B – Exhaust Tip Removal

- ⇐ Using a 4mm hex key, remove all three set screws from both exhaust tips, then remove exhaust tips from vehicle
- Continue to Section C
