**Lexus Division**  
**Toyota Motor Sales, U.S.A., Inc.**  
 19001 South Western Avenue  
 P.O. Box 2991  
 Torrance, CA 90509-2991

**2004 – Early 2007 Model Year RX330/350/400h  
 Floor Carpet Cover and Retaining Clips  
 Safety Recall Notice (*Interim Notice*)**

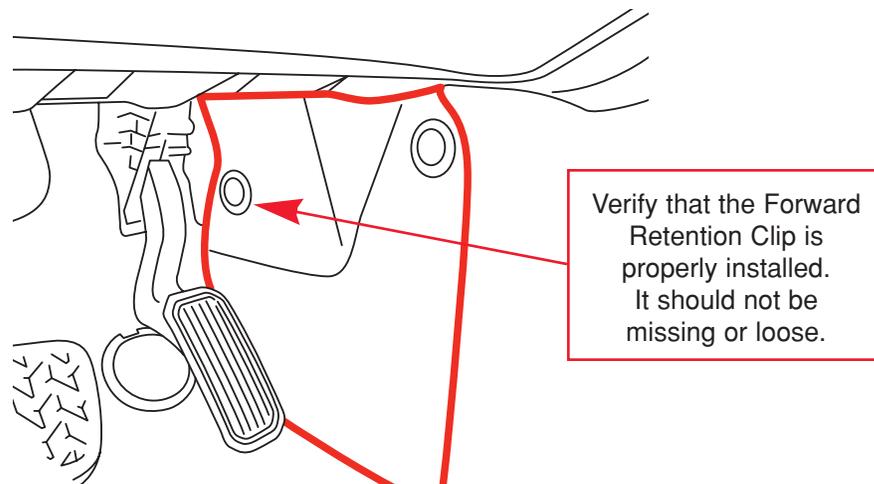
In 2004 through early 2007 model year RX330/350/400h vehicles, if the forward retention clip used to secure the driver's side Floor Carpet Cover, which is located in front of the center console, is not installed properly, the cover may lean toward the accelerator pedal and interfere with the accelerator pedal arm. If this occurs, the accelerator pedal may temporarily become stuck in a partially depressed position rather than return to the idle position. An accelerator pedal temporarily stuck in a partially depressed position may increase the risk of a crash.

- If your vehicle exhibits the condition described above, please contact any Lexus dealer for diagnosis and appropriate repair. The inspection and if necessary repair will be performed at **no charge** to you.
- Until the remedy parts are available, you may minimize the possibility of this condition occurring by verifying that the forward Retention Clip is properly installed and the Floor Carpet Cover is not leaning. The location of the forward retention clip is depicted in the diagram. If you are not comfortable conducting the inspection, any Lexus dealer will be happy to perform the interim inspection at **no charge**.

Once the remedy parts are available, Lexus will replace the Floor Carpet Cover with one of a different shape as well as the forward and rear retention clips. ***Lexus will send a second owner notification when the replacement parts are ready and preparations are complete.***
