BLUE BIRD

R11TB

Engine Compartment Mounted Fuel Filter Hose Routing

Models Affected: 2009 through 2012 Model Year Blue Bird Vision buses with optional Engine Compartment Fuel Filter Features 4023313 and 4023314

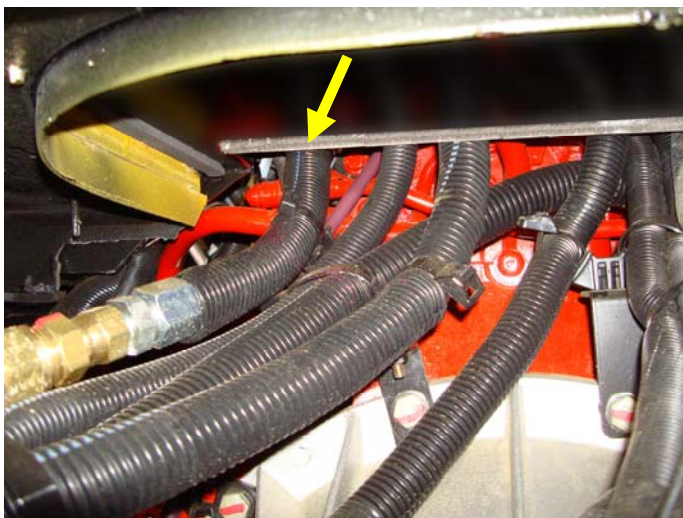
Fig. 1

Fuel hose may be in contact with transmission body access cover and other components in the engine compartment area.

1. Park bus on a level surface, apply parking brake, turn off engine, remove ignition key, chock wheels and disconnect battery when working under the vehicle.
2. Inspect the fuel lines for interference with the transmission body floor access cover on the left hand side of the vehicle, under the driver's seat, at the top of the transmission. Minimum of .25 inch clearance is required. (Fig. 1) This is also visible from above the engine.
3. If necessary, replace existing bracket with new bracket (00111133) behind the engine near top of transmission to lower fuel lines. Use existing fasteners and saddle with new tie straps provided to secure fuel lines. (Fig. 2)

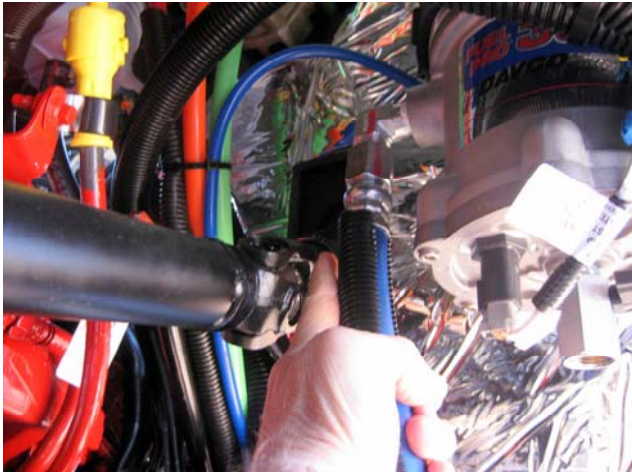
Fig. 3

With Feature 40233-13 FILTER,FUEL,DAVCO 382

4. Inspect fuel lines as they pass by the steering shaft then back to top of transmission. Adjust fuel hose if necessary so that there is a minimum of .50 inches clearance to steering shaft. Rotate hose toward driver control module, away from steering shaft knuckle. (Fig. 3)
5. Secure fuel hose in this area with tie strap to existing mount. (Fig. 4)

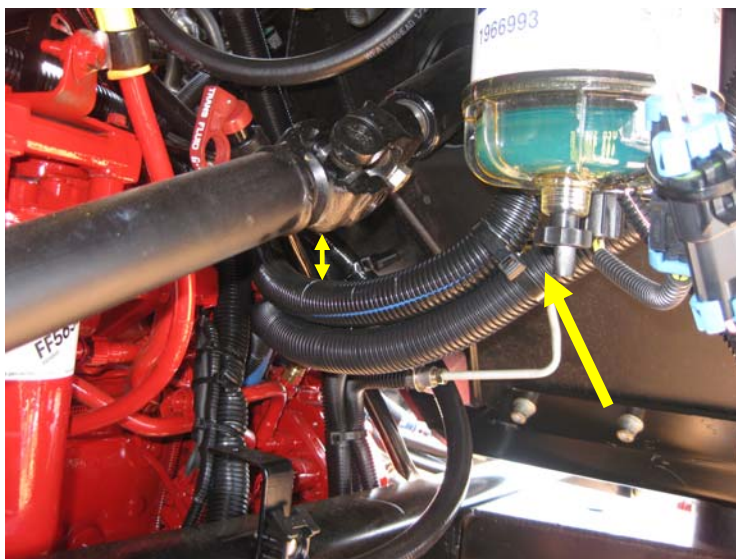
Fig. 5

With Feature 40233-14 FUEL FILTER,RELOCATE ON DCM

6. Inspect fuel line as it passes *under* the steering shaft then back to the top of the transmission.
7. Adjust fuel hose if necessary so that there is a minimum of .25 inches clearance to the steering shaft. Secure fuel hose in this area with tie straps (Fig. 5)

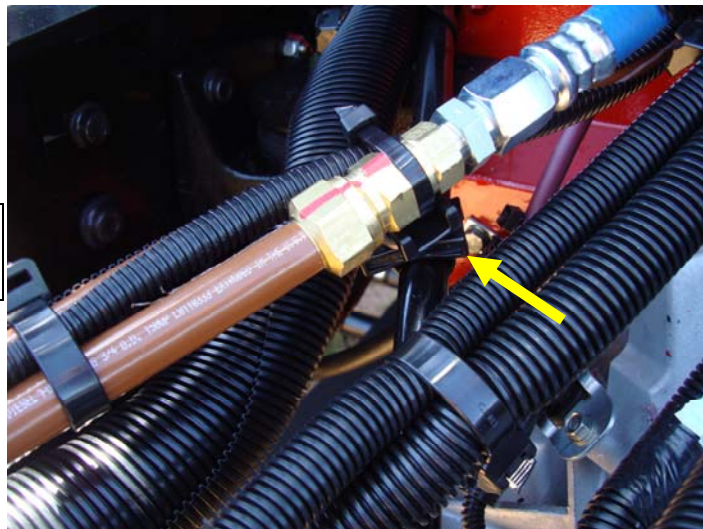
Fig. 8

This view shown from the top of the transmission for clarity.

8. Inspect and provide clearance between fuel line and air lines with swivel and tie straps. (Fig. 6)
9. Inspect and provide clearance between fuel line and both power steering lines with swivel and tie straps. (Only one shown in Fig. 7)
10. Inspect and provide clearance between fuel line and transmission dipstick tube above transmission. Secure fuel hose to dipstick tube with swivel and tie straps. (Fig. 8)
