SERVICE ADVISORY # 11-160

Montana, Big Sky LP Line Relocation

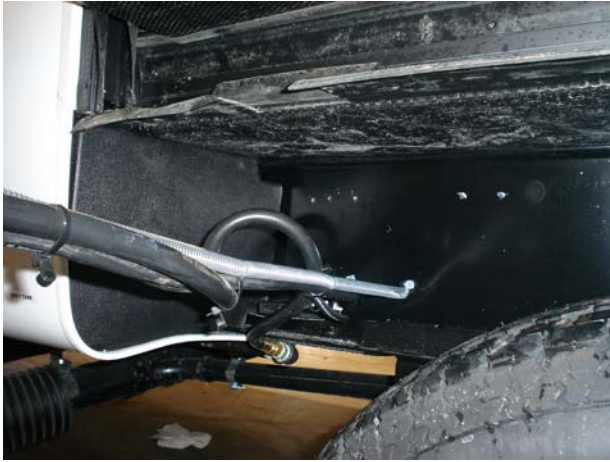
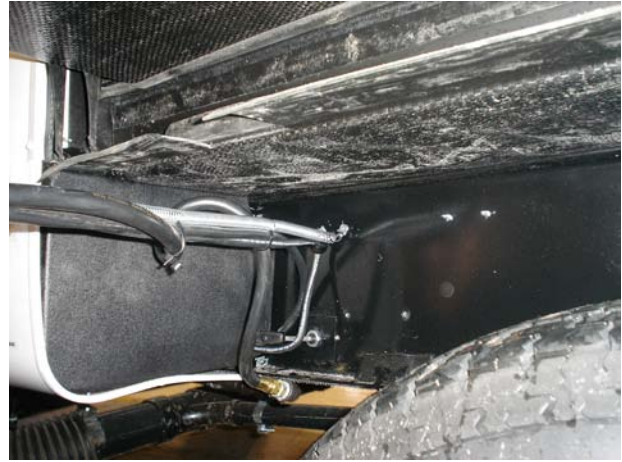
Keystone RV Company is conducting a voluntary RECALL notification campaign in accordance with the National Traffic and Motor Vehicle Safety Act. It has been determined that on some vehicles the LP line may become damaged as a result of contact with the tire. A propane leak, in the presence of an ignition source, could result in a fire and/or explosion causing property damage and/or personal injury.

- Step 1** Loosen the existing P clamps holding the LP hose, and electrical wire to the frame. Loosen the screw holding the spring to the frame. Reposition the LP line, electrical line, and spring tie down brackets up and to the front of the wheel well area. See figure 1& 2.
