**FMVSS 217 Emergency Exit Pushout Windows  
Non Compliance - Drivers Side Pushout Window(s)  
May Contact Rain Visor**

RECALL

**Models Affected: 2011 and 2012 Model Year All American (A3) and Vision Models that are Equipped with Pushout Window(s)**

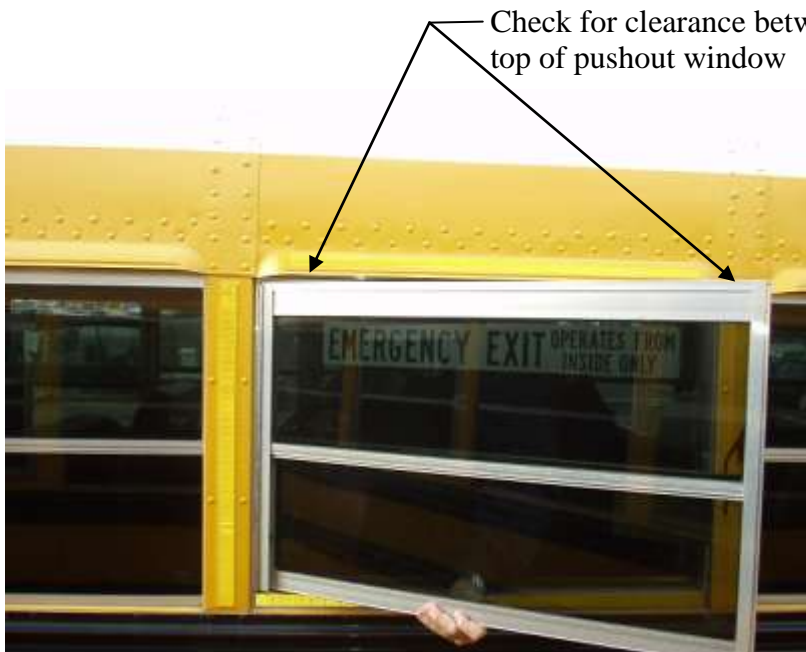
The emergency exit pushout windows on the left side of the bus may not meet FMVSS 217 window opening requirement because the window may contact and bind against rain visor when opening and closing window(s).

1. Park the bus on a level surface, apply parking brake, and remove ignition key.
2. On left side of bus (driver's side) only, open each pushout window to a full open position. If the rain visor contacts any of the top window area when opening the window to a full open position, proceed to repair procedure below. If there is no contact between the top of the window(s), no further action required.

1. Park the bus on a level surface, apply parking brake, and remove ignition key.
2. Open the window until the top of the window contacts the rain visor and mark visor.

3. Closed the window and grind the edge of the rain visor as required to provide a minimum of 1/16 (0.062) inch clearance between rain visor and top of window when opening and closing pushout window.
4. Touch up the edge with primer.
5. After the primer has dried, touch up the edge with touch up paint.
6. After all the windows have been inspected and/or corrected, place bus back in service.
