# Compliance Recall Circular

Code: 44J5

Subject: 2011 Touareg Hybrid  
Vehicle Certification Label  
**UNITED STATES ONLY**

**REVISED 04/21/2011**

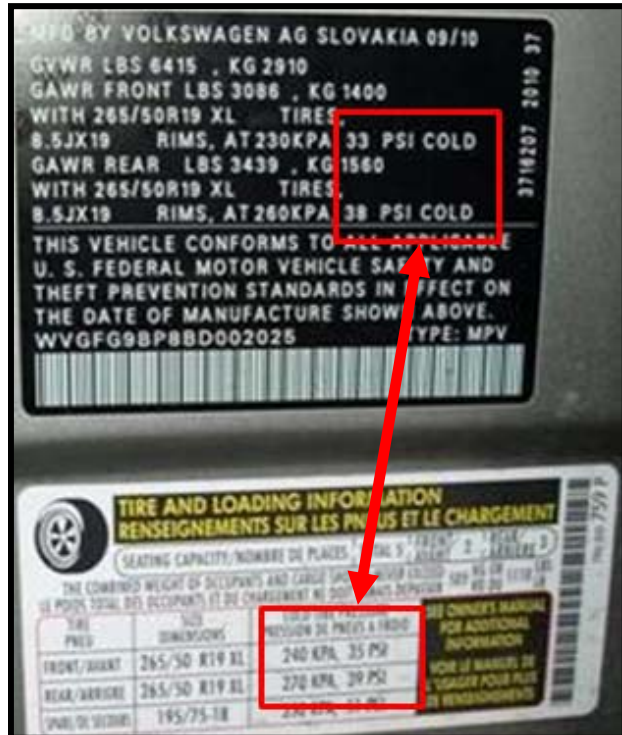
### Section A – Inspect for updated label

- Open driver side door
- Locate label in lower B Pillar
- ⇐ Compare the Front and Rear Tire pressure values on the “Vehicle Certification Label” and match the values on the “Tire and Loading Information Label”
- If the front and rear tire pressures DO NOT match between the labels continue to section B
- If the front and rear tire pressures DO match between the labels continue to section C

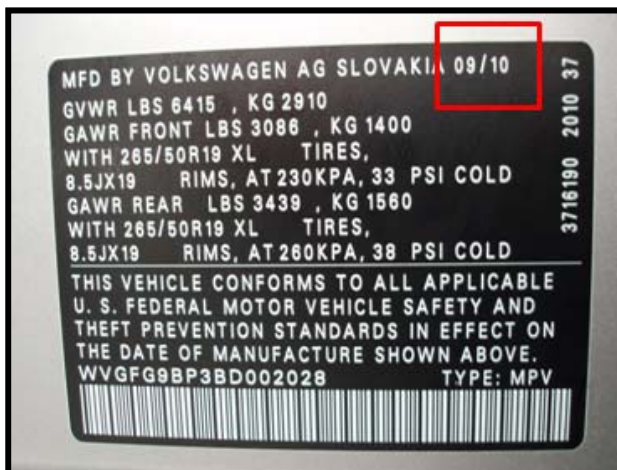
### Section B – Affix Overlay

- ⇐ Inspect overlay build Month / Year to ensure the existing label Month / Year is the same
- Clean the surface of the existing “Vehicle Certification Label”

Note: Surface of existing label must be clean, dry and free from oil residue

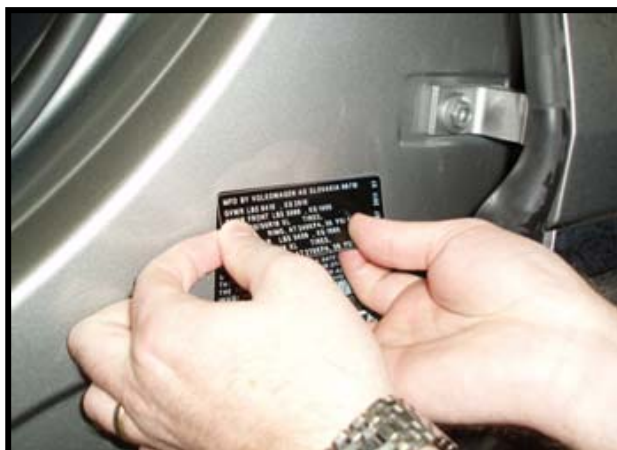
- ⇐ Affix the overlay over the existing label aligning the left and top edges of the labels. Ensure minimal air bubbles are created while installing the overlay
- Continue to Section C
