Compliance Recall Circular

Code: 44J5

**Subject: 2011 Touareg Hybrid
Vehicle Certification Label
UNITED STATES ONLY**

March 2011

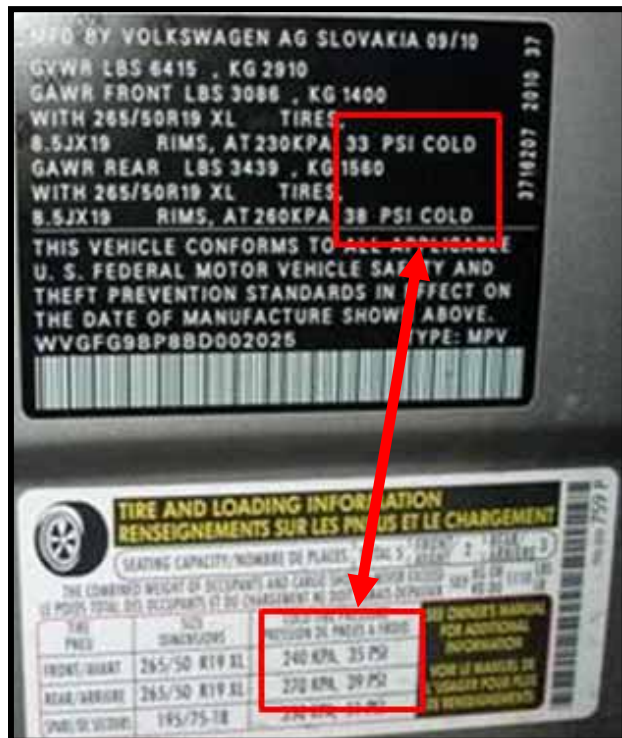
Section A – Inspect for updated label

- Open driver side door
- Locate label in lower B Pillar
- ⇐ Compare the Front and Rear Tire pressure values on the “Vehicle Certification Label” and match the values on the “Tire and Loading Information Label”
- If the front and rear tire pressures DO NOT match between the labels continue to section B
- If the front and rear tire pressures DO match between the labels continue to section C

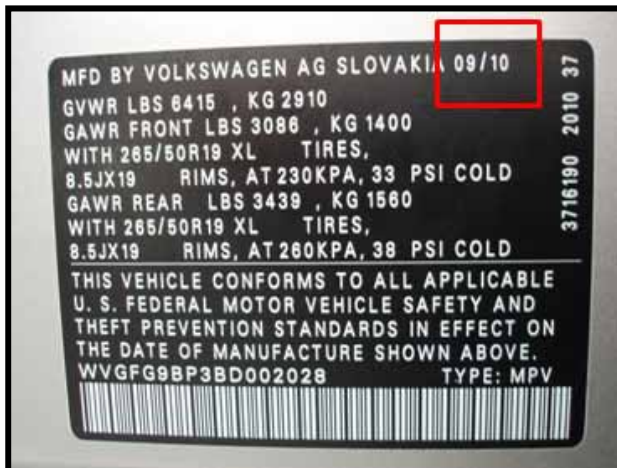
Section B – Affix Overlay

- ⇐ Inspect overlay build Month / Year to ensure the existing label Month / Year is the same
- Clean the surface of the existing “Vehicle Certification Label”

Note: Surface of existing label must be clean, dry and free from oil residue

- Peel the overlay off the backing paper

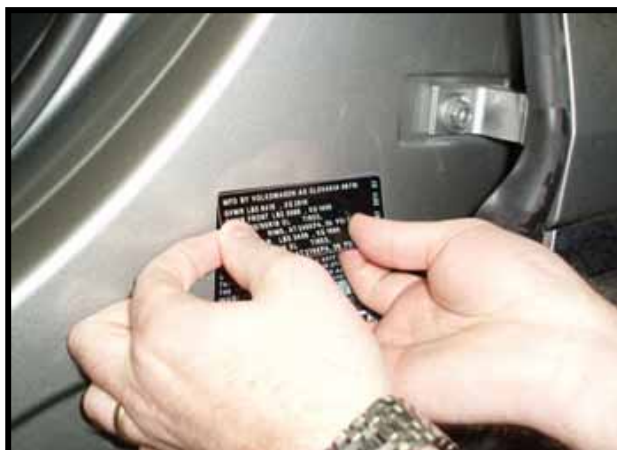
- ⇐ Affix the overlay over the existing label aligning the left and top edges of the labels. Ensure minimal air bubbles are created while installing the overlay
- Continue to Section C
