ITB11-039g

VOLUNTARY SAFETY RECALL CAMPAIGN 1997-2003 QX4 IN SALT STATES FRONT STRUT HOUSING CORROSION

CAMPAIGN ID #: R1109
NHTSA #: 11V-244
APPLIED VEHICLES: 1997- 2003 QX4 (JR50)

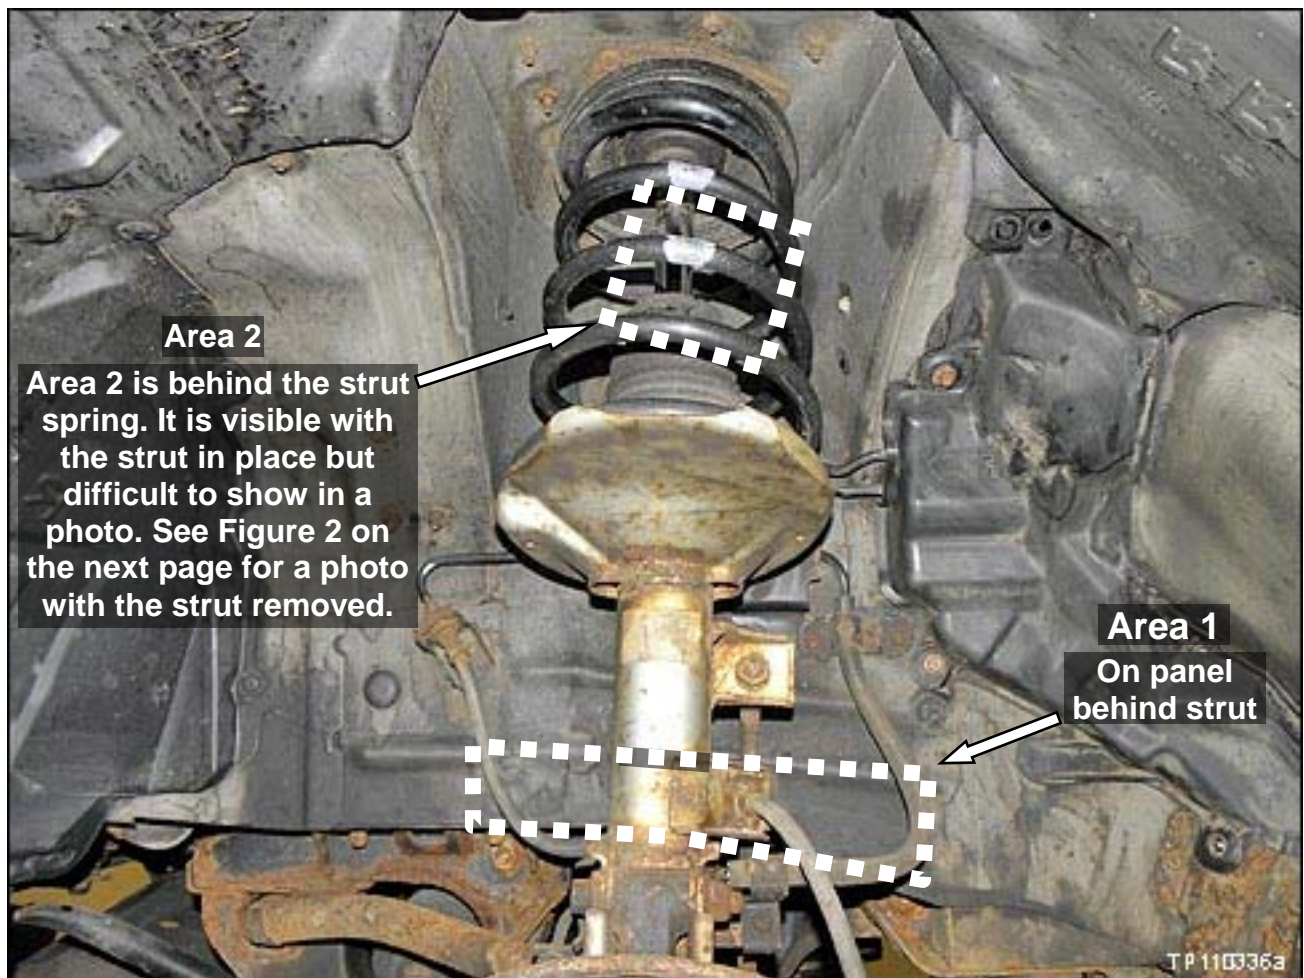
Figure 1

3. Inspect for corrosion on the driver side AND passenger side in the wheel house Area 1 and strut housing Area 2 (see Figures 1, 2, 3, and 4).

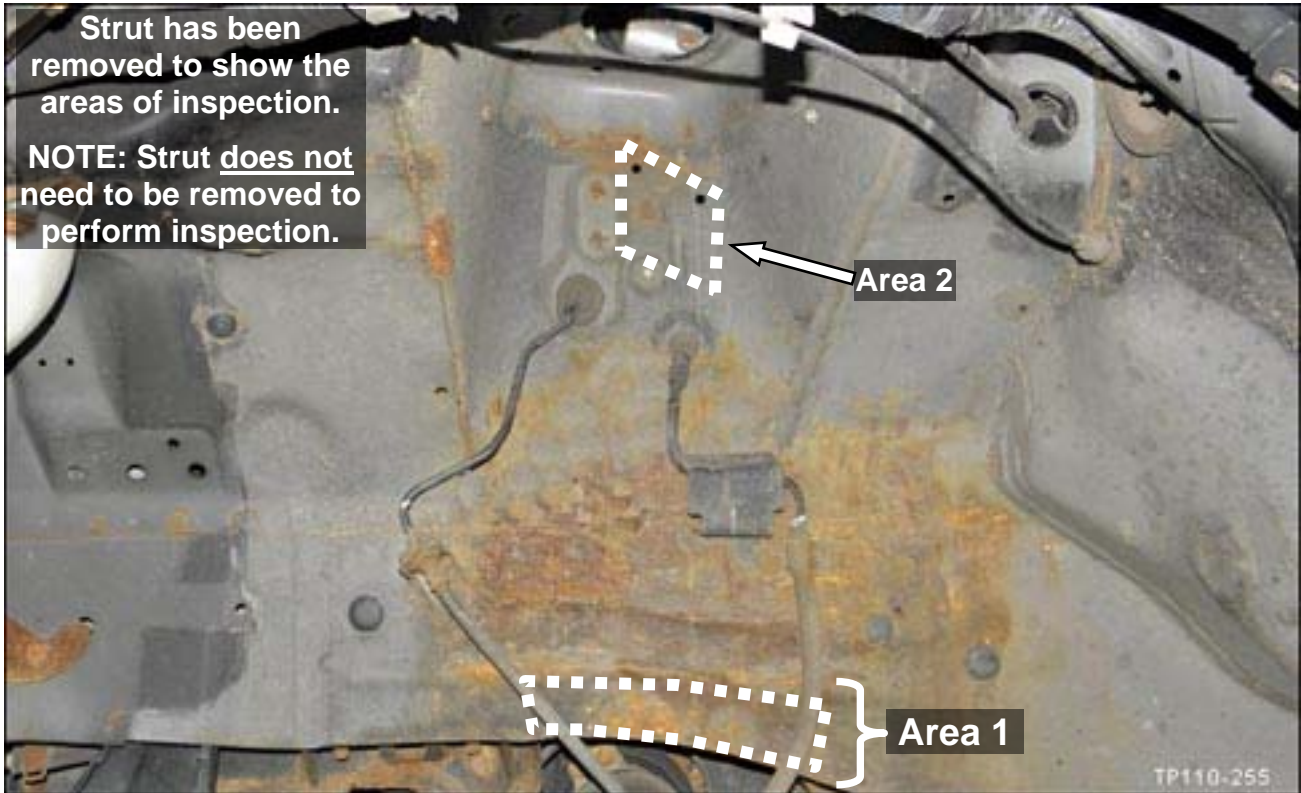
Figure 2

This example photo shows the inspection areas in relation to the repair bracket installation.

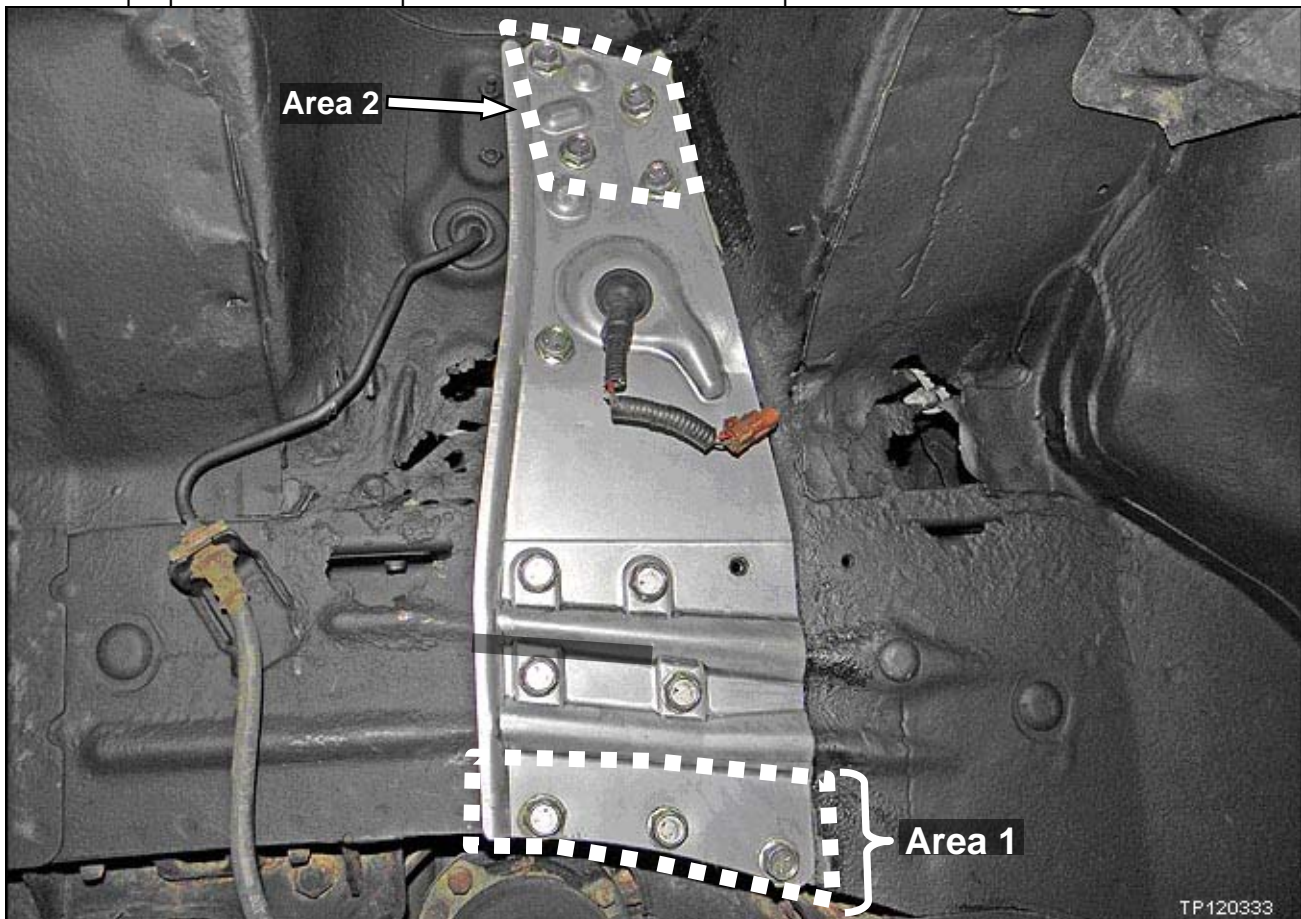
Figure 2A

Area 1

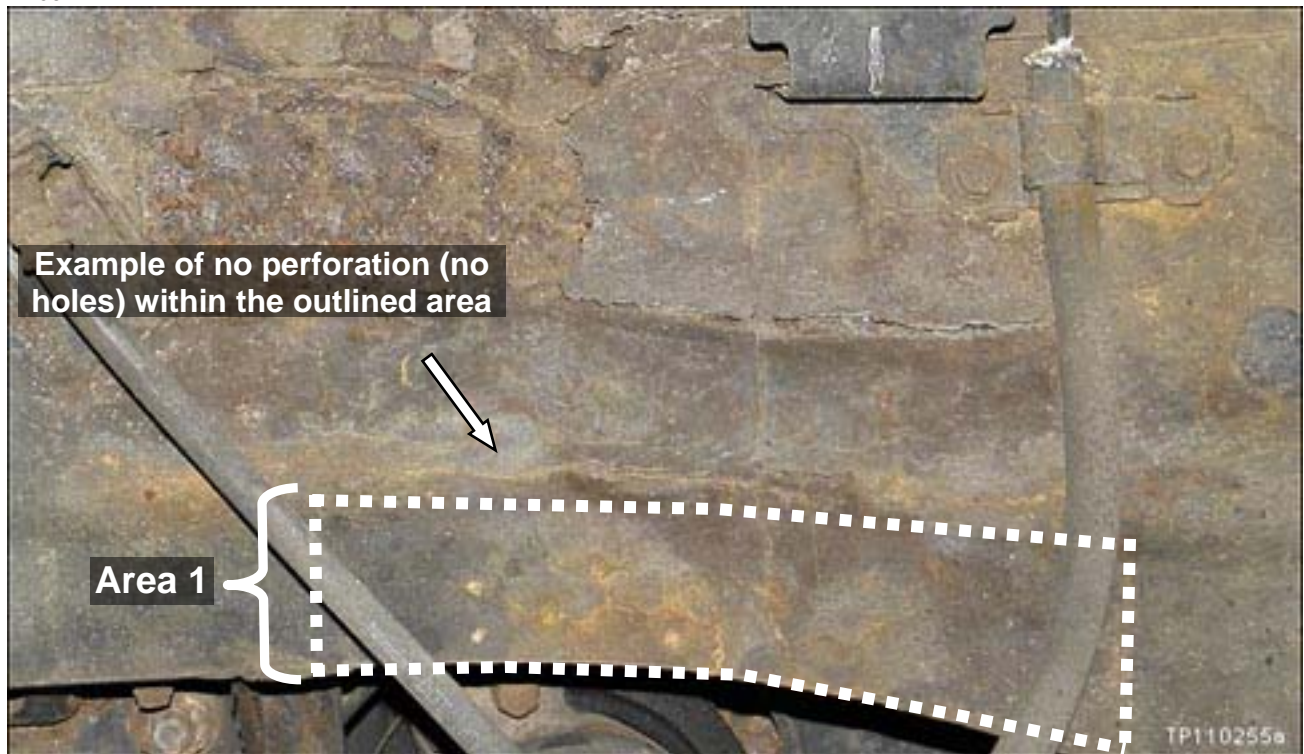
Figure 3

Area 1: Look for perforation (holes) in the metal only in the area outlined above.

- a. Retain the vehicle at the dealer. (The vehicle is not repairable.)
- b. Supply the customer with a rental car.
- c. Fax a completed Non-Repairable Report to Morley (see page 54).

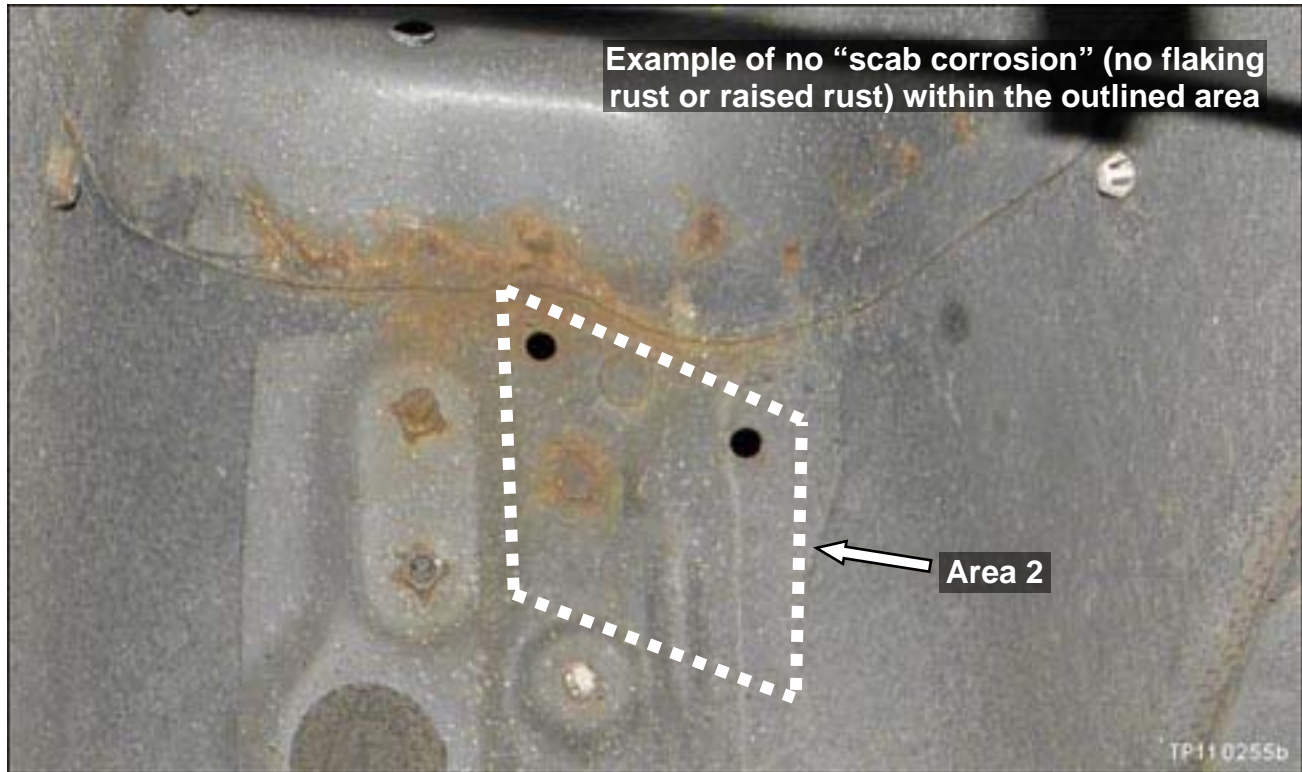
Area 2: Look for "scab corrosion" (flaking rust or raised rust) on driver side **AND** passenger side only in the area outlined above.

- The area shown in Figure 4 applies to driver side **AND** passenger side.
- If needed, refer to examples (additional photos) of Area 2 scab corrosion inspection on page 47.

- a. Retain the vehicle at the dealer. (The vehicle is not repairable.)
- b. Supply the customer with a rental car.
- c. Fax a completed Non-Repairable Report to Morley (see page 54).

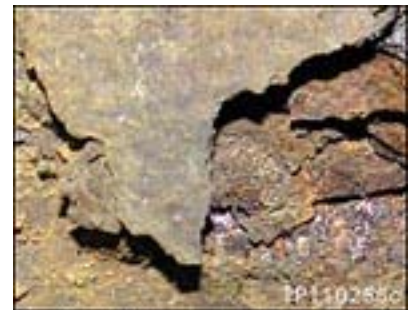
Figure 5 is an example of "scab corrosion" (flaking and raised rust).

If there is **scab corrosion** (flaking or raised rust) in Area 2, driver side **OR** passenger side:

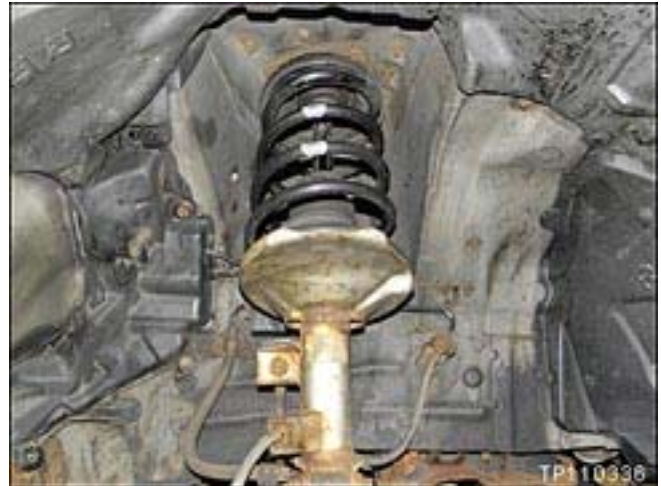
Figure 6

NOTE: Passenger side is shown, driver side is similar.

2. Visually inspect for corrosion and rust on the wheel housing panel and the strut housing panel (driver and passenger side).
 - Inspect for corrosion and rust on the panels only.

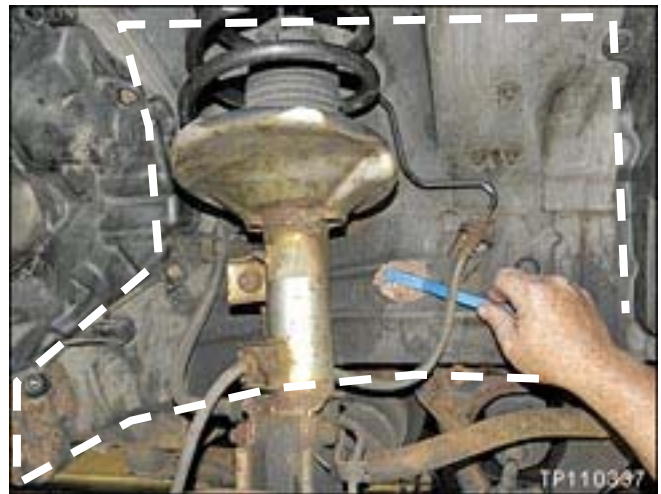
Figure 7

1. Use a wire brush to remove loose rust in the area shown with dashed line.

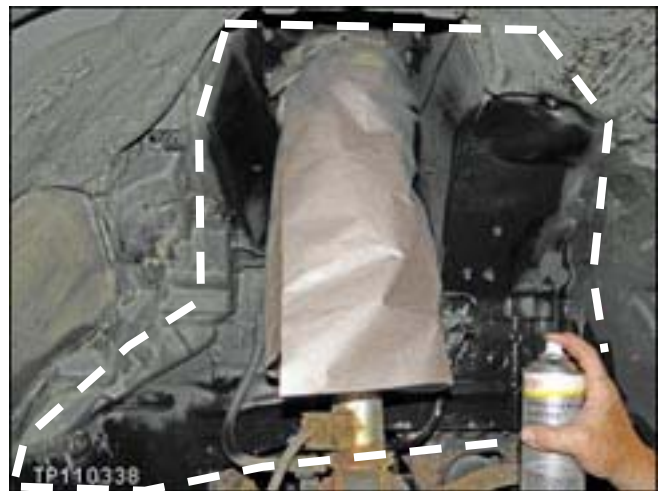
Figure 8

- Use DuPont Etch Primer (P/N A-4119S™) or equivalent.
- Follow all product instructions.
- Coat all of the exposed metal areas on the strut housing and wheel house panels.

- A second coat may be needed for heavy rust spots.
- Let each coat dry for 5 minutes.

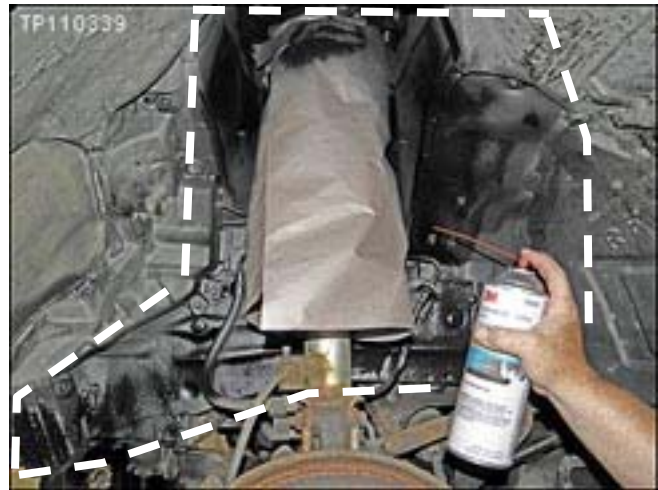
Figure 9

6. Let the undercoat dry for about 1 hour before removing the strut cover.

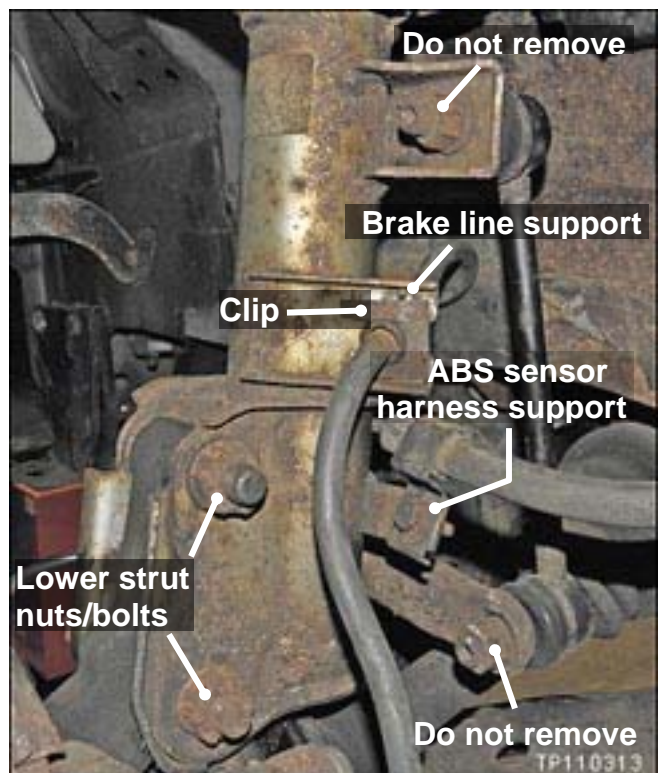
Figure SR2

2. Disconnect the following items:
 - Remove clip and take the brake hydraulic line loose from its support.
 - Discard the clip, use new clip for reassembly.
 - Remove the bolt for ABS sensor harness support.
 - Take the ABS sensor harness loose from support on the other side of strut (not shown).
 - Remove the lower strut bolts.
 - Discard the nuts, use new ones for reassembly.

NOTE: Do not remove the nuts from the stabilizer connecting rod.

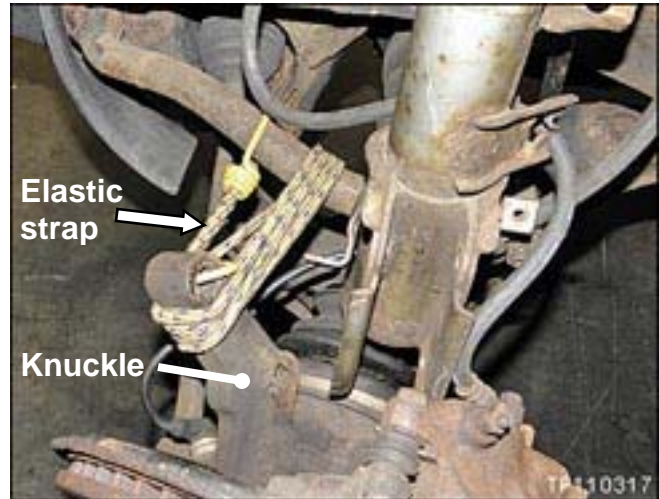
Figure SR3

3. **Carefully** separate the knuckle from the strut.

NOTE: Do not let the knuckle fall away from the strut. This will cause the weight of the knuckle assembly to pull on the brake line and the driveshaft boot (if equipped).

NOTE: Make sure the knuckle assembly is secure. Its weight must be supported during the entire repair process.

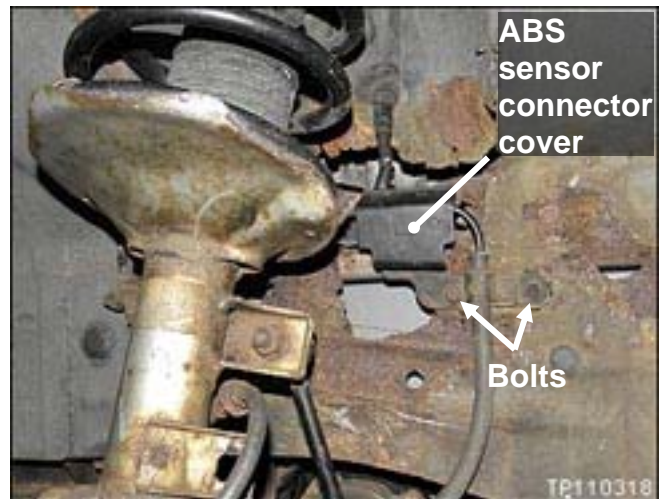
Figure SR4

5. Remove the 2 bolts for the ABS sensor connector cover.

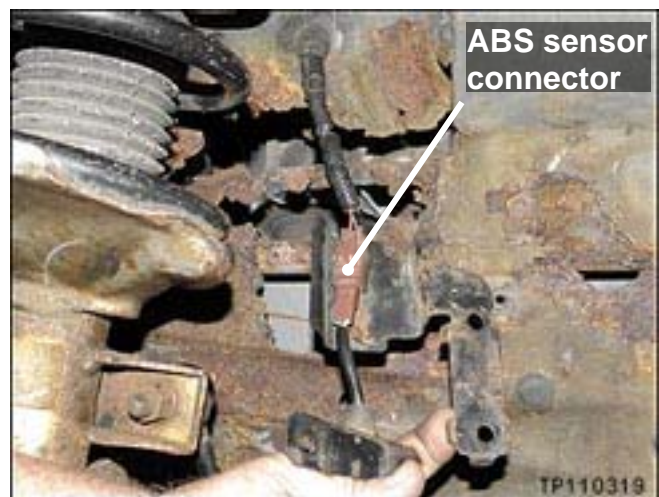
Figure SR5

6. Disconnect the ABS sensor connector.

- ABS sensor connector is on the back side of the cover.

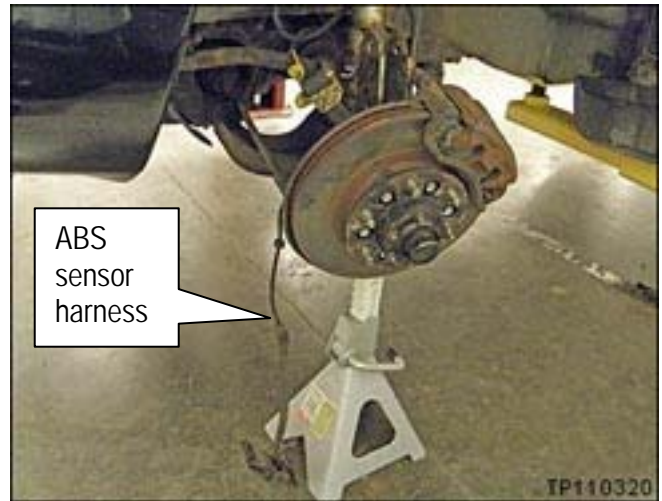
Figure SR6

7. Pull the ABS sensor harness from behind the strut.

8. Let the ABS sensor harness hang out of the way as shown.

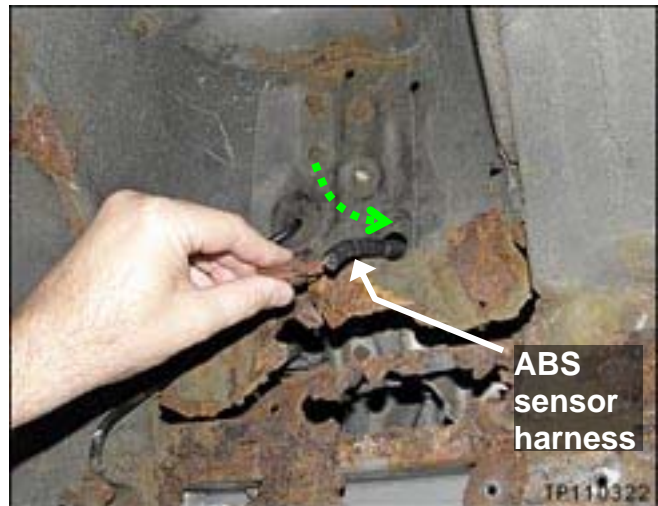
Figure RB1

1. Inspect the ABS sensor harness for damage. If damaged, repair as necessary.
2. Push the ABS harness and connector through the panel.
 - The harness/connector will now be out of the working area.

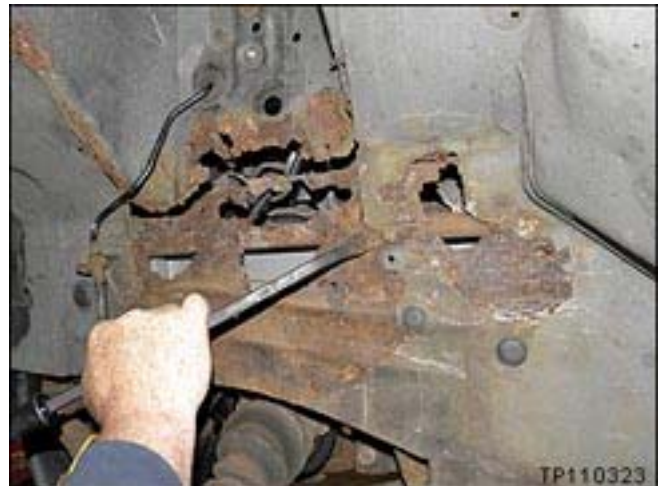
Figure RB2

3. Use a scraper bar to scrape off loose flaking rust and corrosion.

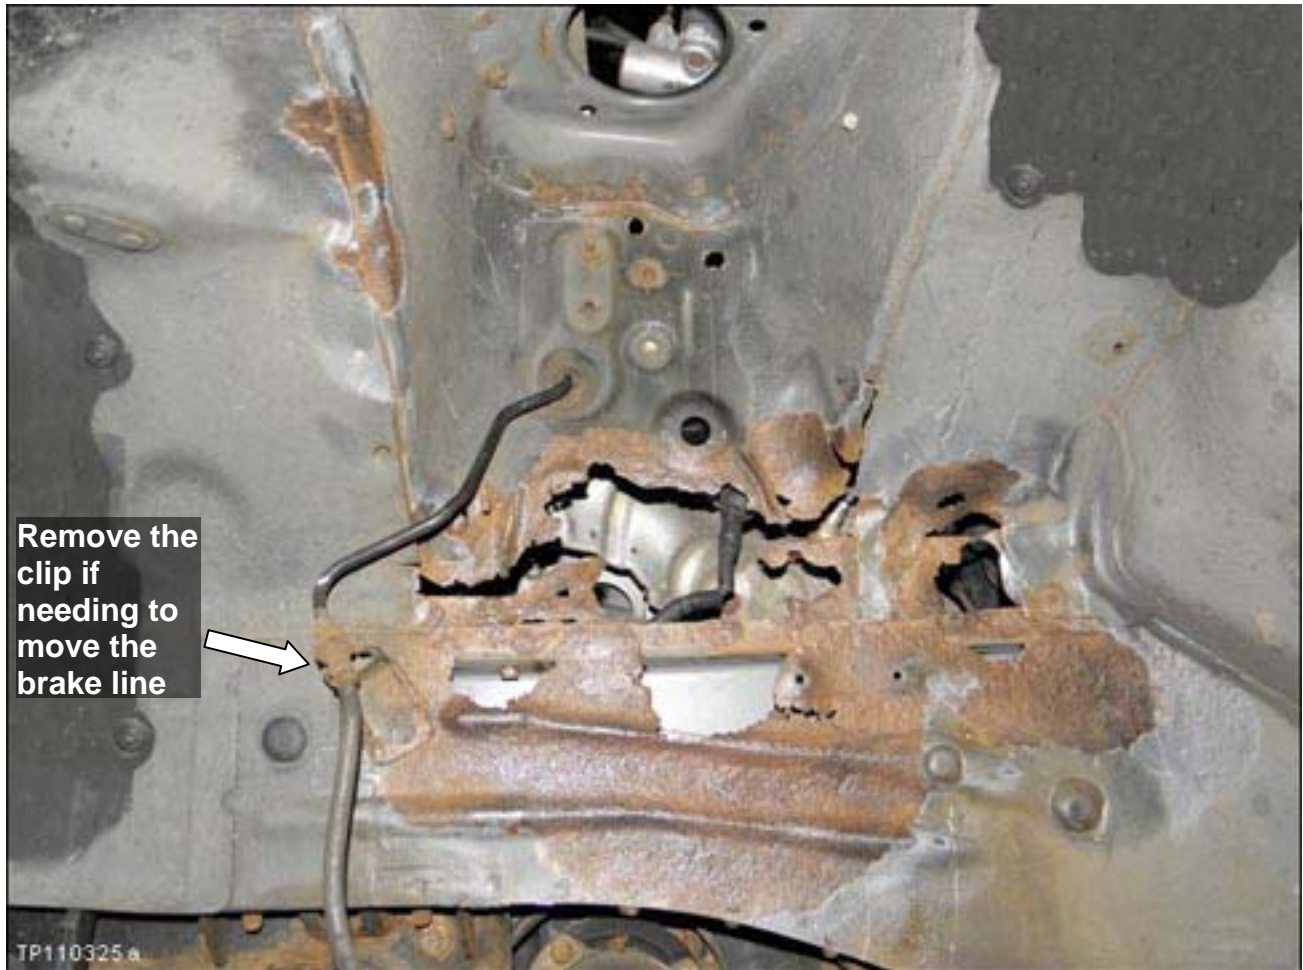
Figure RB3

4. Clean all the loose rust from the strut housing and wheel house areas (see Figure RB3).

NOTE: If the brake line is in the way of an area that needs cleaning, move it out of the way by first removing the clip from the mount.

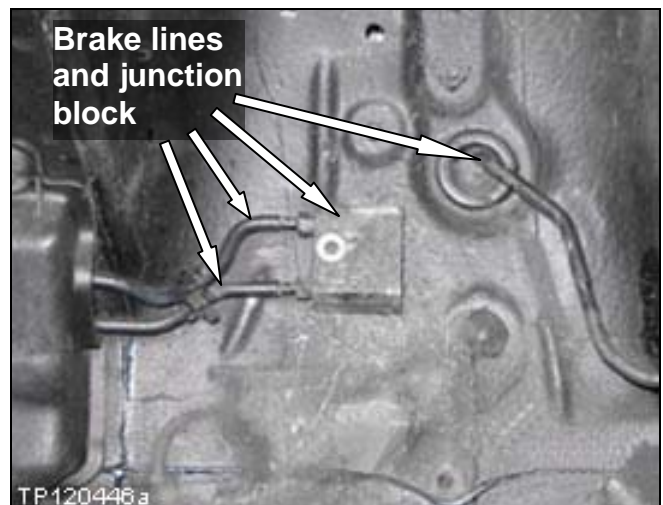
Figure RB4

4a. Passenger side: work around the 2 brake lines and junction block best as possible (see Figure RB4).

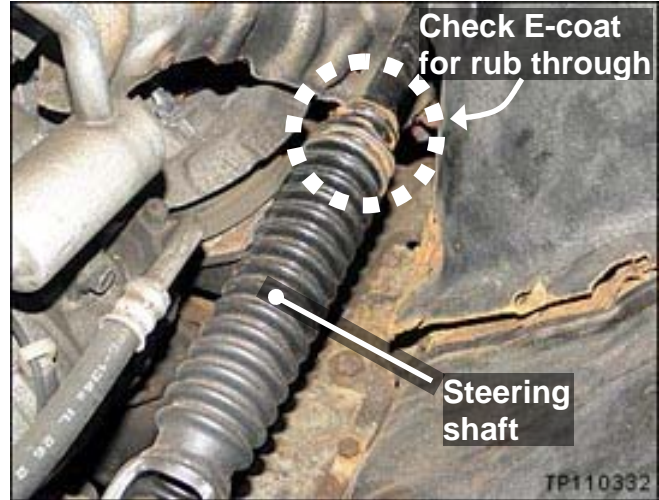
Figure RB5

- **ONLY if the E-coat has been rubbed through to bare metal**, the steering shaft will need to be replaced.
- If the steering shaft needs replacement, you will be instructed to replace it later in this procedure.

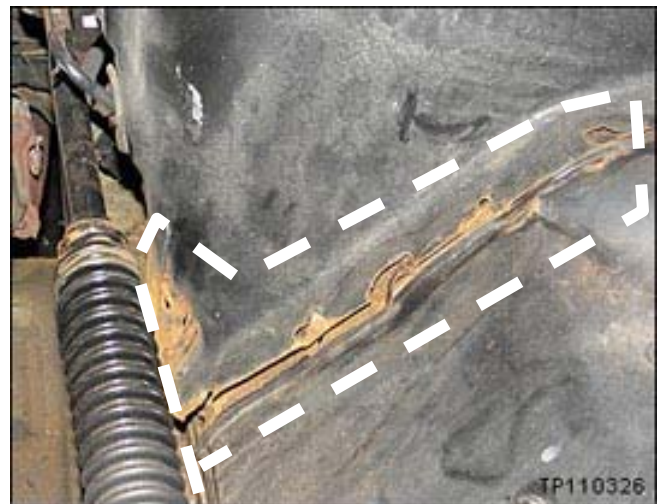
Figure RB6

Use a wire brush to clean any loose rust, paint, or other debris from the area shown with dashed line.

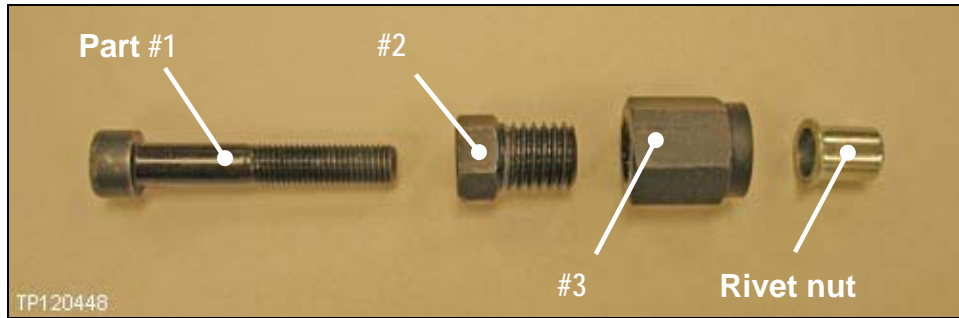
RB13 – Rivet Tool

NOTE: Rivet Tool J-50835 comes with extreme pressure lubricant. Apply to the threads and contact points of part #2 and part #3 for approximately every 60 rivet nuts installed (enough for 15 brackets).

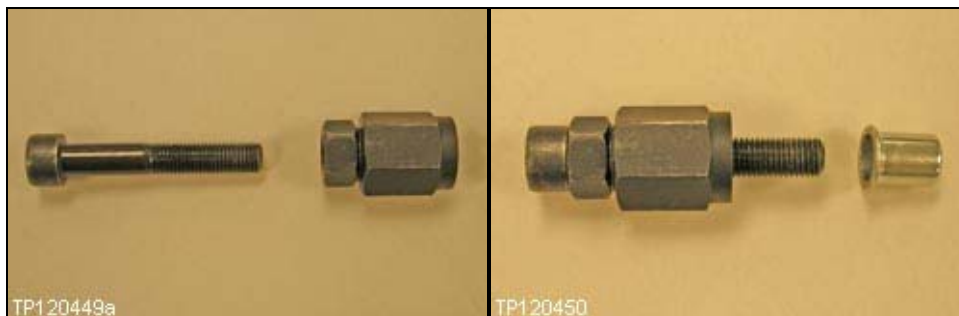
Figure RB14

1. Thread no more than finger tight part #2 into part #3 until it bottoms out (see Figure RB14).
 - This is a left handed thread.
2. Insert part #1 through part #2 and part #3 (see Figure RB15).

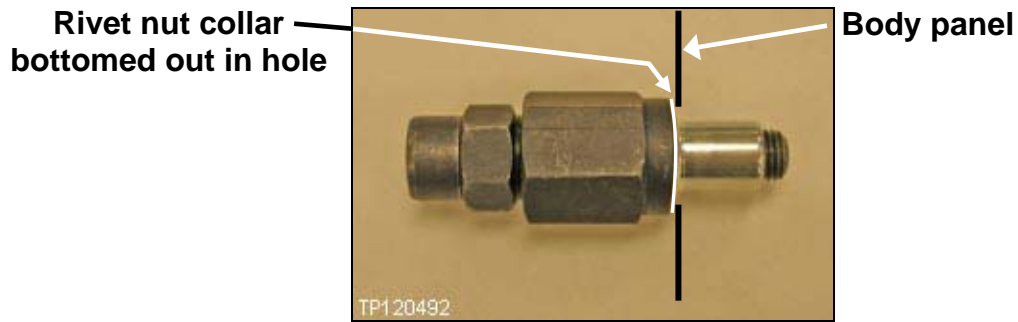
Figure RB17

4. Insert the rivet nut into the 13.1 mm (33/64 in) hole until it bottoms out on its collar.

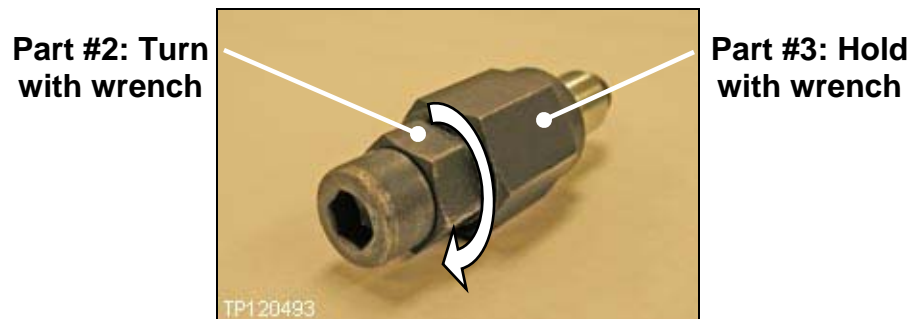
Figure RB18

5. Install the rivet nut by performing the following:
 - a. Hold the rivet nut and tool against the body panel with moderate pressure.
 - b. Hold stationary part #3 while turning part #2 clockwise.
 - c. Turn part #2 approximately 2 turns or until turning resistance increases.
 - At this point, the rivet nut is installed.

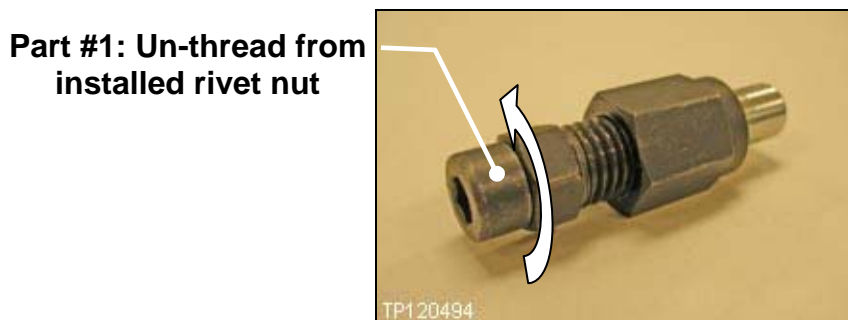
Figure RB19

- d. Un-thread part #1 from the rivet nut.

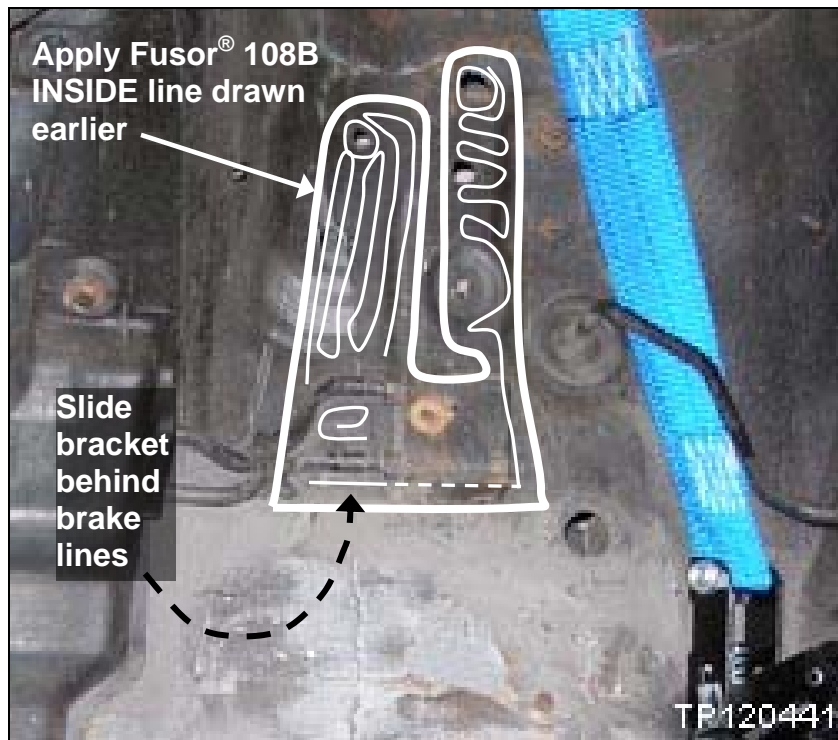
RB24 – Passenger side

27. Passenger side: Liberally apply Fusor® 108B on the strut housing area within the white line drawn earlier (see page 24, step 20, and Figure RB24 below).

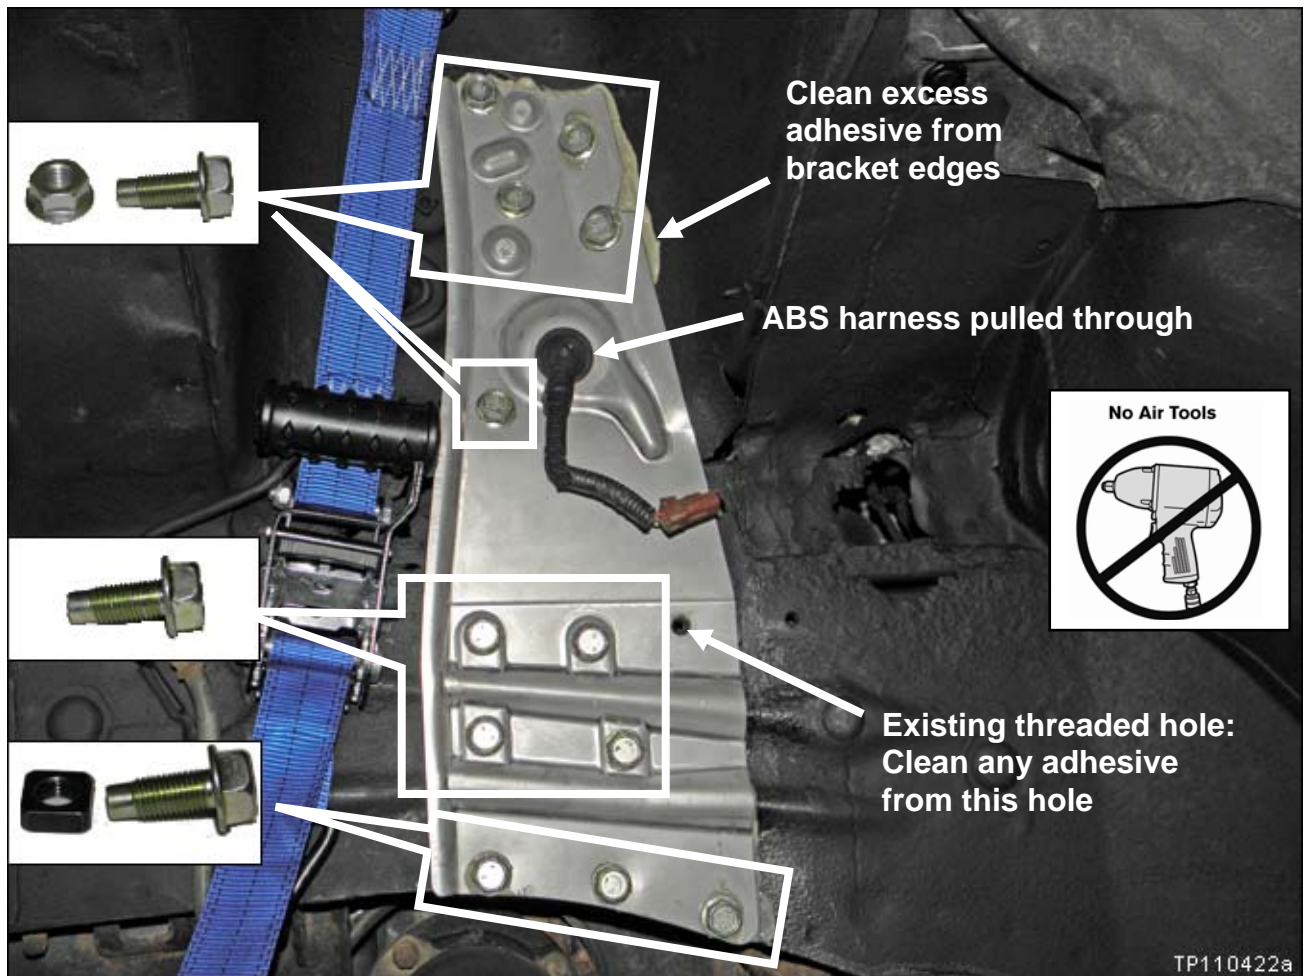
Figure RB25 – Driver side

- Driver side: make sure the ABS harness is pulled through its hole in the repair bracket.
- Use the correct nuts (see Figure RB25, or RB26 on next page, as it applies).
- **Do not use air tools to tighten the bolts.**
- Torque all new bolts/nuts to 50 N•m (5.1 kg-m, 37 ft-lb).
- Secure all existing bolts.

NOTE: See additional repair bracket bolt installation information on page 33.

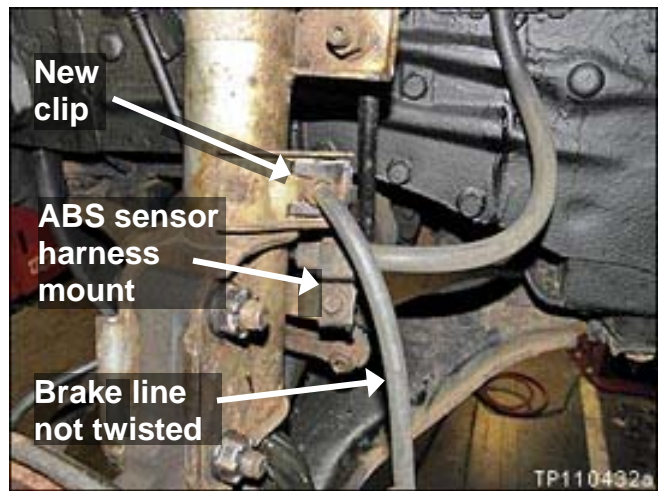
Figure RB37

- Use a new clip for the brake line mount (P/N 46206 – 2J00A).
- Confirm the ABS sensor harness is mounted correctly as shown in Figure RB37.
- Make sure the brake line is not twisted.

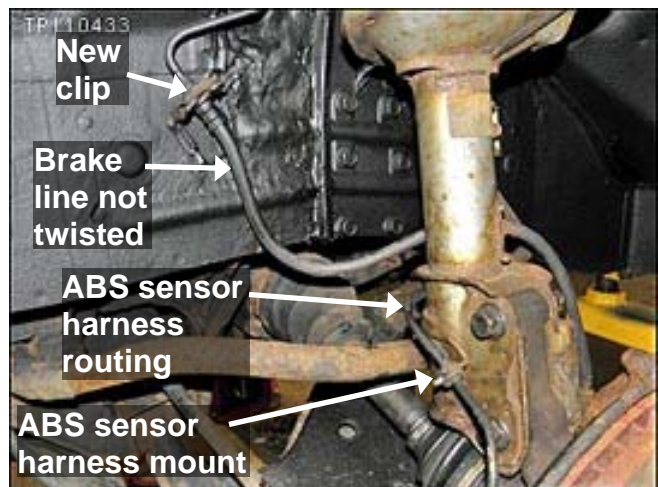
Figure RB38

- Use a new clip for the brake line mount (P/N 46206 – 2J00A).
- Make sure the brake line is not twisted.
- Confirm the ABS sensor harness is routed correctly behind the strut.
- Make sure the ABS sensor harness is mounted correctly as shown in Figure RB38.

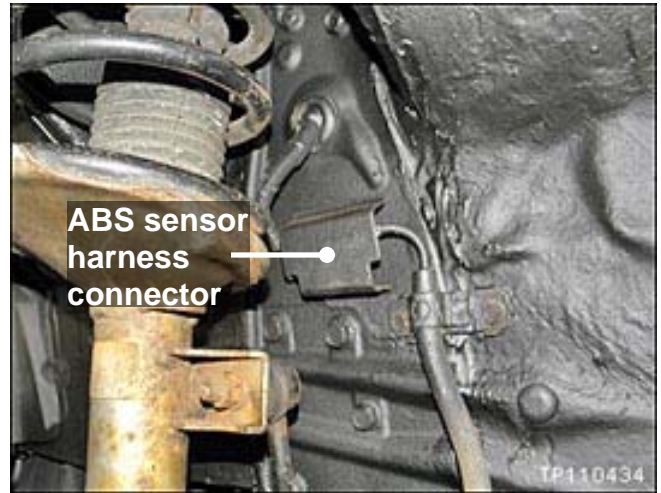
Figure RB39

- Make sure the ABS sensor harness connector cover is installed as shown.
 - If the cover is missing, install a new one.
 - Coat the cover with 3M Rubberized Undercoating (P/N 051135 – 08883); don't get any undercoat on the strut rod.

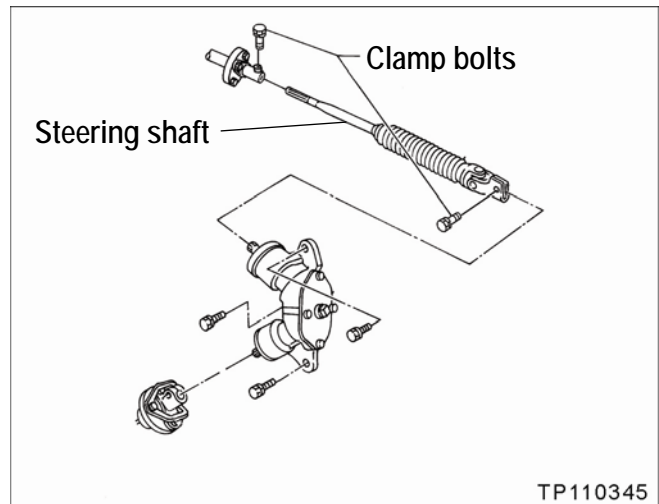
Figure SS1

2. Remove the clamp bolts at each end of the steering column upper joint (steering shaft).

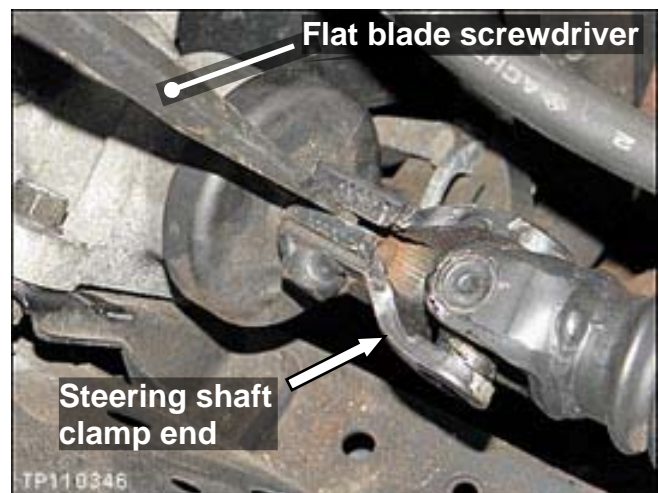
Figure SS2

3. Use a flat blade driver or other suitable tool to loosen both clamp ends of the steering shaft.

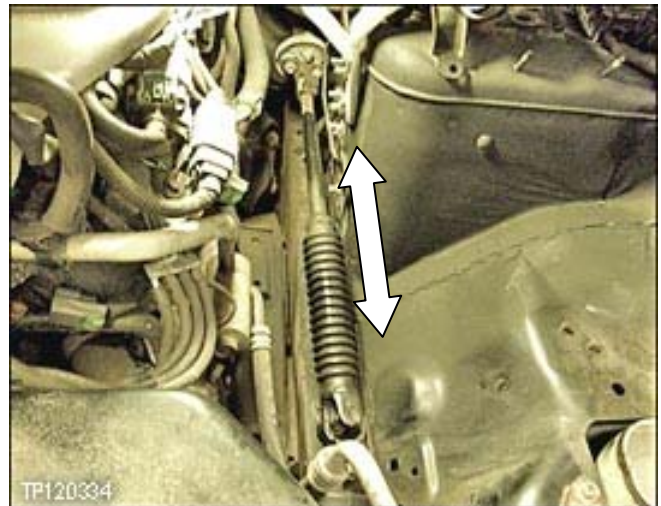
Figure SS3

4. Loosen the clamp ends enough so the steering shaft is loose at both ends.
 - Steering shaft will move back and forth a small amount.

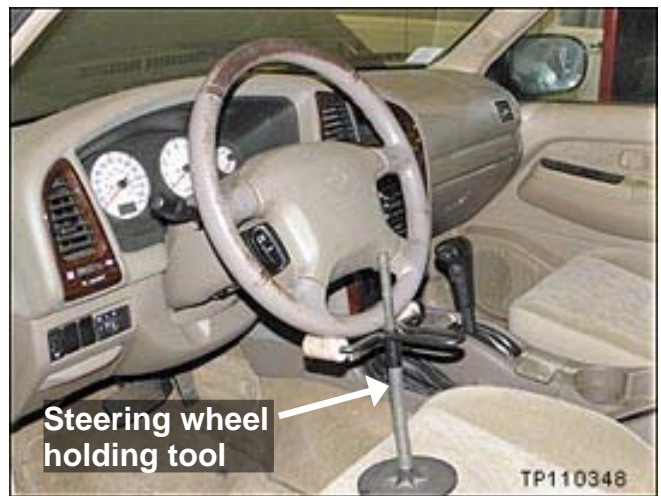
Figure SS4

5. Set the steering wheel in the straight ahead position.
6. Position a steering wheel holding tool as shown.
 - This will keep the steering wheel stationary while replacing the steering shaft.

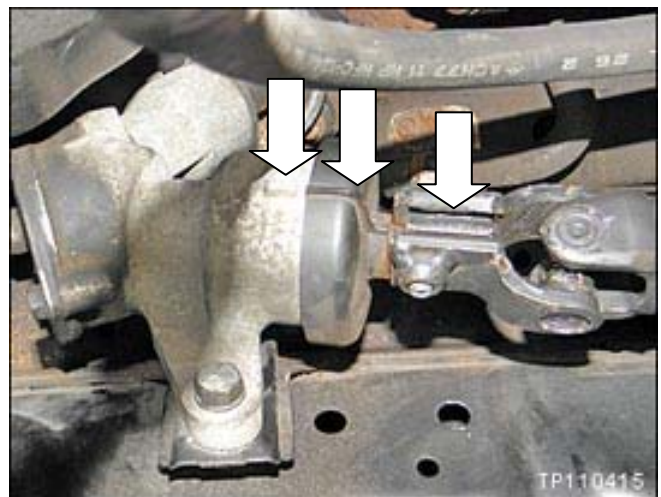
Figure SS5

- Tab on transfer gear assembly
- Raised area on rubber cover
- Gap on steering shaft clamp

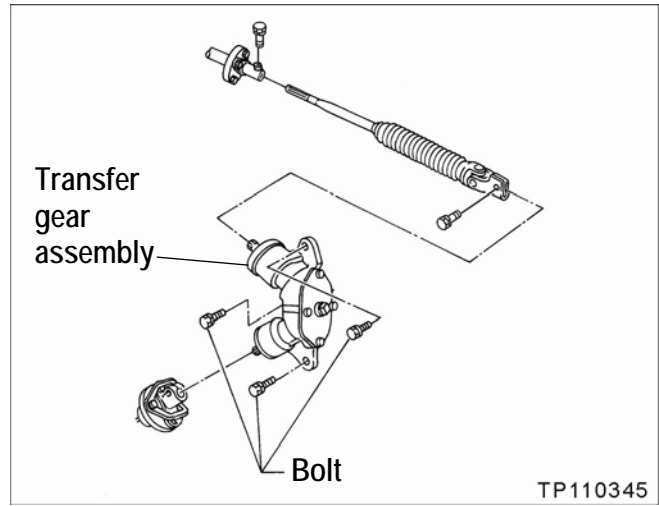
Figure SS6

7. Remove the 3 transfer gear assembly mounting bolts.

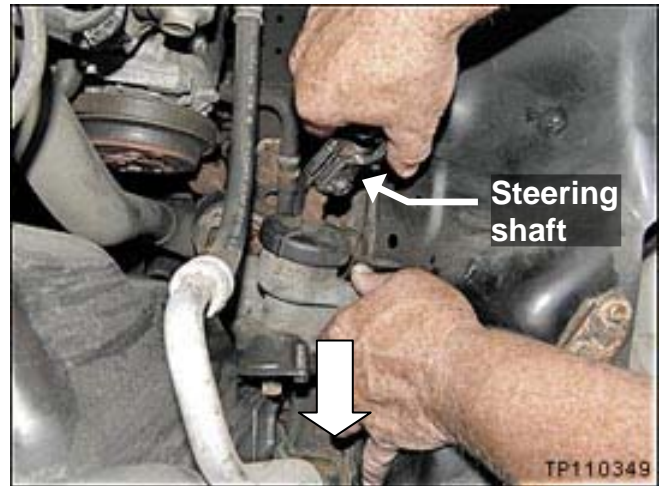
Figure SS7

8. Push the transfer gear assembly forward and remove the steering shaft.

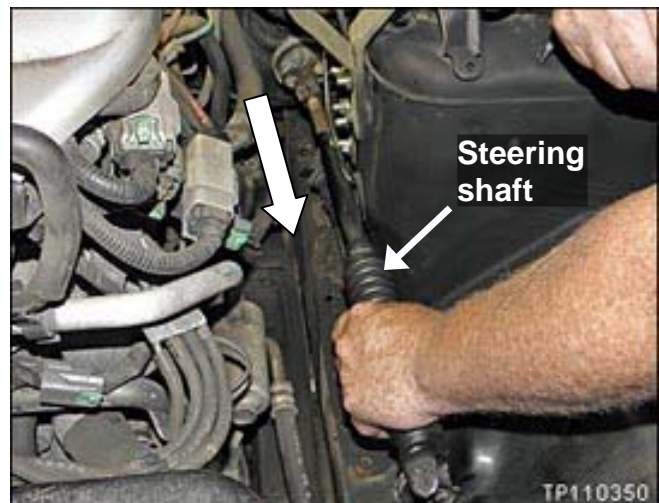
Figure SS8

9. Pull the steering shaft to remove it from the other end.

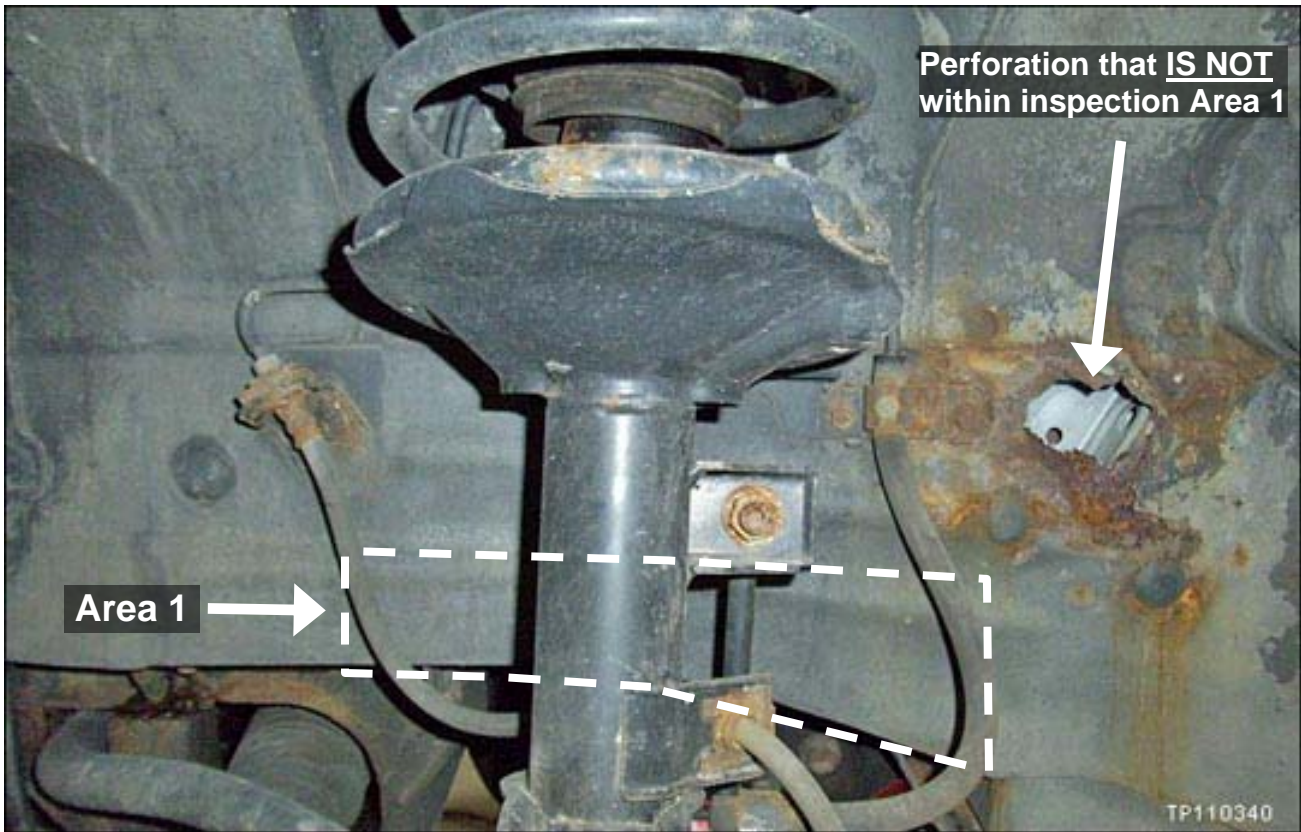
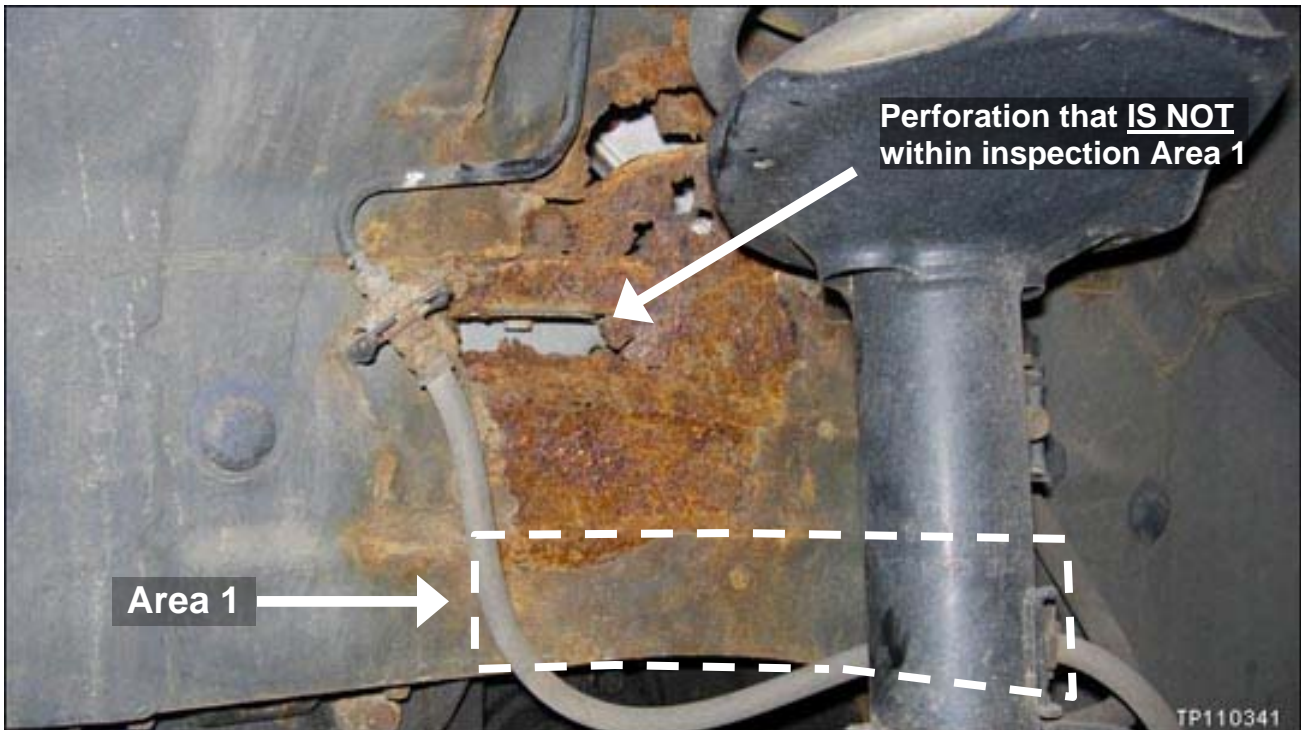
Example (Additional Photo) of Area 1 Perforation Inspection

Examples (Additional Photos) of Area 1 Perforation Inspection
